**Site Specific Environmental and Social Management Plan  
(SSE & SMP)**

**Site No. 27  
Sri Abhinawarama Viharaya, Lihiniyawa  
Kalutara District - Package 8  
October 2018**

**Sri Lanka Landslide Mitigation Project  
Asia Infrastructure Investment Bank  
(AIIB)**

**Environmental Studies and Services Division  
National Building Research Organization  
99/1, Jawatta Rd  
Colombo 05**

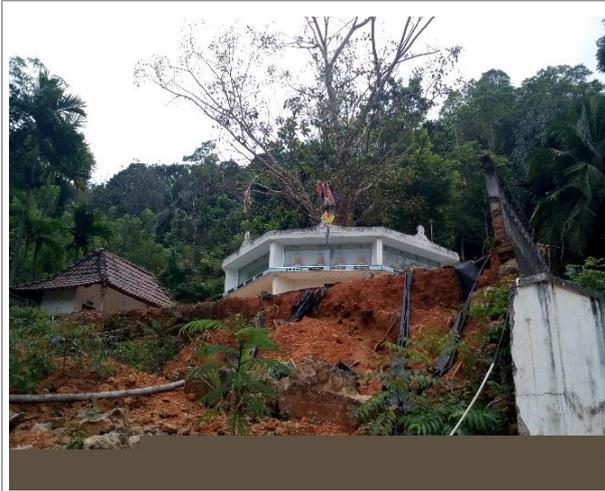
The location where the failure had occurred is on South –West escarp slope of the ridge, this slope is trending towards the North- West direction. The incident had resulted cutting failures at 2 places. One at the hermitage of the temple and the other adjoining the Bo tree. Due to this cut slope failure, the open space between rear wall of the hermitage and the vertical cut has been filled with debris. From the second failure, a portion of the retaining wall of the Bo-tree has been collapsed. At the inspection dislodged earth piles were observed behind the retaining wall of the Bodhi tree.

*Fig 2a: Cutting failure near the Bhoodhiya*

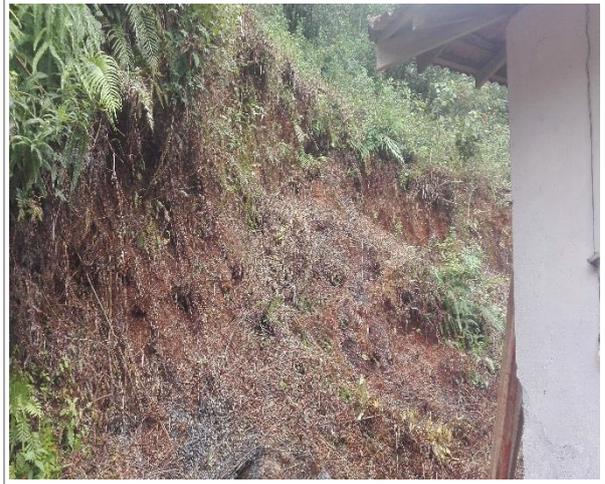
- i. The collapse at the hermitage had damaged the forest vegetation in the area.
- ii. There were no casualties due to the incident.
- iii. The incident had not caused damage or cracking to other buildings in the temple.
- iv. The retaining wall of the Bo-tree was partially damaged.

*Fig 2b: Area of cut slope behind the hermitage.*

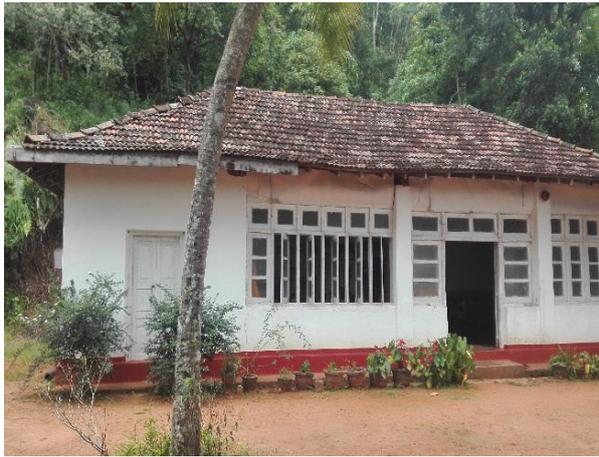
*Fig 2c: Hermitage of the Temple, the cutting failure had occurred on the slope behind this building. The natural forest vegetation on the hill crest is observed.*

As no any physical remedial measures were done to stabilize the slope and hence the destabilized slope sections at the two locations are at risk of future failure. The potential failure risks could be considered high as the slope is relatively steep. Due to this, especially the priest and the villages who are attending to various religious functions are exposed to high risk from potential failures

The nearest building (hermitage) may have some impacts in the form of structural damage during the project actions due to ground vibration induced by heavy machinery operation. Before the construction the building should be evacuated.

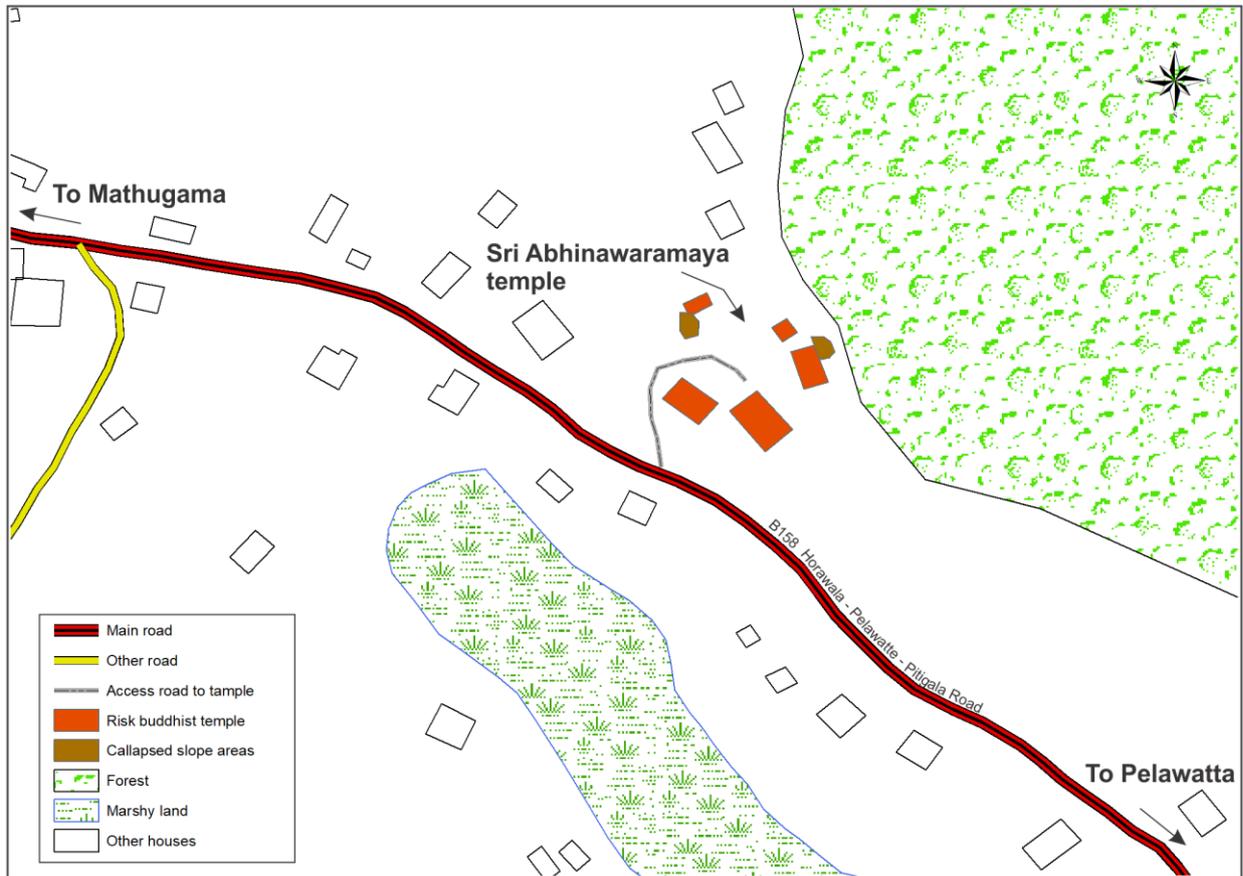
Fig 3: Diagrammatic interpretation of affected slope area and buildings due to ground movement

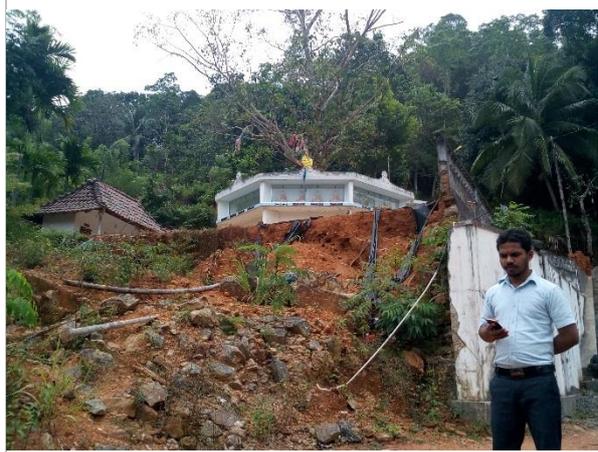
*Fig b: Collapsed wall around the Boodhiya.*

This risk may not be triggered in this site. There some damaged walls in the Bo-tree area, but can be removed without big obstructions.
