REDUCTION OF LANDSLIDE VULNERABILITY BY MITIGATION MEASURES PROJECT

Site Specific Environmental and Social Management Plan

Site No. 150

**Failed Slope between culvert No. 98/4 and 99/1 of Colombo Kandy Road
A-001 (Pahala Kadugannawa area)
Kegalle District**

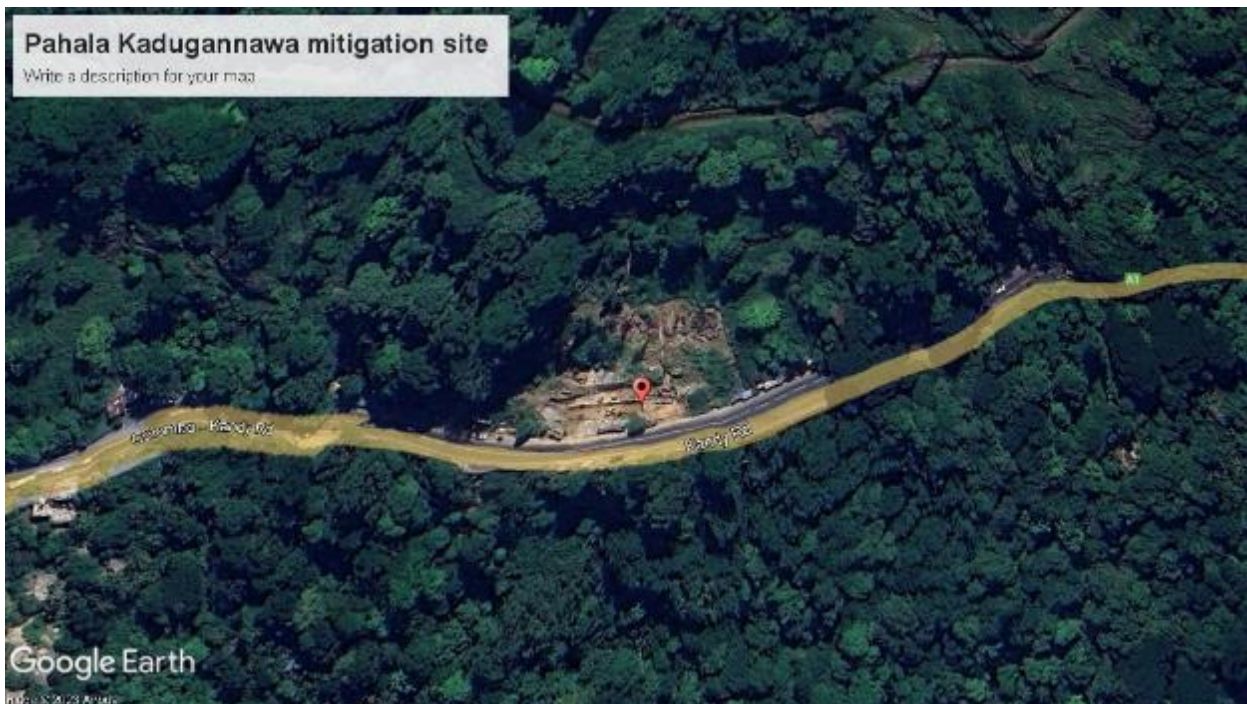
Figure 2: Google image of the proposed landslide mitigation site, the surrounding environmental features and service infrastructure.

Refer figure 2: Google image and 3: Drone image of the proposed landslide mitigation site showing the surrounding environmental features and service infrastructure.

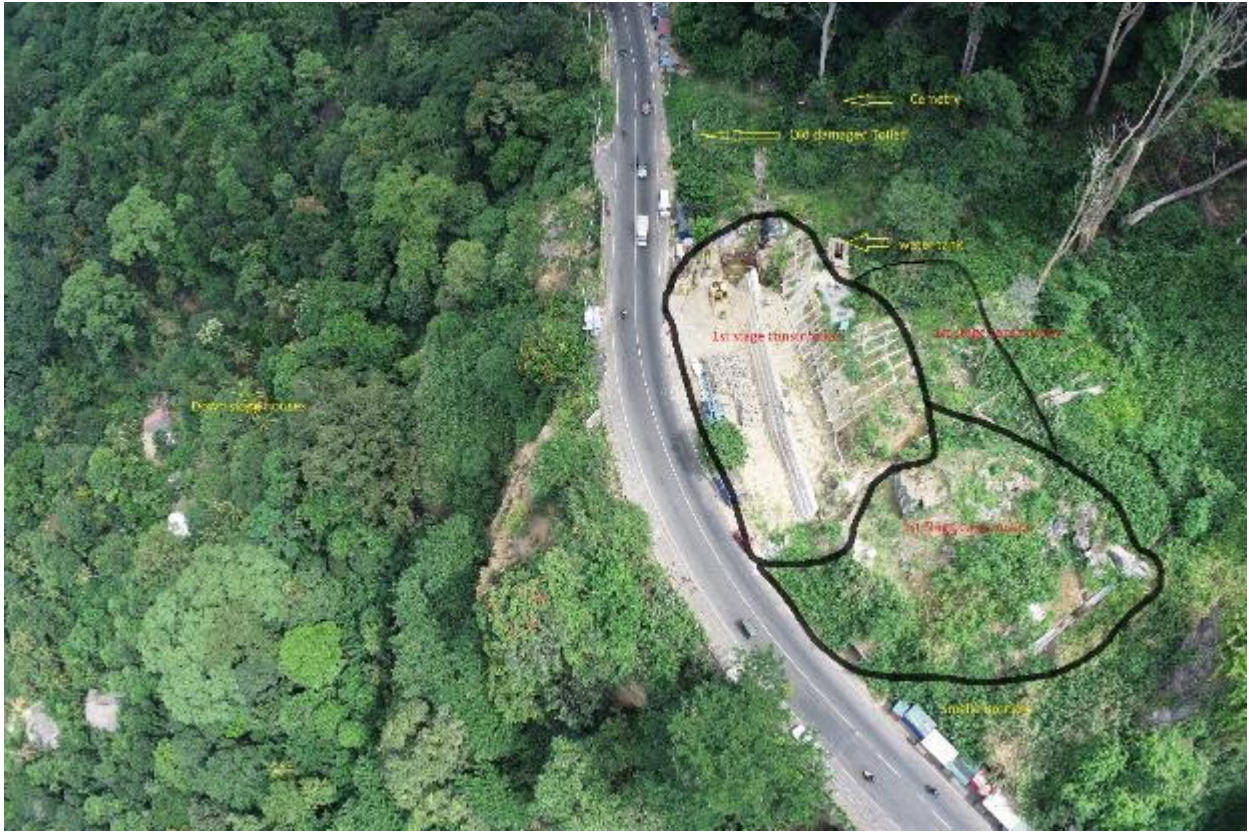
Figure 3: Drone image of the proposed landslide mitigation site, the surrounding environmental features and service infrastructure.

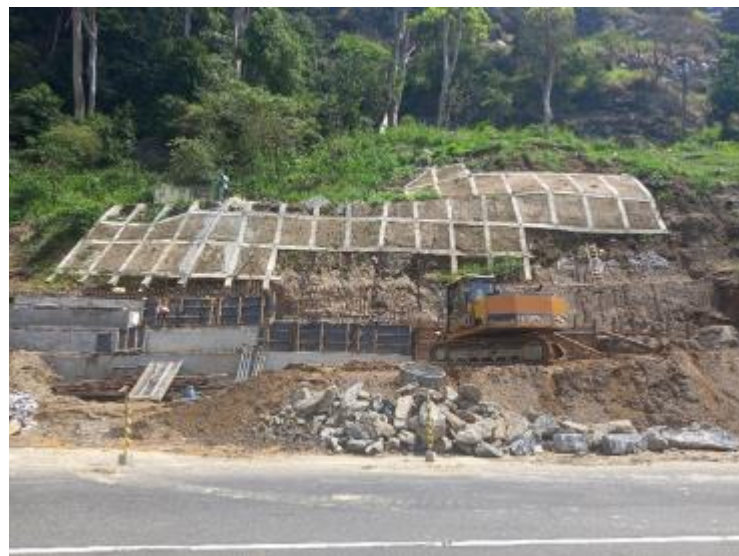
Figure 5: Illustration of current situation of the site

Construction of cascade drains has been stopped in its halfway leading for high water flow into the landslide body. b) Soil nailing works have not been completed yet, leaving a stretch of unprotected steep slope section with a high probability to fail during a heavy rain, with the absence of a properly functioning

drainage management system. c) The toe wall has been constructed for a length of 42 m for which the backfilling has not been carried out while 94 m of toe wall is remaining to be completed. Accordingly, the toe wall is not providing the designed toe support, essentially making the total slope segment unstable
d) Part of the unstable debris mass displaced during the landslide situation in 2021 are still deposited on the steep slope, which can dislodge easily into another catastrophic failure or a debris flow during the next monsoon season (*Please refer figure 5*).

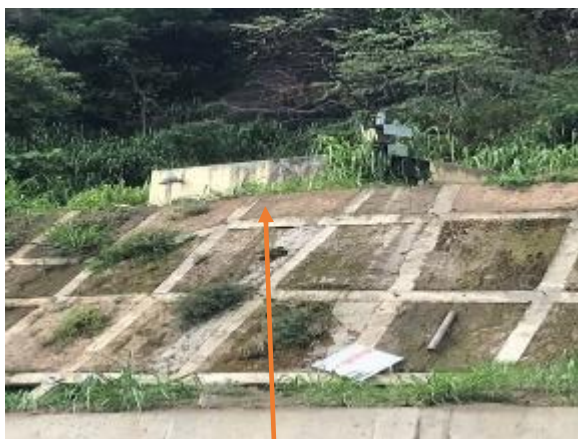
Figure 7d: Water tank

A water tank of National Water Supply and Drainage Board that was constructed in 1989 to collect the spring water for the use of the settlements of the downslope area is located immediately at the upslope area of the site. Currently, the tank and the supply lines are not functioning. An old damaged toilet complex is located between the road and cemetery area and is currently not functioning.

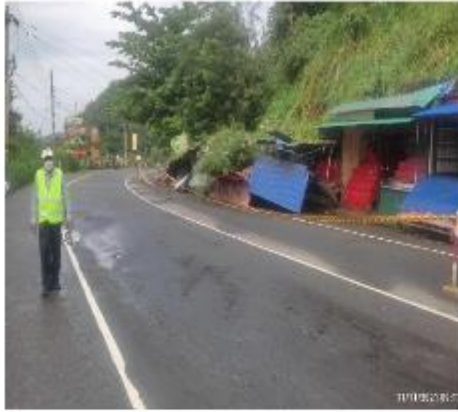
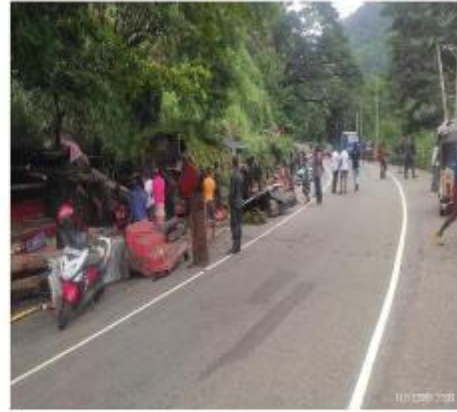
Figure 3-2 Land slide areas between culverts 98 / 4 to 99 / 1

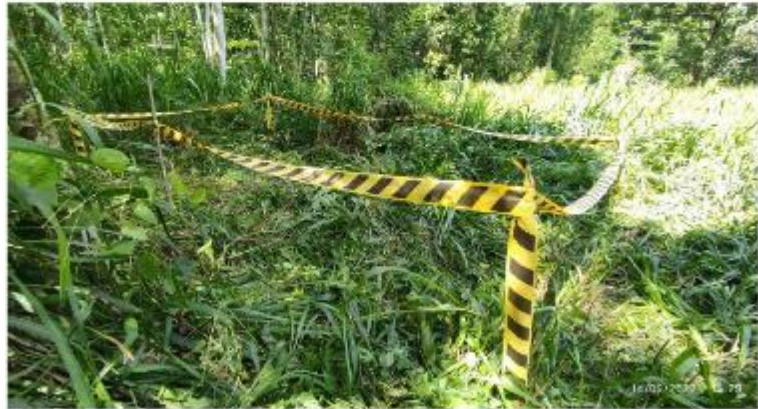
Figure 3-6 Proposed land area for re burial of remains at Ganethenna Cemetery

17. An order was issued by the District/ Magistrate's Courts, Mawanella to the remains in the cemetery (only 850m² area) at the Ganethenna Public Cemetery near the Samurdi Bank, which is located in Ganethenna GN Division of Mavanella Divisional Secretary Division (GPS Location – 7°14'45.2"N 80°29'33.1"E.). 29 graves have to be reburial and the proposed land extent will be 44.5 m² (Annex 08) for re burial process. Relative of the graves have agreed to re burial the graves in one place. Consent from the executive committee (Maranadara Samithi, Mawela) has been already issued for this relocation. (Annex 09).

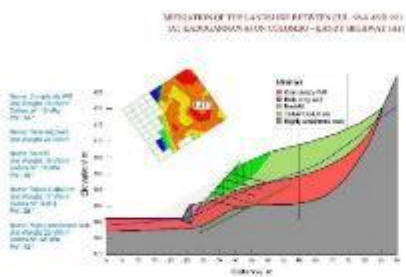
Figure 19: Design stability analysis result for connection #1 (FOS = 1.47)

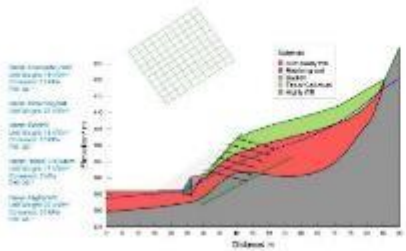
Figure 20: Geotechnical model prepared for design stability assessment of connection #2

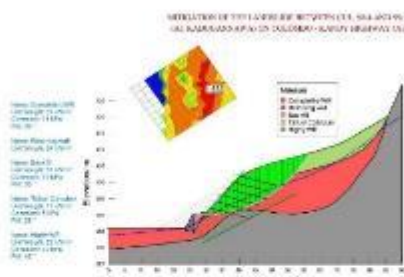
Figure 21: Design stability analysis result for connection #2 (FOS = 1.68)

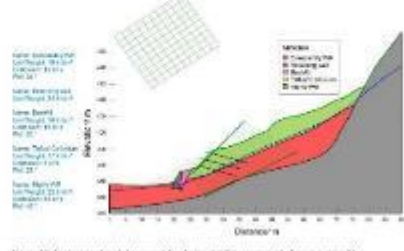
Figure 22: Geotechnical model prepared for design stability assessment of connection #3
