REDUCTION OF LANDSLIDE VULNERABILITY BY MITIGATION MEASURES PROJECT

Site Specific Environmental and Social Management Plan

**Site No.104
Deniyaya Hospital
Matara District**

November 2022

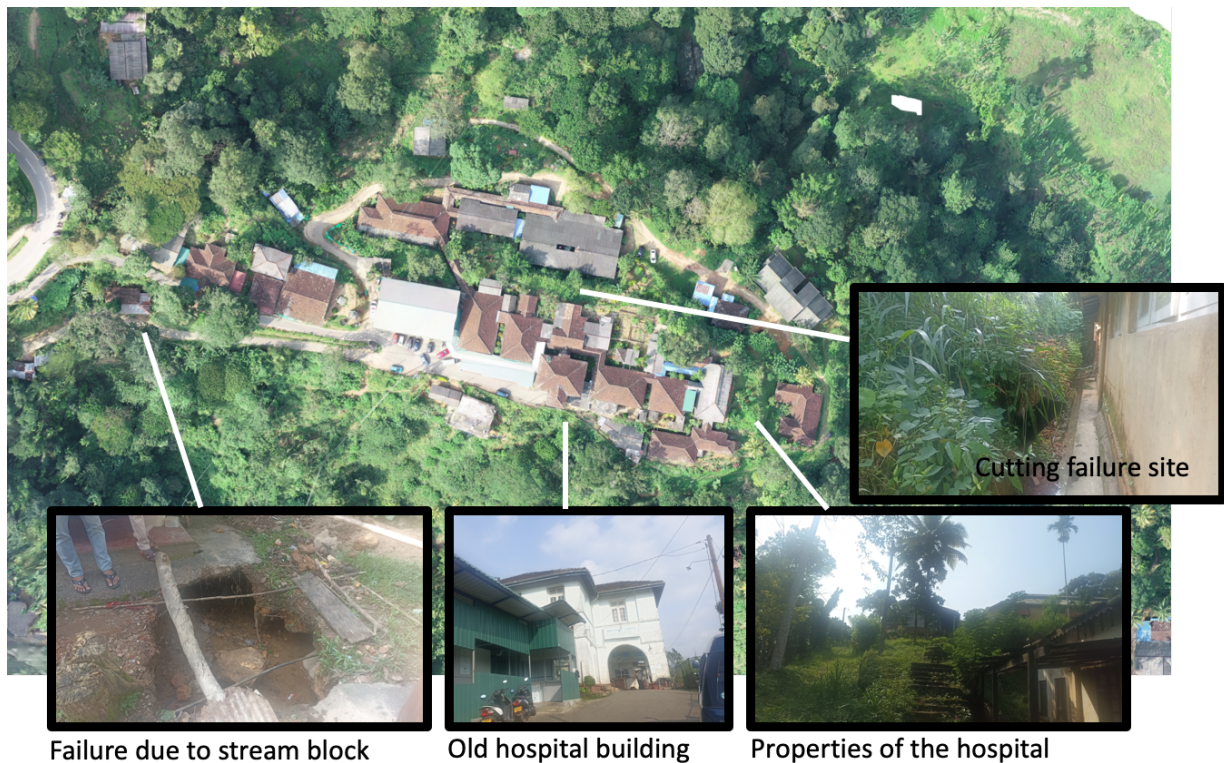
It could be observed small-scale slope instability situations in the area of the scar of landslide occurred in May 2003. Due to that, a negative impact could take place to the porch area of OPD building. Further, as that area is situated in the scar of the landslide, it can also affect the stability of the building. The slope situated in southern direction to the OPD building belongs to landslide risk area

According to Landslide Research and Risk Management Division of NBRO, District office Matara tension cracks had occurred due to a landslide situation in May 2003 adjacent to the building and were developed to western direction from the scar of landslide for a distance of about 20 m along the access road. These tension cracks in access road area for OPD of the hospital have been widened due to heavy rain occurred in 2013. RDA has applied tar on the tension crack. A slight land subsidence could also be identified along the tension crack. Several cracks could be observed in the pavement of the porch of the OPD building and they are located closer to scar of the landslide occurred in May 2003. Along the cracks, there is a vertical settlement of 0.25 inches, for a horizontal settlement of one inch (Opening). Further, several cracks could be observed which have been formed from top to bottom of the wall in porch area. In the access road of the hospital, in the area opposite to office buildings, there is an instability around the south bank and at that slope also, a tension crack has been developed and a slight land subsidence has also taken place. It could be observed that solid waste has been deposited in the sloppy area. It could be observed some cracks on the floor of the southern corner part of the building of Ward number 5. Those cracks are developed parallel and tangential to the slope. There is a cut slope with 2.75m height, situated with 4.5m distance to the southern direction to mentioned building and a random rubble wall is constructed there.

Ref. Figure 3: Risk elements and the special features of the location
