## REDUCTION OF LANDSLIDE VULNERABILITY BY MITIGATION MEASURES PROJECT

Site Specific Environmental and Social Management Plan

**Site No. 43**

**St. John Boaco's College (Primary Section) - Hatton  
Nuwara-Eliya District**

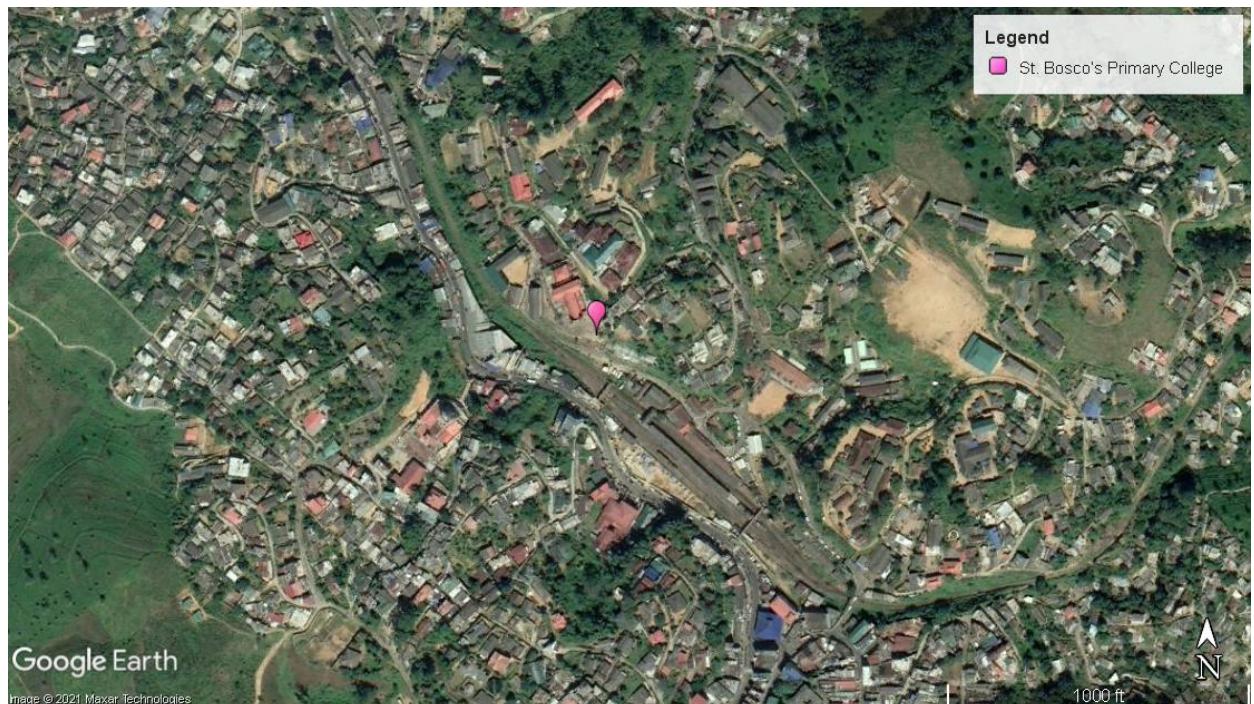
Figure 2: Google image of the proposed landslide mitigation site, the surrounding environmental features and service infrastructure.

The proposed mitigation site is located within the St. Bosco's Primary College premises. The extent of the land area of the school is about 50 perches. The general topography of the school is characterized by undulating slopes. The school stand towards to the Hatton railway station. The school is bordered by St Cross Church, private lands and Bosco road.

The land ownership is the Department of Education. The church land is owned to the Bishop of the Central Province. The school has a population of 600 students from grade 1 to 5, 18 teachers at present. *Ref. Fig 2 for Google image of the proposed landslide mitigation site and surrounding features and service infrastructure.*

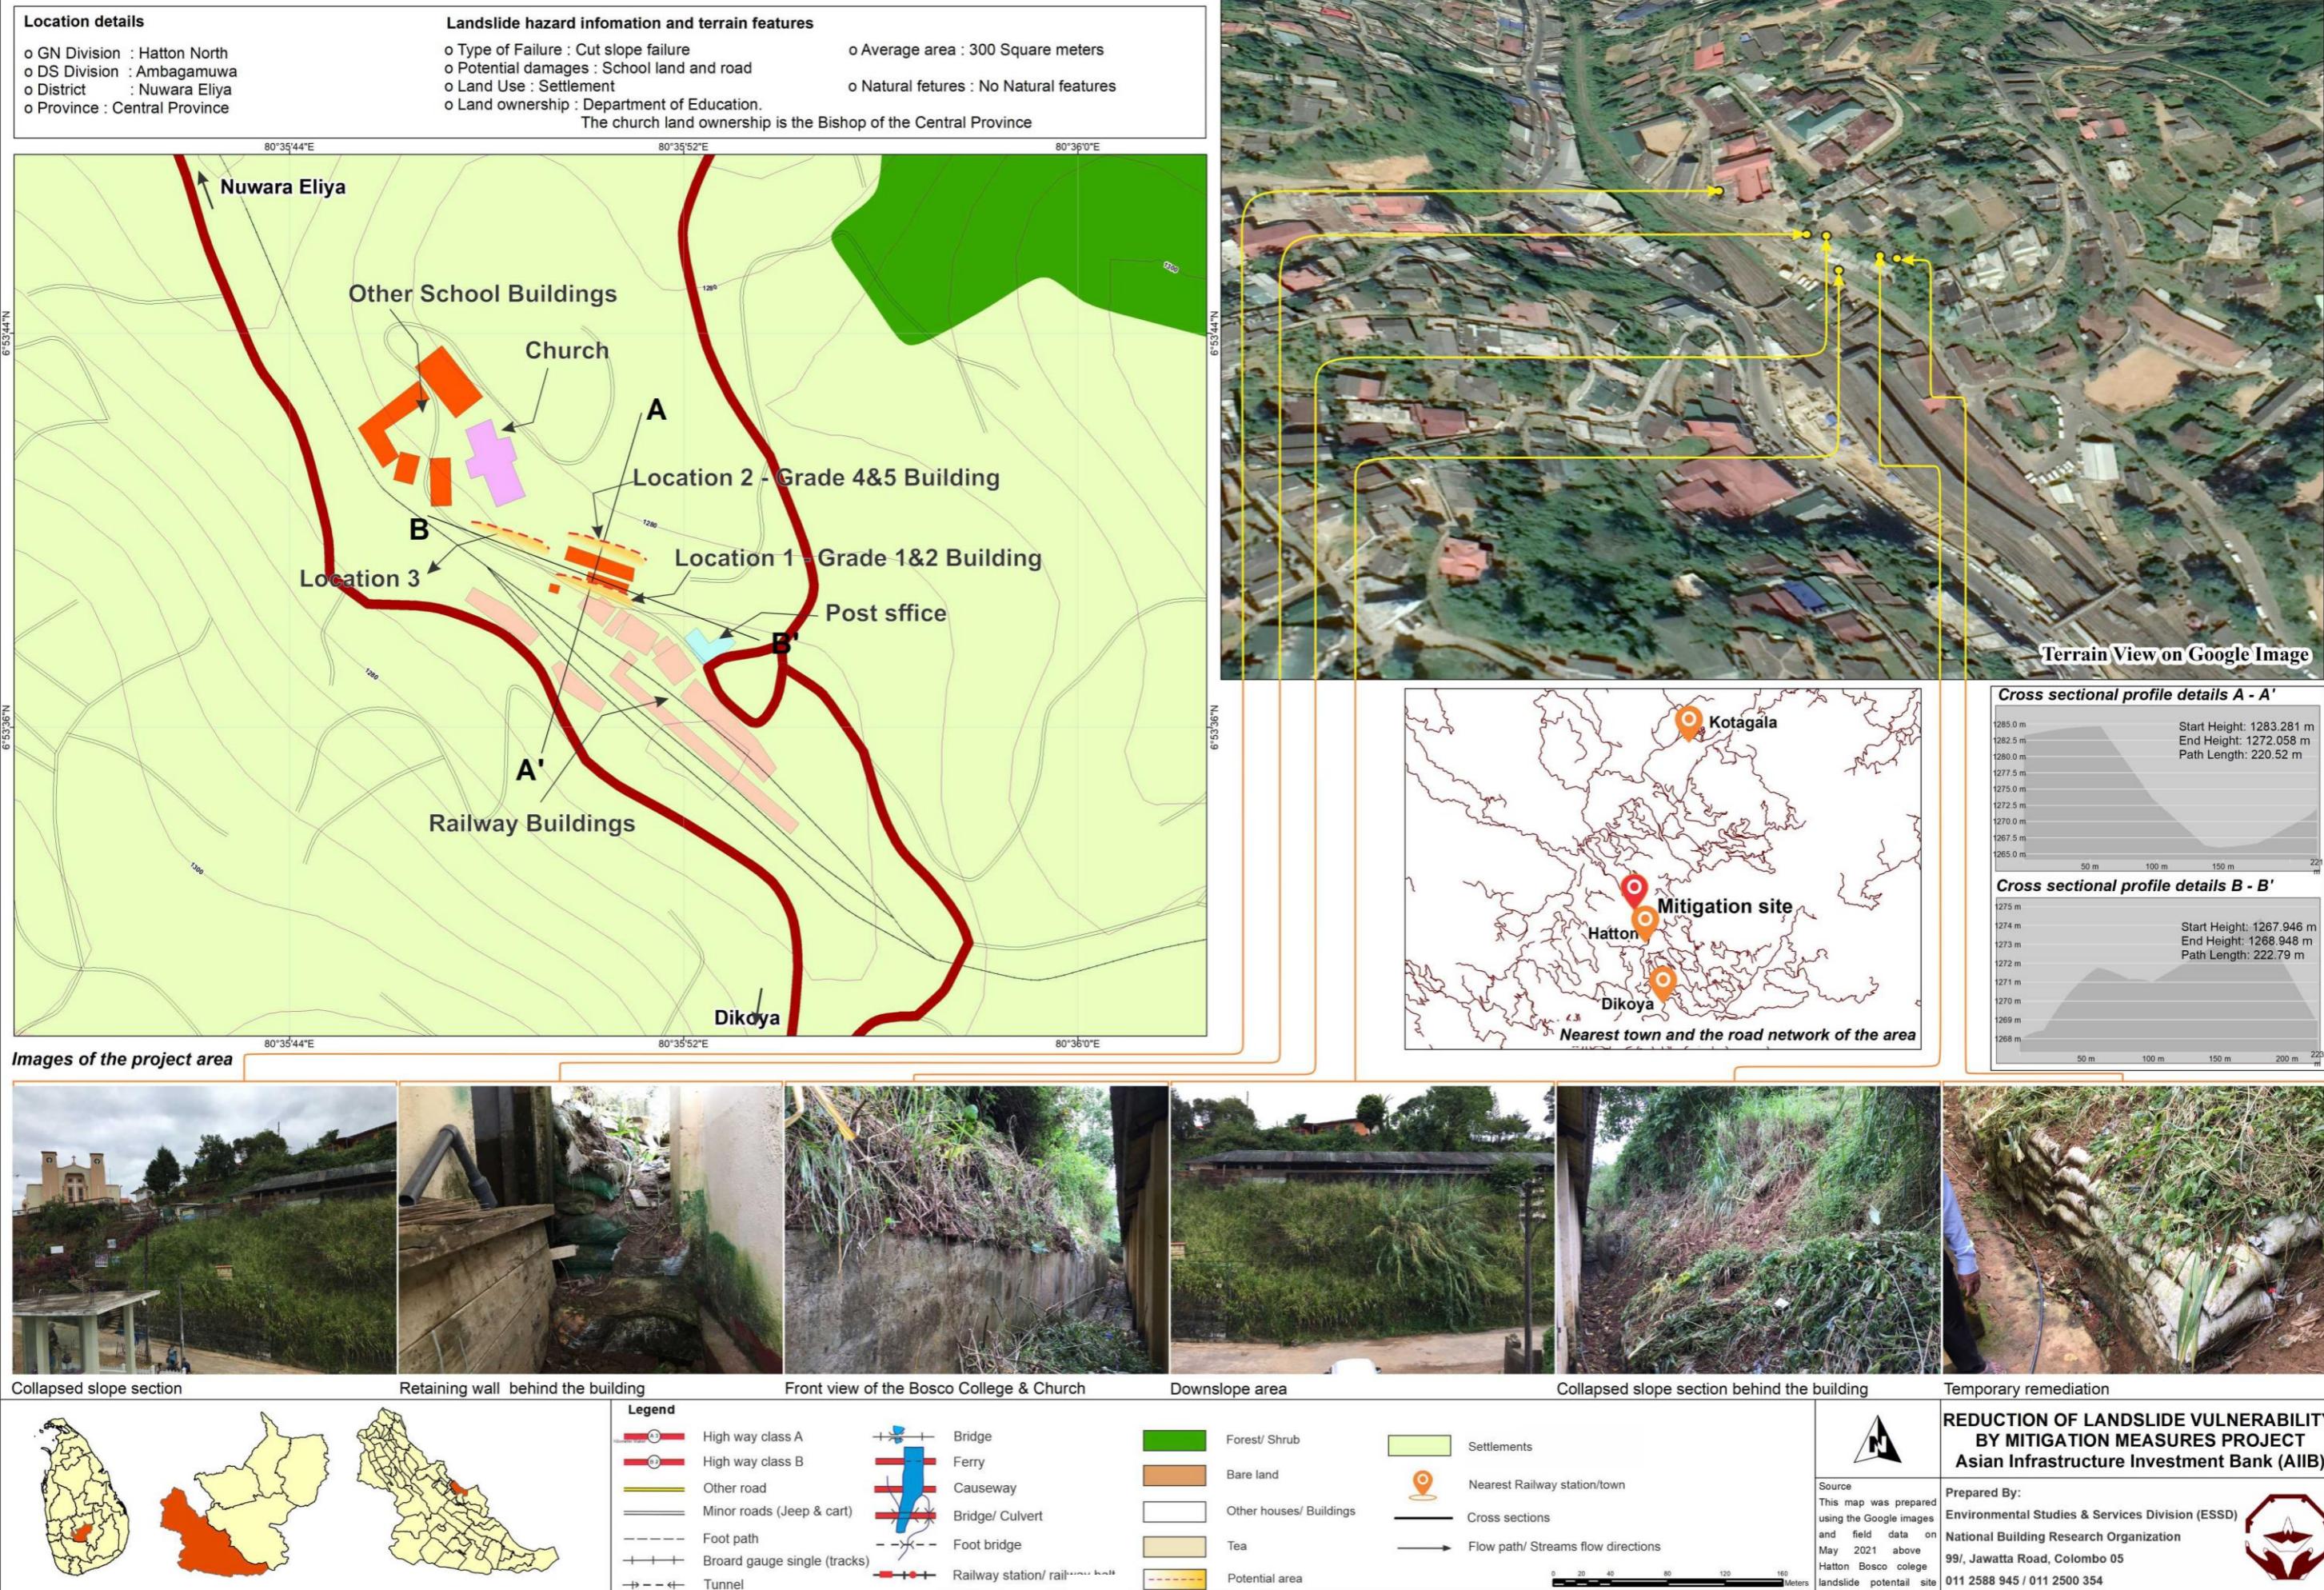
Figure 3: Google image, cross sections, land use, risk elements and the photographs of special features of the location

The observations of the upslope area indicates, the main cause of the slope failure and instability is cut slopes and poor drainages within the school premises. Several cuts too have been made in the sloppy lands within the school premises for buildings. This also has contributed to slope instability and cutting failures. The slope modifications have not followed engineering slope stability norms while drainage management on the slopes were poor. The cumulative impact had resulted cutting and slope failures. The tension cracks had appeared in the floor in front of the church boundary wall.

*Refer Fig 3: cross sections, land use, risk elements and the photographs of special features of the location.*

The proposed project aimed to combat further progressive failure of soils/slopes. The school and church premises are highly potential to damage by for cutting and slope failures; therefore, preventive measures such as soil nailing, reshaping, turfing and surface drainage management will be implemented as the mitigation measures.

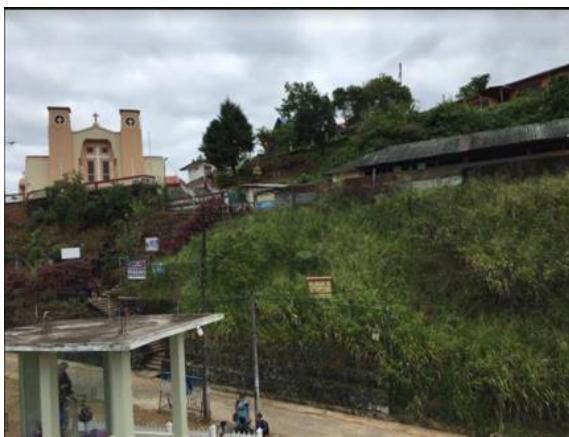
Figure 4a: Front view of the school and church

**Location 3:** The boundary wall of the St. Cross church has cracked due to the surcharge of the filled soil. The tension cracks can be seen at the floor near the boundary wall. The St Cross church is the historical Roman Catholic church in Hatton. It has 175 years of historic period. Currently about 1800 Roman Catholic families are engaging with the church religious activities. A Sunday Dhamma school is held with 600 students by the church.

- i. School children, teachers and non-academic staff
- ii. School buildings
- iii. Activities of the school
- iv. Teachers' parking facility
- v. Septic tank and sewage lines
- vi. Water conveying lines to school
- vii. Catholic statue at the downslope
- viii. Church and its religious activities, devotees
- ix. Bosco road and its commuters and pedestrians

Ref. Fig.4 Sensitive elements that may be affected by the project actions.

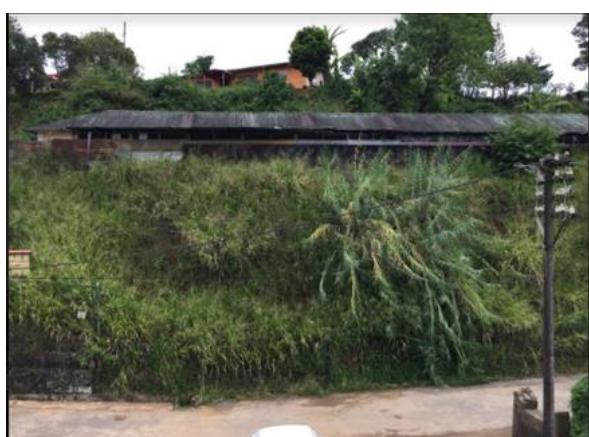
**Location 1:** The location 1 is a slope behind the building of grade 1,2 and it slopes towards the Bosco road. This slope is identified as a cutting failure. The unstable slope behind this hall is with an inclination of about  $60^0$ . The primary section of the school comprises of two buildings, staff room, principal's office and toilet complex. The adjacent building to the unstable slope has no proper storm water drains. A retaining green net had been constructed at the downslope sloppy area. About 600 students are studying at the primary section. Eighteen (18) teachers are in the primary section.

Figure 4b: Unstable slope of the location 1

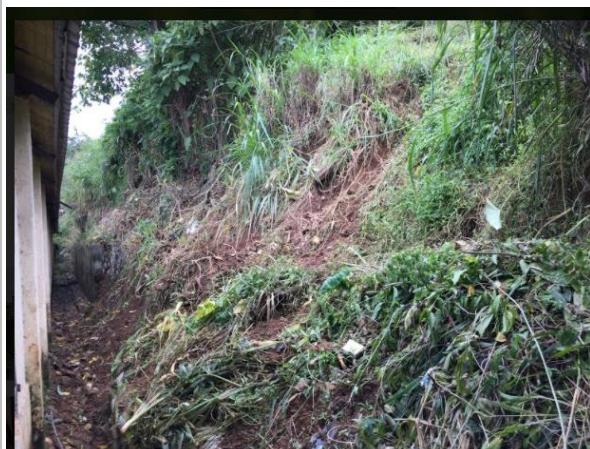
**Location 2:** The unstable slope behind the building of grade 3,4,5. The slope is at about  $60^0 - 70^0$  inclination. Toilet complex, septic tank and sewage lines are located in the right-hand side of the unstable slope. Eight classrooms are located in this building and building is at high risk.

Figure 4c: Unstable slope behind the grade 3,4,5 building (location 2)

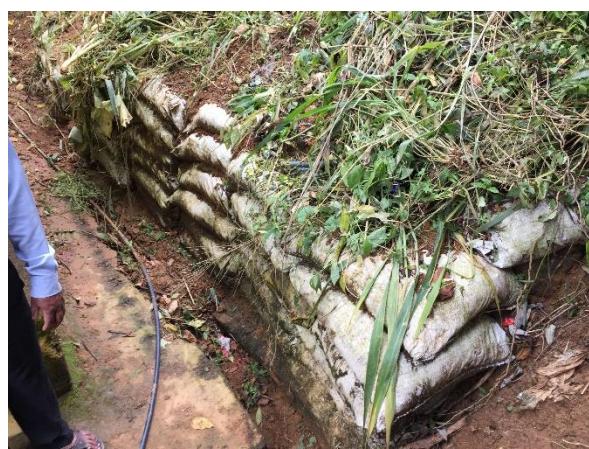
With the occurrence of cut slope failures and unstable slope sections in surrounding areas of the school premises, the school management has constructed a green net to reduce the slope failure towards the road and also constructed concrete wall and a retaining wall (soil bag) behind the building of grade 3,4,5.

Figure 4d: Constructed soil bag retaining wall (location 2)

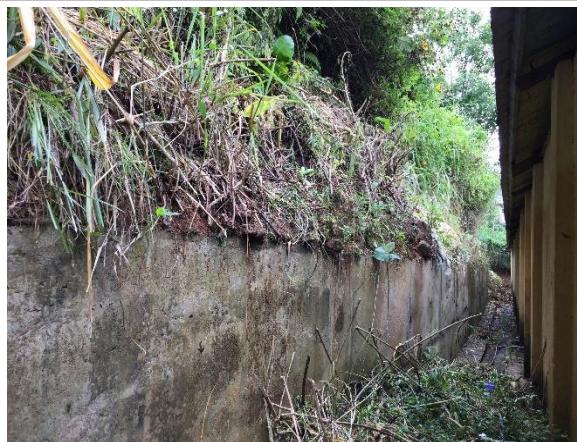
Figure 4e: Constructed concrete retaining wall (location 2)

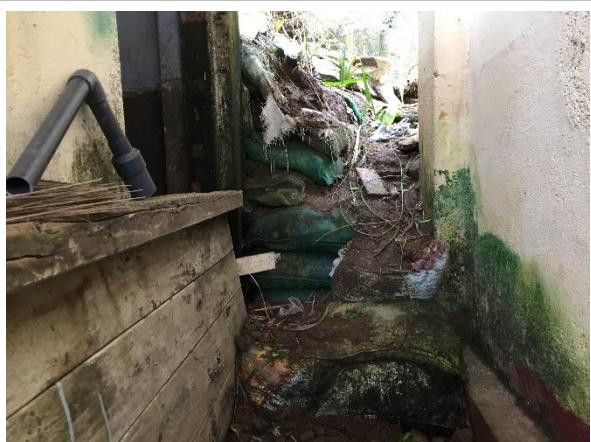
Figure 4f: Damaged toilet complex (location 2)

<b>xiv. Impact on septic tank and sewage lines</b> The septic tank and the sewage lines of the school is located near the unstable slope (location 2). During construction period these sewage lines may be damaged. Therefore, necessary actions should be taken.	Site preparation & construction	Construction Contractor
<b>xv. Use of sanitary facilities of contractor's workforce</b> School management does not allow using toilets of the school for the contractor's workforce. Therefore, separate sanitary facilities should be arranged for the workforce.	Construction	Construction Contractor
<b>xvi. Working hours</b> The construction activities should be in accordance with school management. Noise, vibration and dust generation activities should be carried out after school hours, however, not disturbing the devotees and students of Sunday Dhamma school (during works at location 3). During exam times disturbing (noise and vibration) activities are not allowed. Night time operations at location 1 & 2 are allowed only during school vacations.  If night time operations are required to achieve project targets such works should be carried out with adequate safety measures and the consent from the school management. The construction activities at the location 3 should be carried out not obstructing the activities and the devotees of the church.	Construction	Construction Contractor
