REDUCTION OF LANDSLIDE VULNERABILITY BY MITIGATION MEASURES PROJECT

Site Specific Environmental and Social Management Plan

**Site No.76 – L1
Ella – Wellawaya Road (near 23 km post)
Badulla District**

March 2022

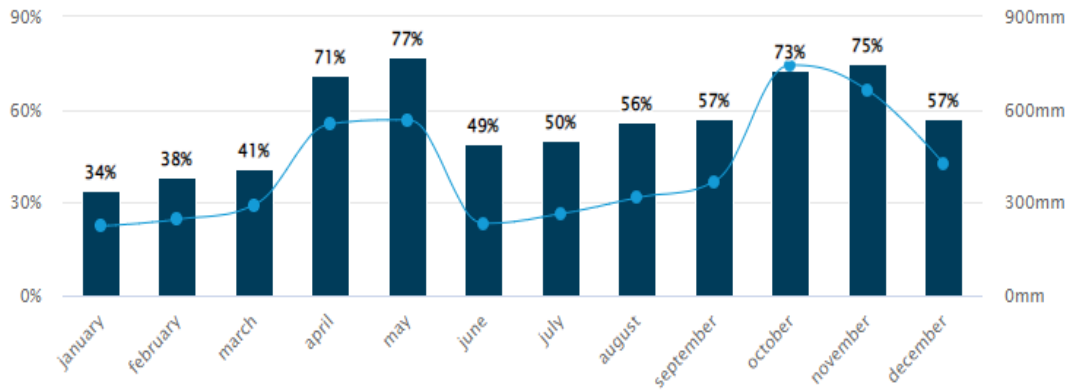
Figure 3: Precipitation (Rainfall) in Ella

Ella is one of the most visited tourist places in Sri Lanka, and climate plays major role on tourist decisions. Accordingly, Ella enjoys an equatorial (or tropical rainforest) climate in accordance with the Kappen-Geiger classification. The yearly average maximum temperature in Ella is 27°C (ranging from 25°C in December to 28°C in April). Annual rainfall is about 4500 – 5000 mm, with the minimum in January and maximum in October (Ref figure 3 below).

So, while implementing the mitigation measures, two things need to be considered; firstly, off tourist seasons, secondly, low rainy period. Accordingly, making flexible schedule would reduce the impact.

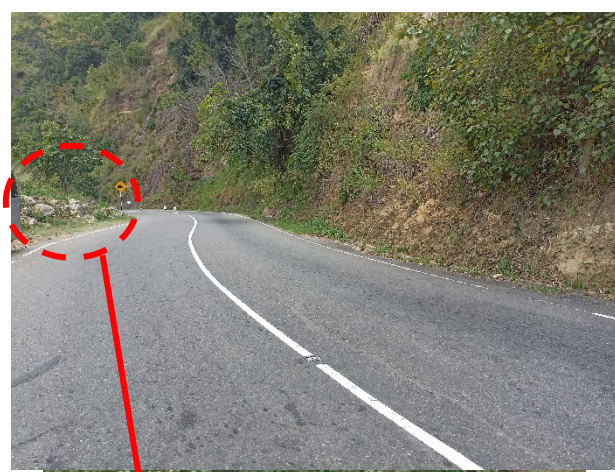
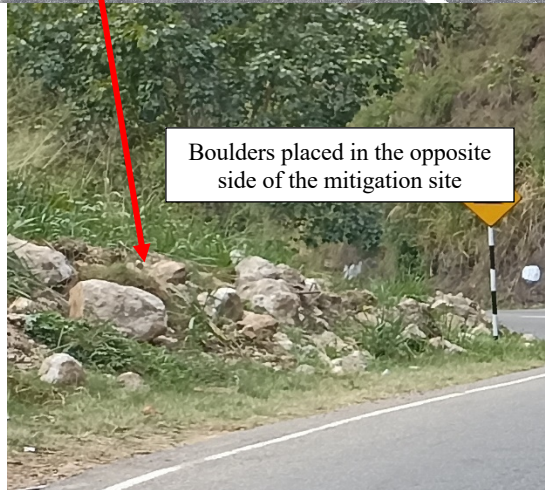
Figure 6a: Ella-Wellawaya (A23) road located adjacent to the cutting failure

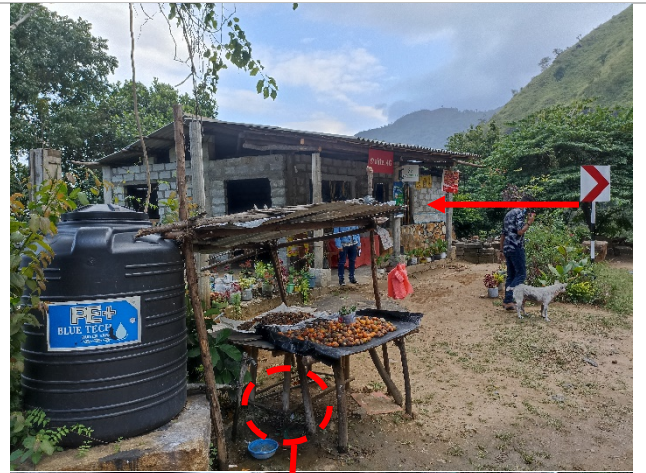
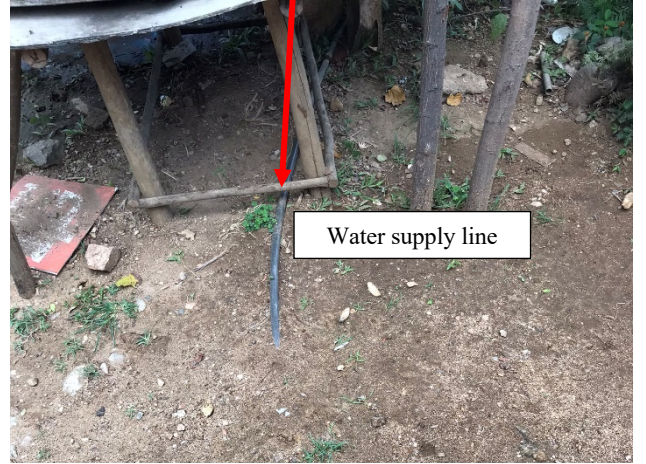
Figure 6b: Shop cum house building located in front of the mitigation site and the water supply line

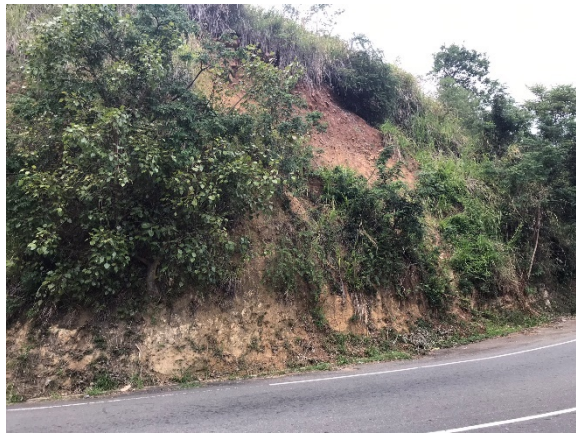
Unstable slope area

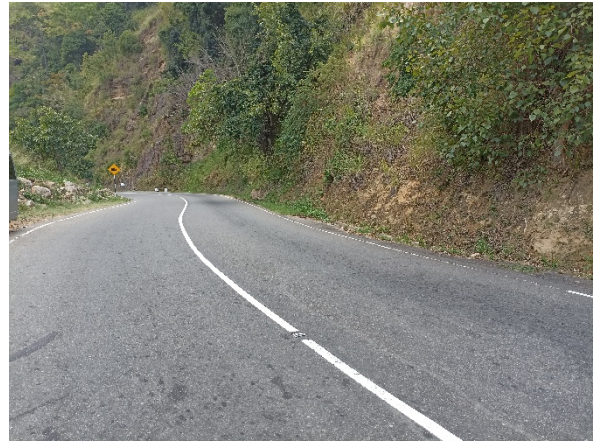
Unstable slope and the Ella-Wellawaya (A23) road
