REDUCTION OF LANDSLIDE VULNERABILITY BY MITIGATION MEASURES PROJECT

Site Specific Environmental and Social Management Plan

**Site No.85 – Location 02
Isipathana Mahamewna Asapuwa
Dodangoda
Kalutara District**

May 2021

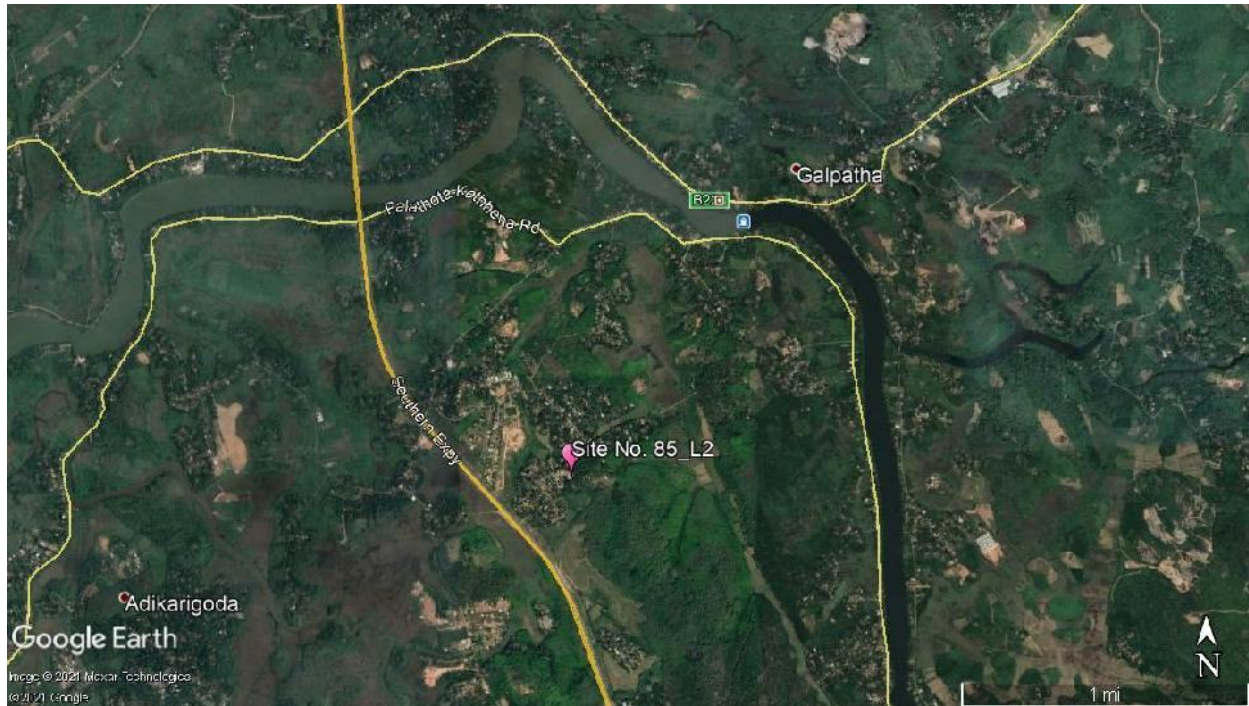
Figure 2: Google image of the proposed landslide mitigation site, the surrounding environmental features and service infrastructure.

The proposed mitigation site is located within the Isipathana Mahamewnaw Asapuwa (Temple) premises. General ground slope angle is around 30° - 32° directed to north –west. Total height of failed cut slope is 10 m – 12 m, and length of the unstable cut is 24 m. 1 m thick colluvium soil layer present at the top underlain by silty SAND residual soil layer

(Ref. Fig 2 for Google image of the proposed landslide mitigation site and surrounding features and service infrastructure.)

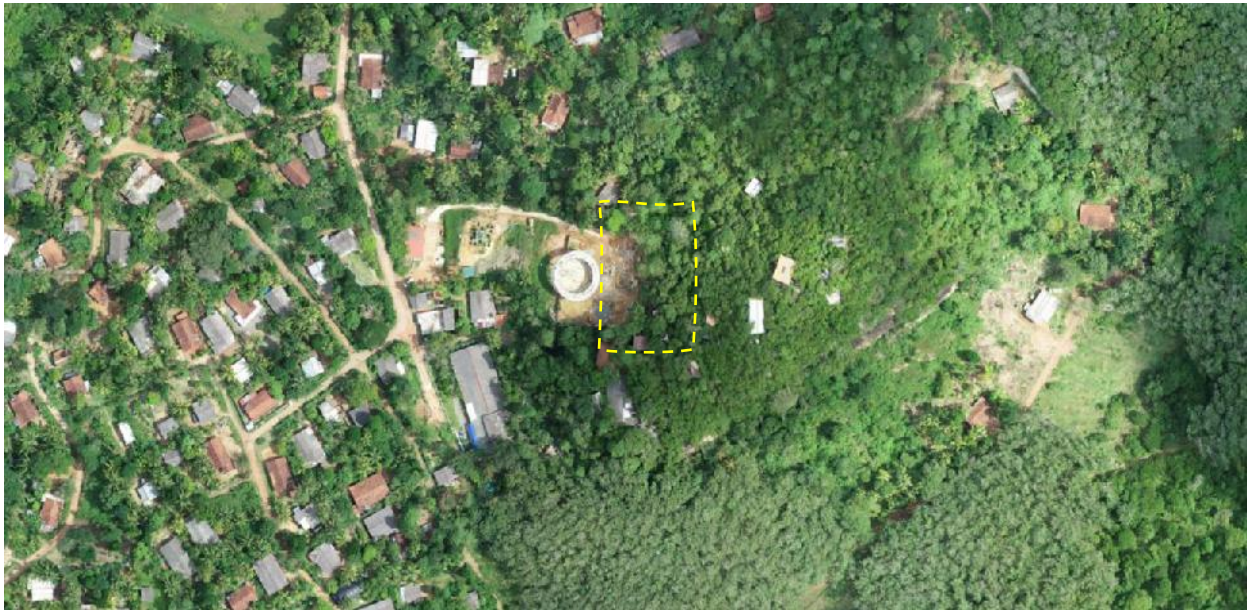
Figure 3: Landslide Incident area and the cross section (Source – Drone Image captured by NBRO)

As per the previous studies, the main cause of the slope failure and instability due to the cutting failure which was occurred while constructing massive retain wall near the Dagoba. Slope modifications did not

follow engineering slope stability standards and slope drainage management in the site absences. Slope instability is caused by excessive rainwater infiltration due to improper land use practices. Due to the failure debris of the rubble spread over the area.

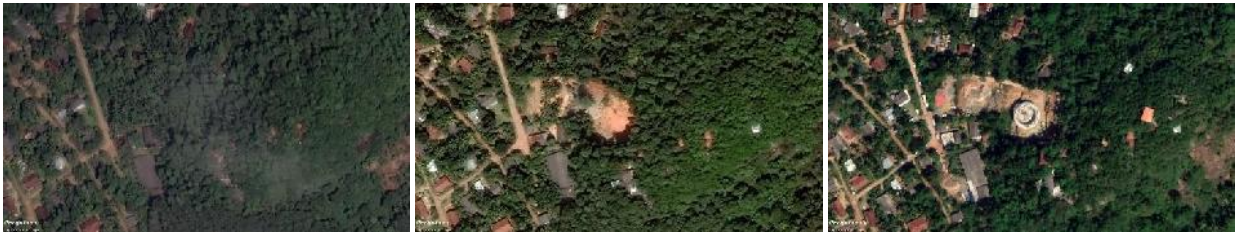
Figure 4 – Changers of the Land uses over the last five years (a – 2016, b – 2017, c – 2020) (Source – Google Earth)

The landslide occurred in 2017 and since 2016 the land has undergone major changes due to various construction activities.

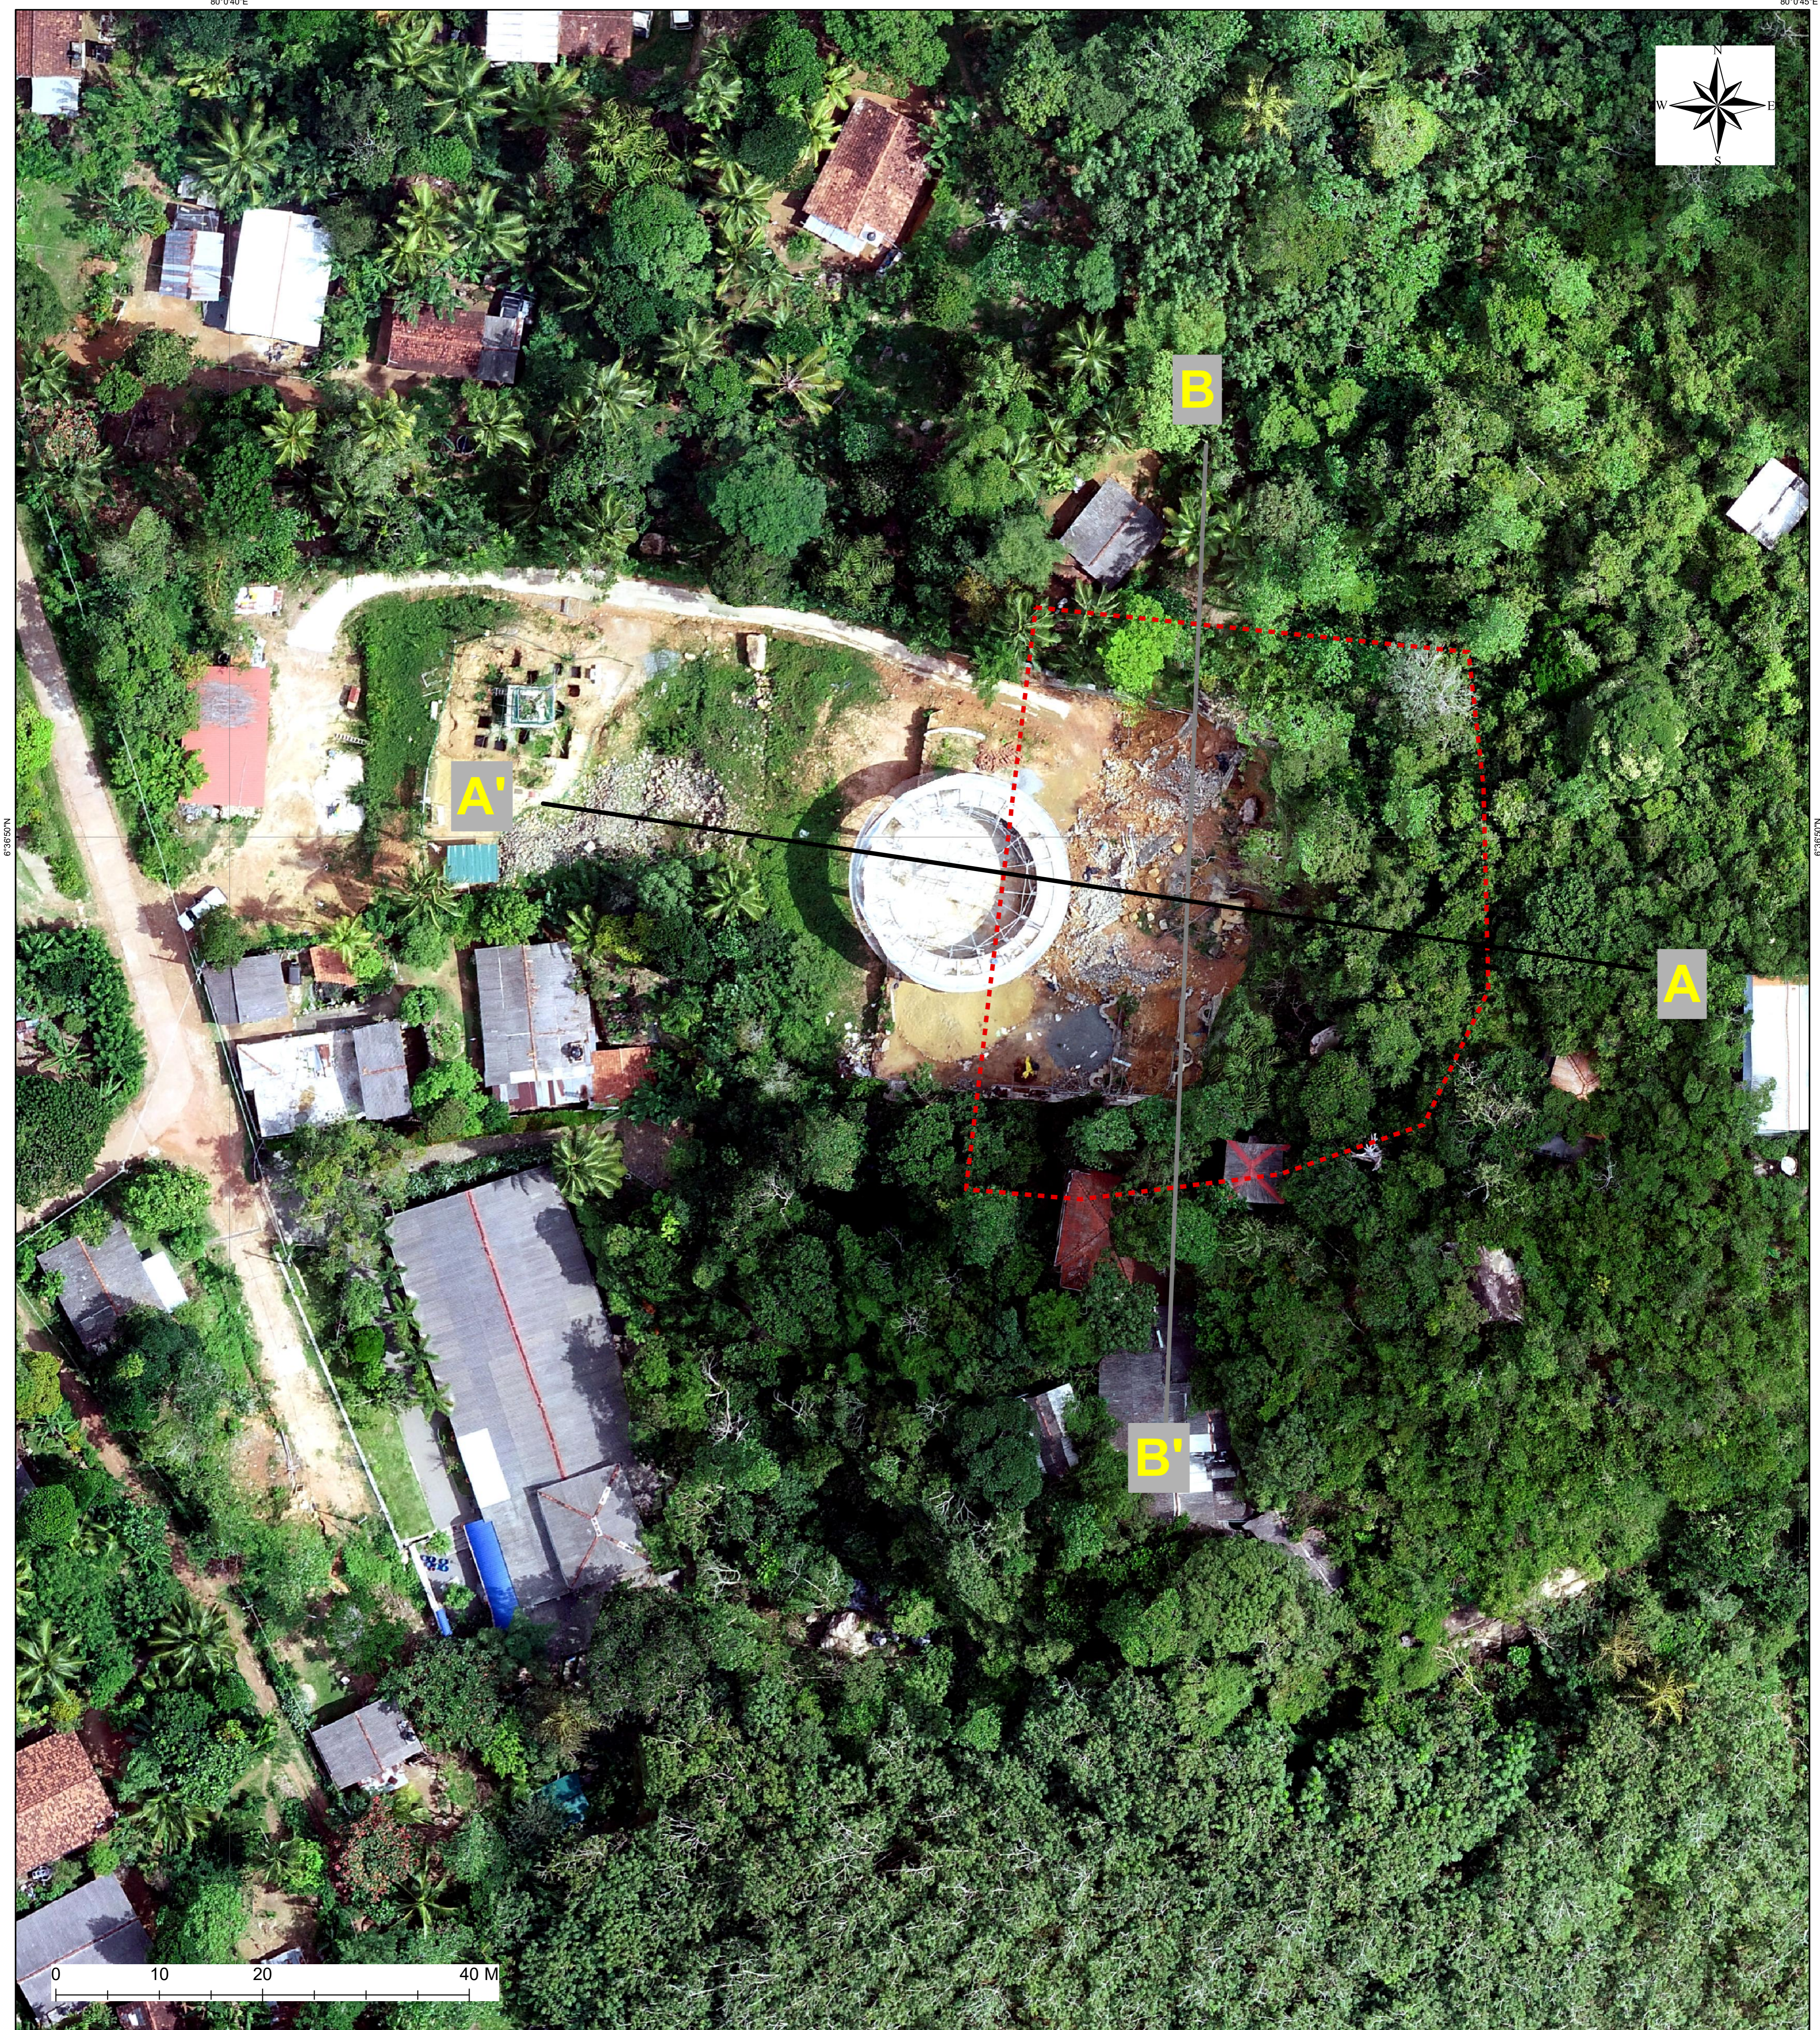
Source - This map was prepared using the drone images captured by NBRO above Serupita Isipathana Mahamewna Asapuwa landslide potential site.

1. No. of Vulnerable Buildings : 02
2. Infrastructure Damage : Road, Electricity line
3. Current Land use : Temple
4. Land use management : Poorly managed+ Human impacted
5. Previous Land use : Forest
6. Level of Hazard : Modest level of landslide hazard (1:50,000 scale)
7. Type of Failure : Progressive slope failures

- Project Impact Boundary (Red dashed line)
- Area of Slope Failure (Yellow dashed line)
- Longitudinal Section A - A' (Black solid line)
- Cross Section B - B' (Grey solid line)

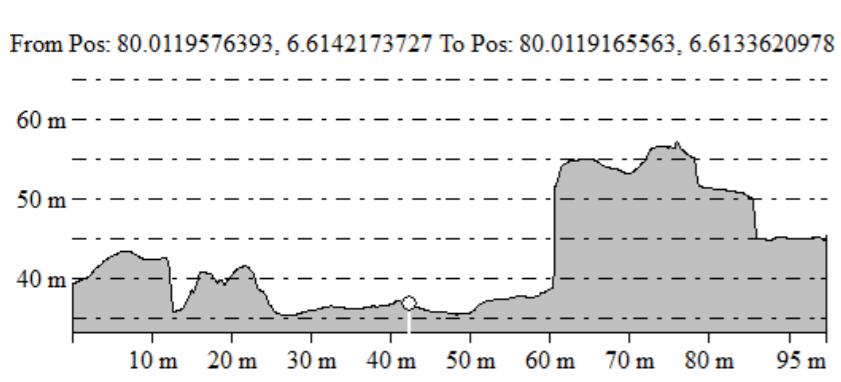
Longitudinal Profile Details A - A'

Start Position: 80.0119576393, 6.6142173727
 Start Height: 39.323 m
 End Position: 80.0119165563, 6.6133620978
 End Height: 45.376 m
 Path Length: 95 m
 Straight-Line Distance: 95 m
 3D Distance on Surface: 140 m
 Vertical Difference (Start to Finish): 6.1 m
 Total Climbing: 39.8 m over 72 m on surface
 Total Descending: 33.8 m over 68 m on surface
 Minimum Elevation on Path: 35.332 m
 Maximum Elevation on Path: 57.118 m
 Azimuth: 182° 44' 59.8"
 Slope/Tilt: 3.66°
 Max Path Slope: 88.93° [60 m along path]

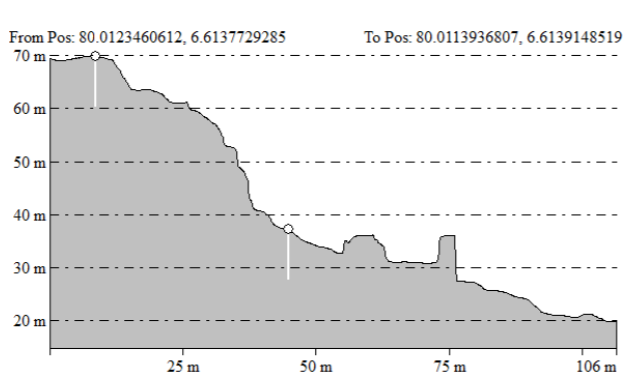
Cross Sectional Profile Details B - B'

Start Position: 80.0123460612, 6.6137729285
 Start Height: 69.383 m
 End Position: 80.0113936807, 6.6139148519
 End Height: 19.826 m
 Path Length: 106 m
 Straight-Line Distance: 106 m
 3D Distance on Surface: 148 m
 Vertical Difference (Start to Finish): -49.6 m
 Total Climbing: 11.8 m over 31 m on surface
 Total Descending: 61.3 m over 117 m on surface
 Minimum Elevation on Path: 19.826 m
 Maximum Elevation on Path: 69.845 m
 Azimuth: 278° 28' 34.6"
 Slope/Tilt: -24.96°
 Max Path Slope: 87.89° [76 m along path]

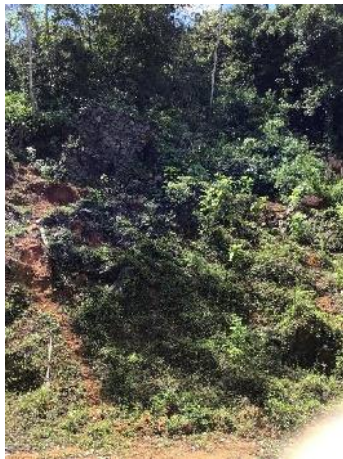
Mitigation area

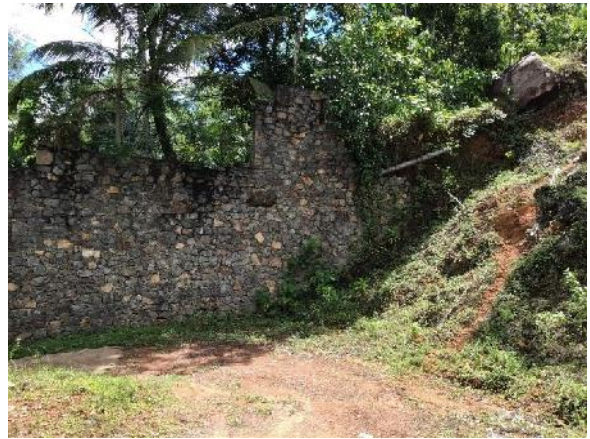
Retaining wall constructed near mitigation area

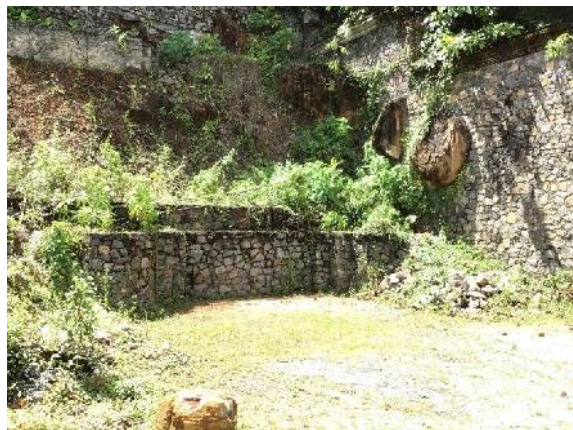
Mitigation area
