REDUCTION OF LANDSLIDE VULNERABILITY BY MITIGATION MEASURES PROJECT

Site Specific Environmental and Social Management Plan

Site No. 148

**Failed Slope between culvert No. 31/1 and 31/2 of
Hatton – Maskeliya - Delhouse Road (B-149)
Nuwara Eliya District**

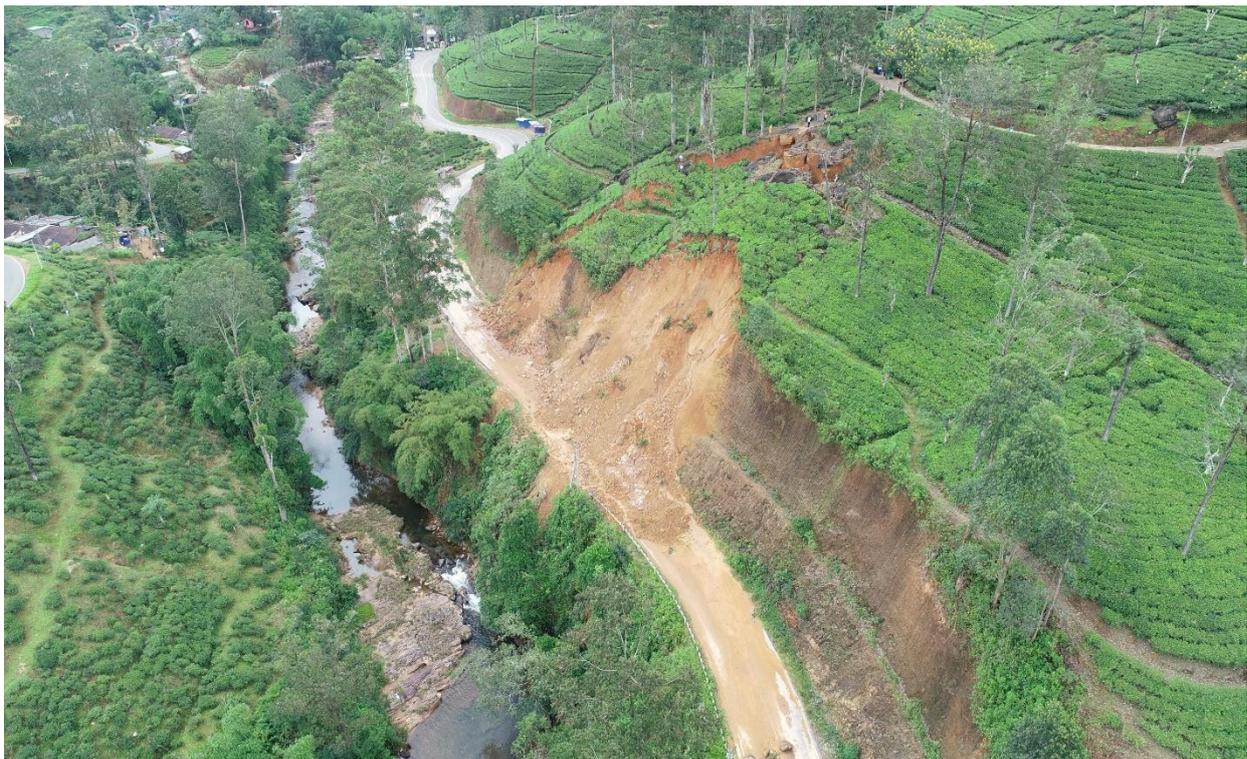
Figure 3: Drone image of the proposed landslide mitigation site, the surrounding environmental features and service infrastructure.

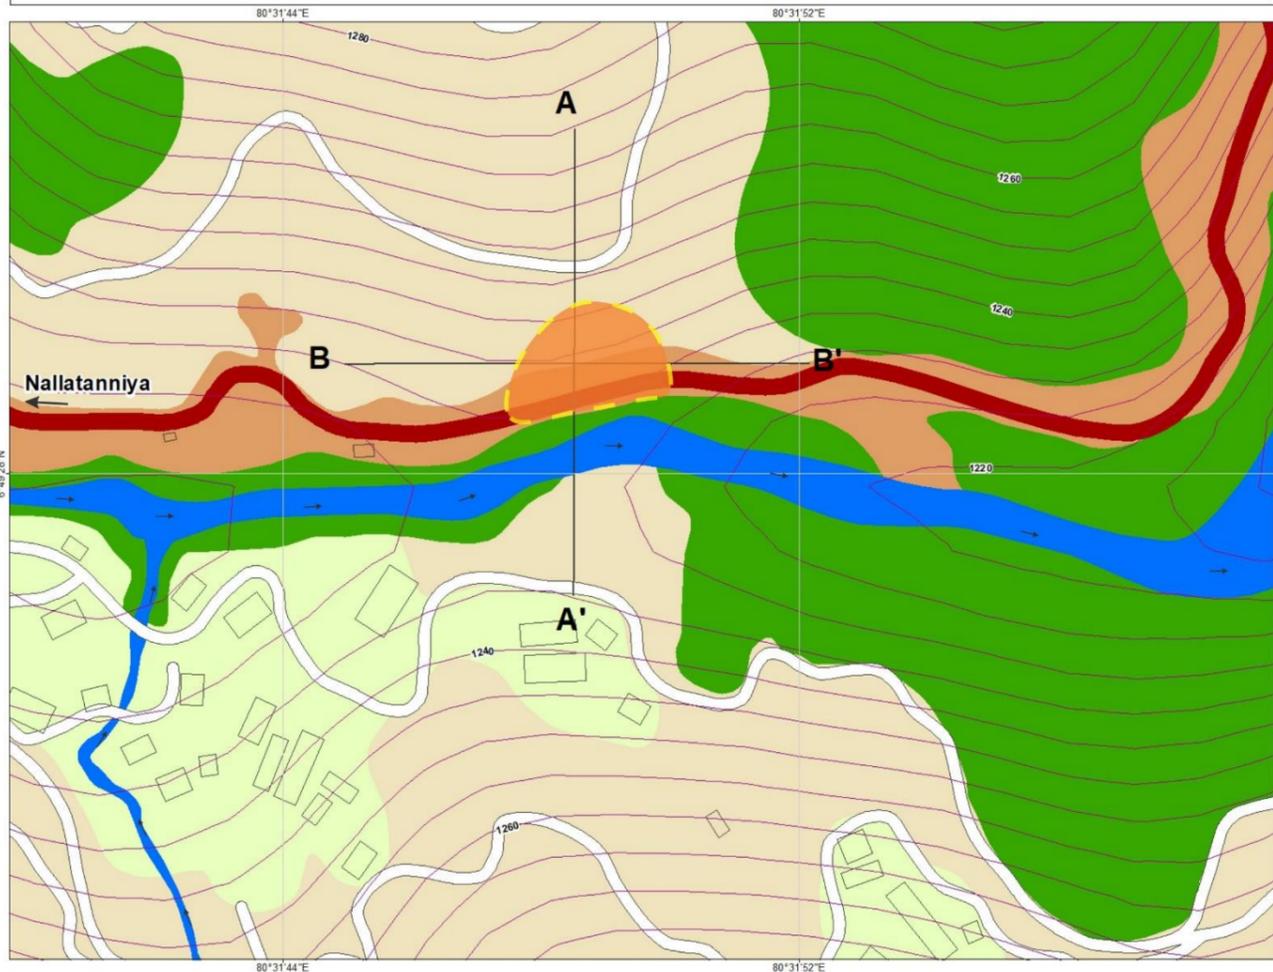
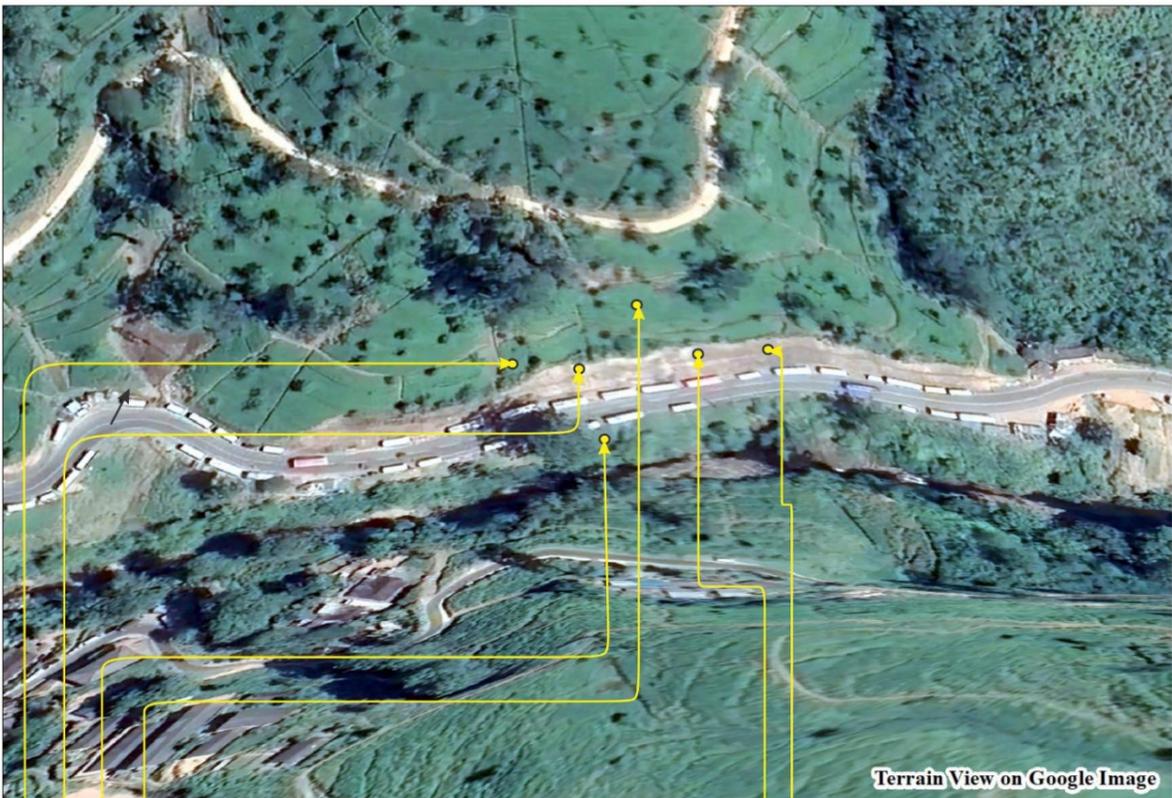
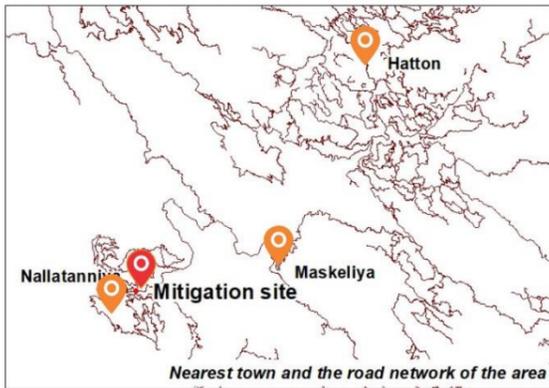
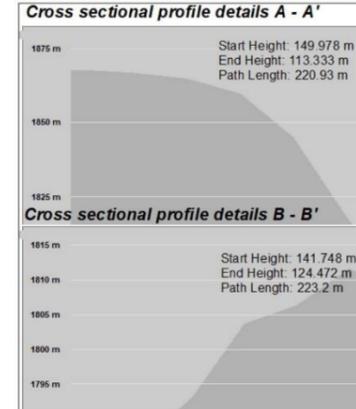
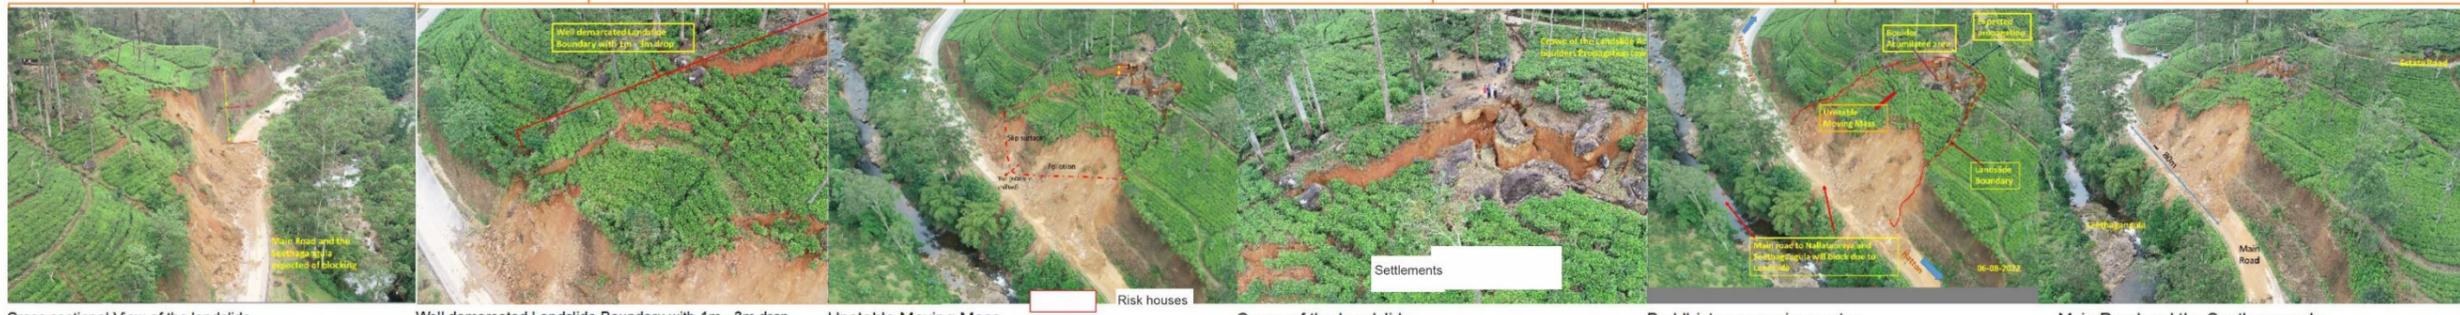
Figure 4: Google image, cross sections, land use, risk elements and the photographs of special features of the location

- o Type of Failure : Ground subsidence
- o Potential damages : Road
- o Land Use : Tea land
- o Land ownership : RDA/Plantation company
- o Average area : 6000 Square meters
- o Natural features : Stream

Refer Fig 4: Google image, cross sections, land use, risk elements and the photographs of special features of the location

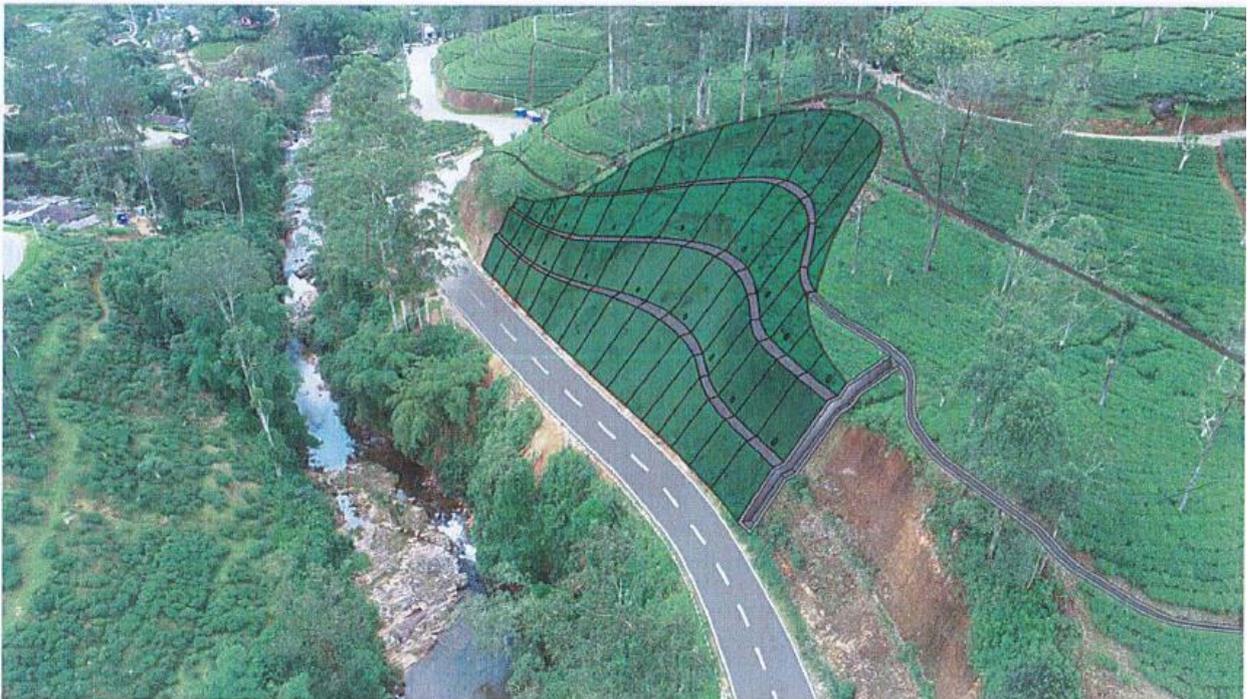
- Removing of trees (few) and tea bushers
- Removing dislodged soil and reshaping
- Protecting the slope with soil nailing
- Drainage management using surface and subsurface drainage network
- Alleviate local slope failures by way of increasing the development metric solution of exposed finished surface via nature-based solution.
- Further, in order to restore and retain the natural aesthetic outlook of this location, the protection works will essentially include nature-based surface protection solutions like turfing and planting.

Ref. Figure 6: View after mitigation of the failed location

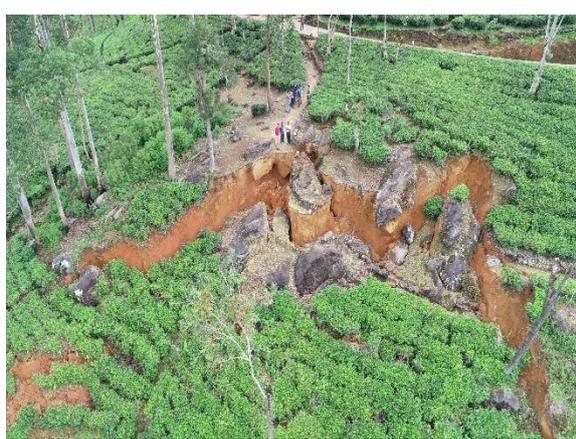
Figure 7a: Scarp of the slope failure and upslope tea plantation

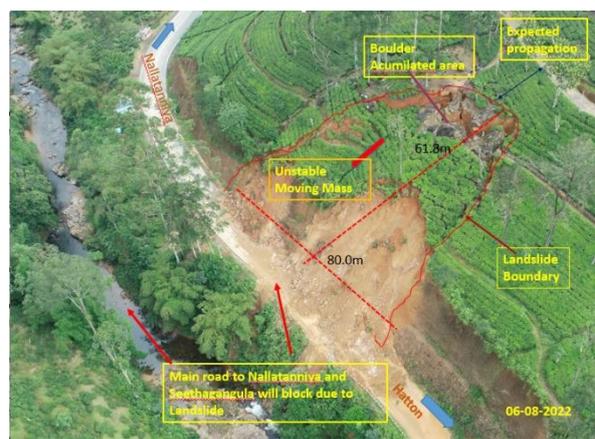
Figure 7b: Entire slope failure area
