REDUCTION OF LANDSLIDE VULNERABILITY BY MITIGATION MEASURES PROJECT

Site Specific Environmental and Social Management Plan

**Site No. 153
Unstable Rock fall /Landslide Locations
at Kandy – Mahiyangana road (Hunnasgiriya – Digana section)**

February 2025

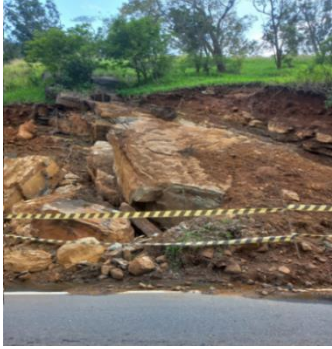
Location No.	Culvert / Bend	Important Environmental Features	Geo-morphological characteristics
L1	Culvert No: 38/4 to 38/5 RHS

<ul style="list-style-type: none"> • A rock slide occurred on a rocky face. • The rocky slope is highly inter-banded and follows the dip direction. • Previously constructed drain was demolished due to the slope failure.
L2	Culvert No: 31/7 to 31/9 LHS

Location	The works envisaged under the project
Location 1	Sealing the joints, rock bolting wherever necessary, is recommended.
Location 2	It is recommended to strengthen in situ by using the rope hooking technique or by inserting rock bolts.
Location 3	It is recommended to remove unstable rock fragments.
Location 4	Recommended to remove the debris and improve the drainage.
Location 5	Recommended to remove the debris and improve the drainage.

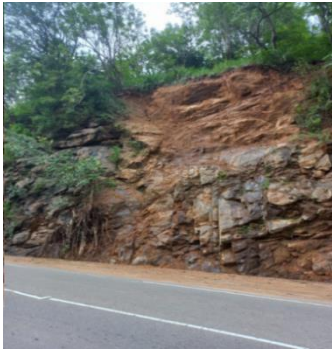
<ul style="list-style-type: none"> • A highly fractured rocky slope cut is observed. • Slope is an escarpment slope.
L3	Culvert No: 29/3 to 29/9 LHS

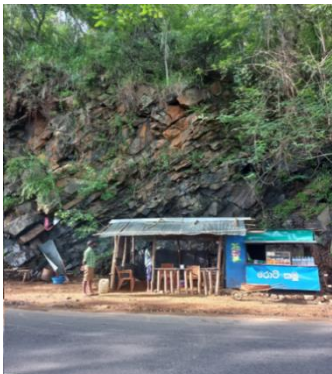
<ul style="list-style-type: none"> • Highly interbedded rock.

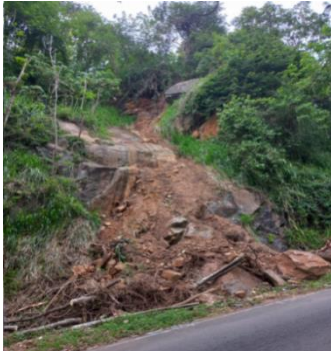
L4	Culvert No: 28/1 LHS

<ul style="list-style-type: none"> • Planer sliding failure was observed.
L5	Culvert No: 17/3 to 17/4 RHS

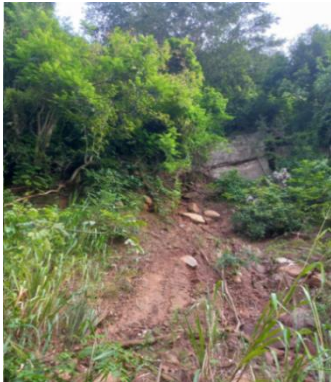
<ul style="list-style-type: none"> • Unstable rock blocks are present at the top. • Slope is an escarpment slope.

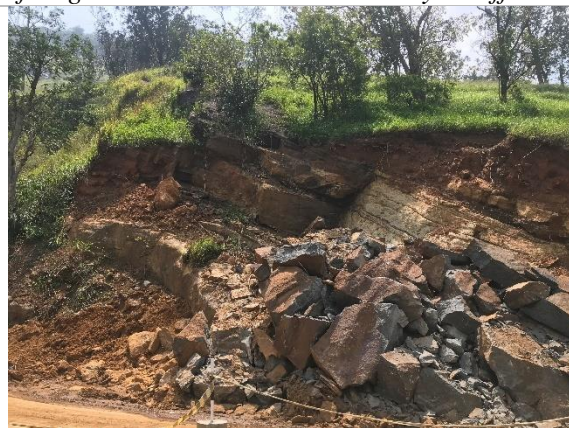
Figure 3a: Mitigation location - L1

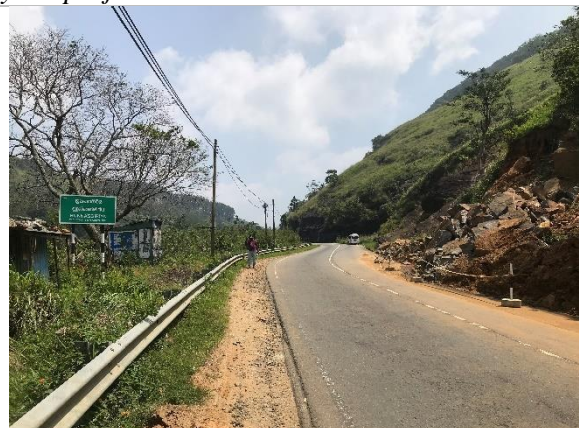
Figure 3b: Debris on the A26 Road (L1)

No accidents or casualties were recorded due to the rock fall and slope falling incidents. Cracks on the road and road subsidence were observed as the physical damages to the road. Some small-scale landslides have occurred, with debris falling onto the road, creating hazards for travelers.
