REDUCTION OF LANDSLIDE VULNERABILITY BY MITIGATION MEASURES PROJECT

Site Specific Environmental and Social Management Plan

Site No. 162 Failed Slope between culvert no. 149/8 and 149/9 of Peradeniya Badulla - Chenkaladi Hwy (A5)

November 2024

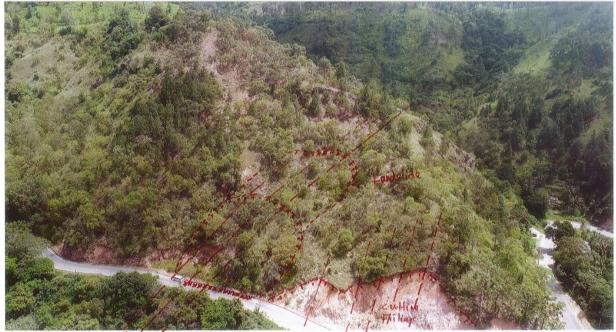
Figure 2: Drone image of the proposed landslide mitigation site, the surrounding environmental features and service infrastructure.

The proposed mitigation site is located in between culvert No. 149/8 and 149/9 Left Hand Side (LHS) of the Passara - Lunugala Road (A5). The failed slope section is located in a sloppy terrain where the natural slope has been cut for the road construction. The slope failure has been emerged left hand side of the up-slope of the road including the road section and the reservation area. The elevation of the area is 749 m. The extent of site proposed to be mitigated is about 12,060 m². The land of the up-slope of proposed mitigation area is owned by Dammeria B Estate, Hapugasthenna Browns Plantation. The road and the road reservation is owned by Road Development Authority, executive engineer office, Badulla.
