REDUCTION OF LANDSLIDE VULNERABILITY BY MITIGATION MEASURES PROJECT

Site Specific Environmental and Social Management Plan

Site No. 163
Failed Slope in between culvert No. 169/3 and 169/4 of Peradeniya Badulla - Chenkaladi Hwy (A5)
Badulla District

October 2024

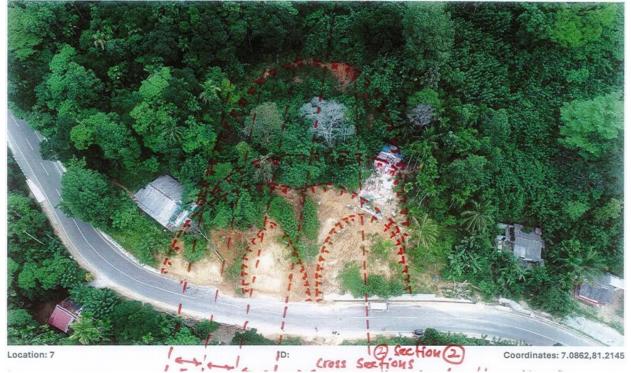
Figure 2: Drone image of the proposed landslide mitigation site, the surrounding environmental features, and service infrastructure.

Refer to Figure 2, 3; Google and drone images of the proposed landslide mitigation site, the surrounding environmental features, and service infrastructure.

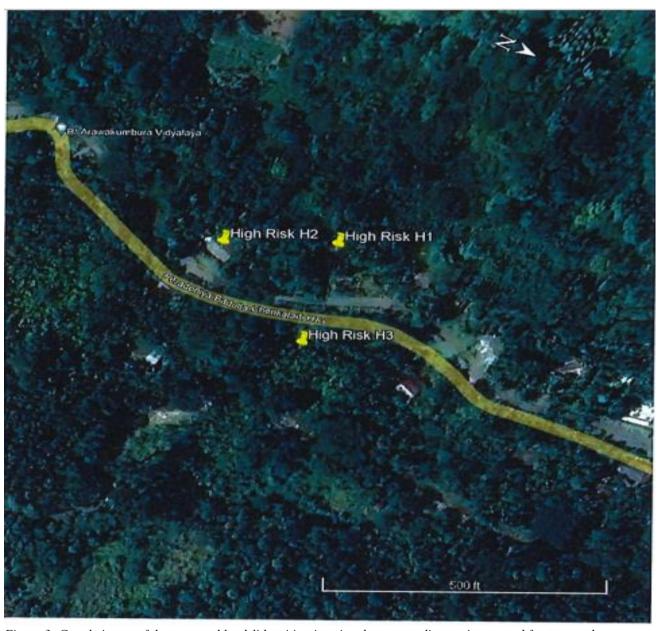
Figure 3: Google image of the proposed landslide mitigation site, the surrounding environmental features and service infrastructure.
