REDUCTION OF LANDSLIDE VULNERABILITY BY MITIGATION MEASURES PROJECT

Site Specific Environmental and Social Management Plan

Site No. 167 Failed Slope between culvert No. 164/10 and 164/11 of Peradeniya Badulla - Chenkaladi Hwy (A5)

October 2024

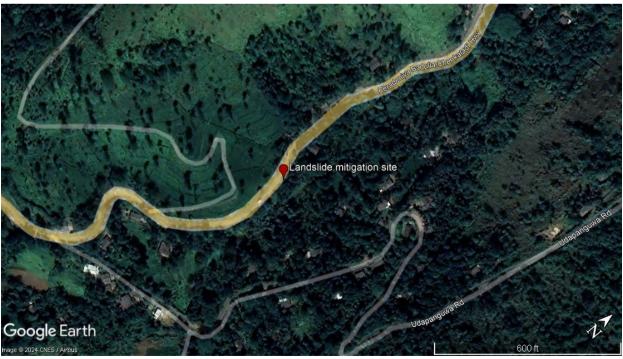
Figure 2: Google image of the proposed landslide mitigation site, the surrounding environmental features and service infrastructure.

Refer figure 2, Google image of the proposed landslide mitigation site, the surrounding environmental features and service infrastructure

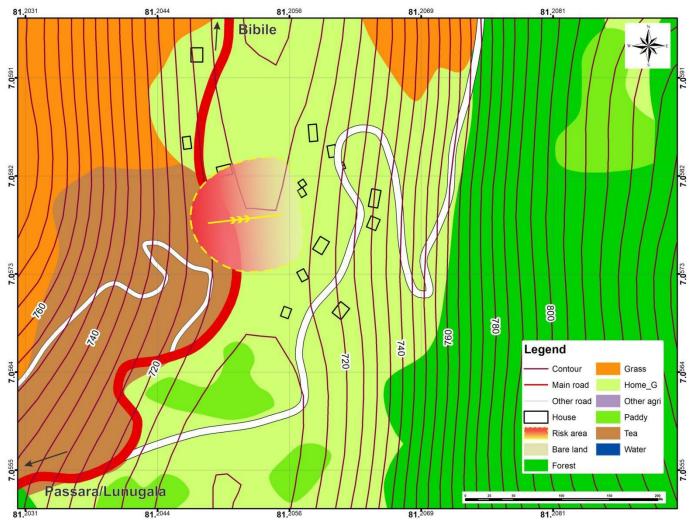
Figure 3: Google image, cross sections, land use and risk elements of the location

Slope failures in this road section were reported several times with the heavy rainfall. A falling of large rock and soil mass on the road blocking the road was reported in December 2023. Further, the downslope cultivated land was subsidized and cracks were formed. According to the information of the nearby people, a water channel flowing to road from the upslope is noticed with the heavy rainfall. slope failure *Refer Fig 3: cross sections, land use and risk elements of the location*.
