REDUCTION OF LANDSLIDE VULNERABILITY BY MITIGATION MEASURES PROJECT
Site Specific Environmental and Social Management Plan

Site No. 180

Athwelthota Gangaramaya Temple
Kalutara District

March 2025

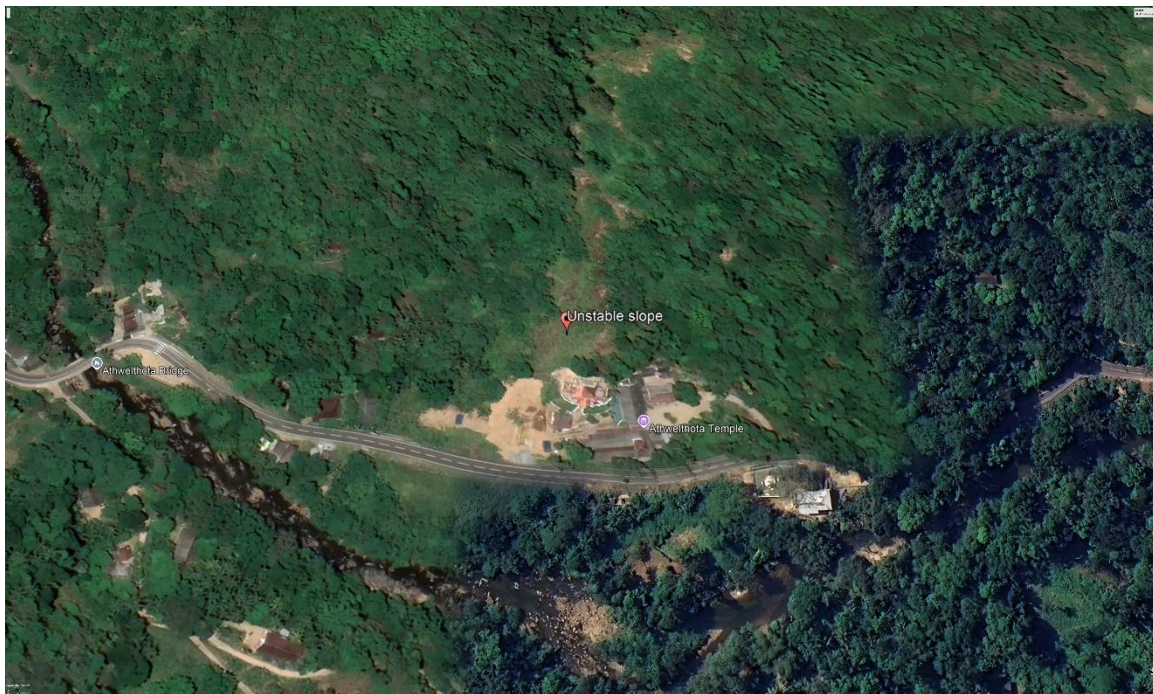
Figure 2. Google image of the proposed landslide mitigation site, the surrounding environmental features and service infrastructure.

Refer figure 2; Google image of the proposed landslide mitigation site, the surrounding environmental features and service infrastructure.

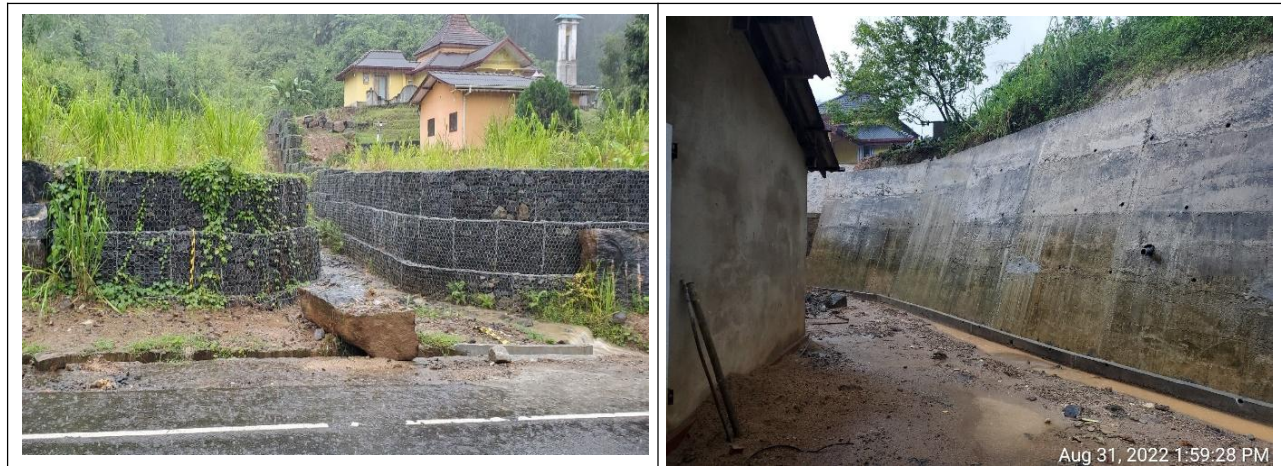
Following the first landslide event, several physical remediation measures, including drainage improvements and other slope stabilization efforts, were implemented to mitigate future risks under RLVMMMP -phase 1 Package 2.

Figure 03. Remediation measures taken after the initial landslide

However, the second landslide event in June 2024 caused damages to the majority of these structures. Since then, no further remediation measures have been undertaken to address the renewed risk posed by the reactivated slope. The National Building Research Organisation (NBRO) conducted a comprehensive investigation of the site. During this assessment, unstable slope sections were identified and demarcated, and the potential risks to the Athwelthota Temple were also evaluated.

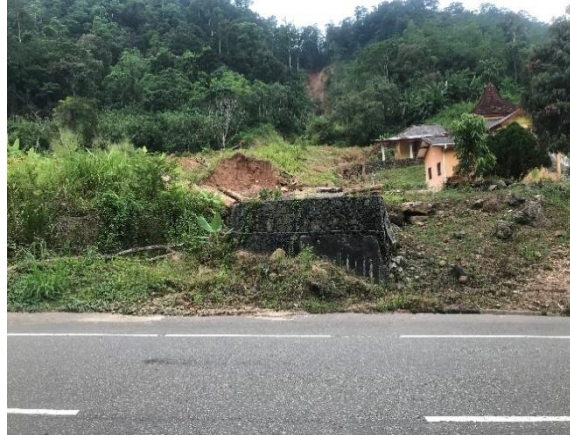
Figure 5 a. View of the unstable slope from B421 road (current status)

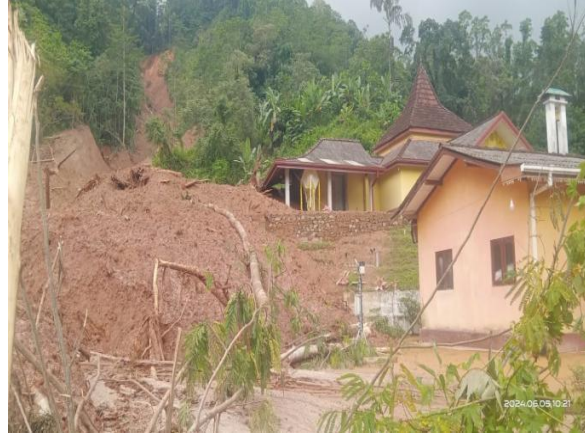
Figure 5 b. The debris on the second event of the landslide (taken at the second event)

Although the second landslide event, which occurred on the night of 2nd June 2024, was not as devastating in terms of human loss, it caused considerable damage to property and infrastructure, particularly affecting the Athwelthota Temple. Notably, mitigation structures that had been constructed after the initial event also sustained partial damage during this second occurrence. However, the recently built barriers were effective to some extent, as they reduced the reach of the debris flow. Despite this, accumulated debris still partially blocked the B421 road, again affecting accessibility and local transport.

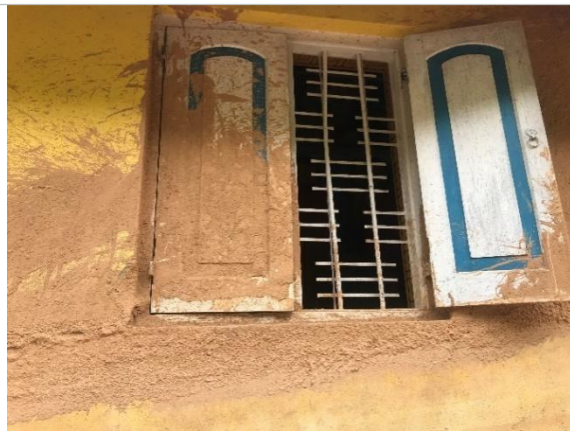
Figure 5 c. damages done to the temple infrastructure (current status)
