REDUCTION OF LANDSLIDE VULNERABILITY BY MITIGATION MEASURES PROJECT

Site Specific Environmental and Social Management Plan

Site No. 188
Unstable Rock fall /Landslide Locations
At Thummodara – Puwakkpitiya road (B426)

June 2025

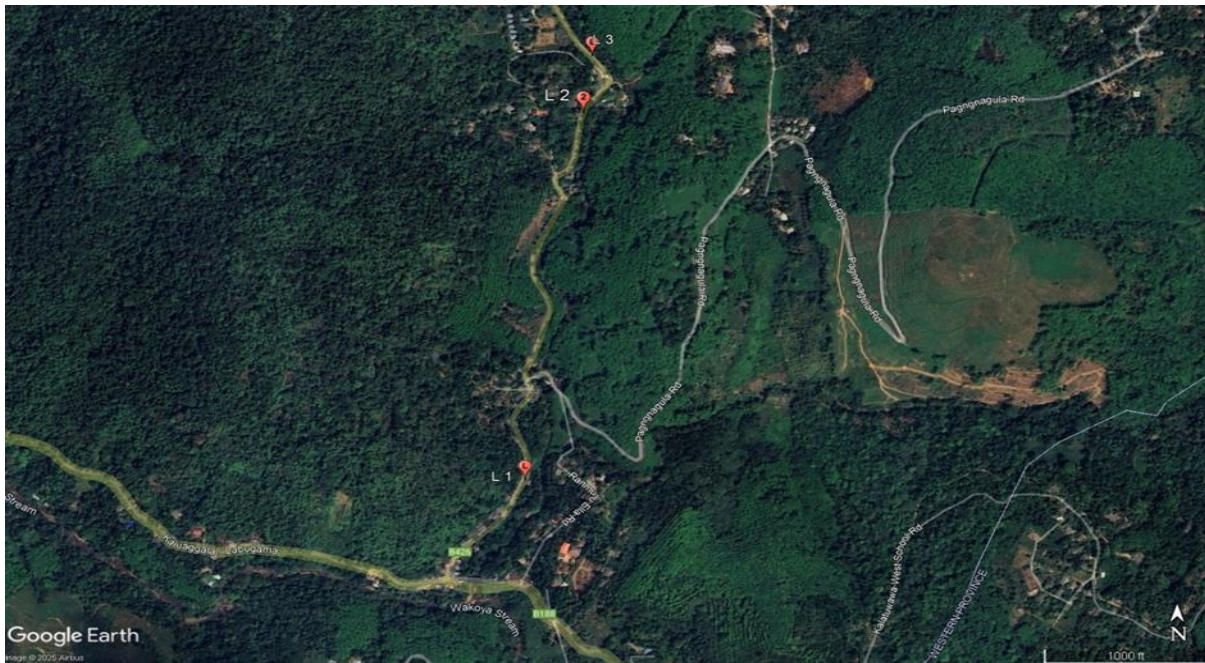
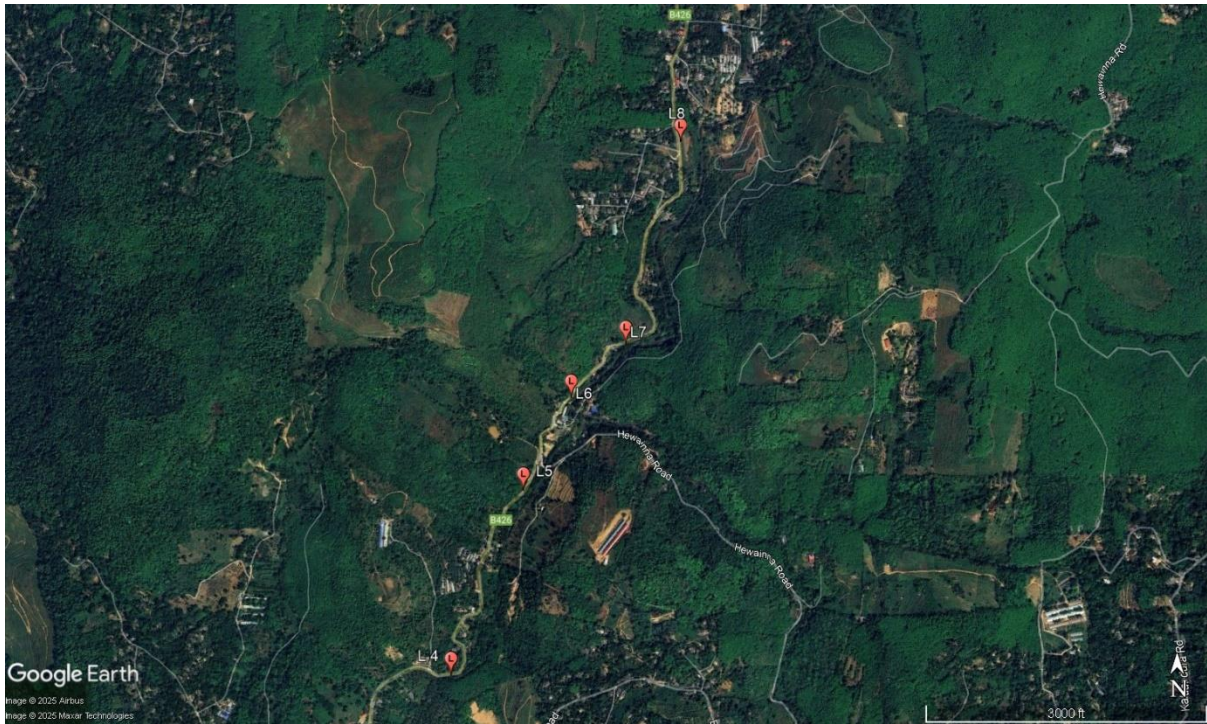
Figure 2: Google image of the proposed rock-fall/ landslide mitigation site, the surrounding environmental features and service infrastructure

Refer figure 2; Google images of the proposed rock fall and landslide mitigation site, the surrounding environmental features and service infrastructure.

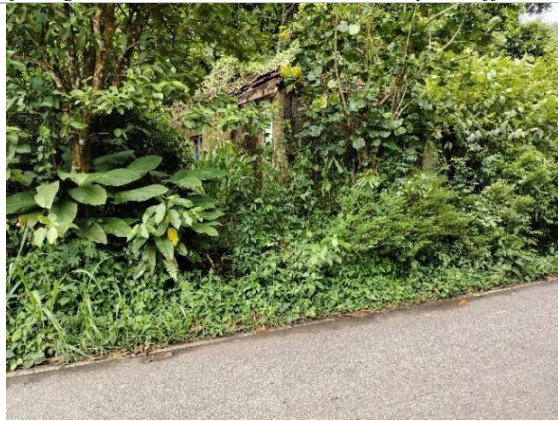
Figure 5a: Damaged and evacuated house (L1)

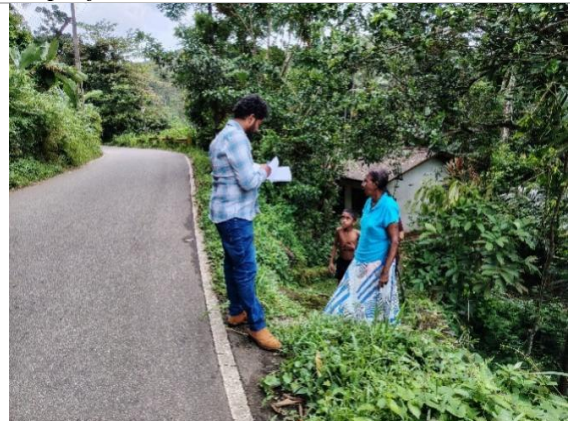
<ul style="list-style-type: none"> Down-slope has eroded near to the road shoulder due to uncontrolled surface runoff. Stream was observed at the bottom of down slope 	<ul style="list-style-type: none"> As an immediate measure, applying a curb drain at road shoulder to divert the rain runoff is recommended. As a long-term measure, the 2 m high gabion wall (40m long) is recommended to stabilize.
L2	1 + 150 to 1 + 300

Figure 5b: Failed down slope section (L1)

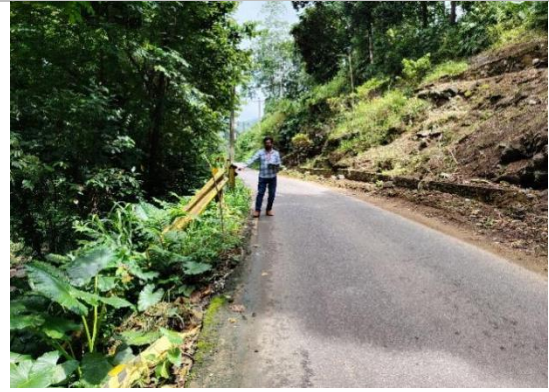
Figure 5d: Broken part of the fence due to landslide (L2)

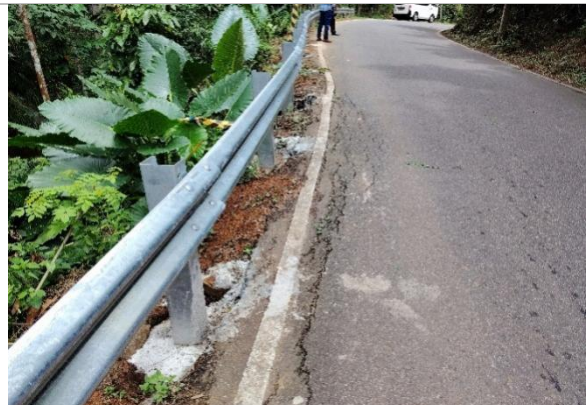
<ul style="list-style-type: none"> Downslope has eroded near to the road shoulder due to uncontrolled surface runoff Slope is approximately 15m high and there is river flow at bottom of the slope 	<ul style="list-style-type: none"> As an immediate measure, applying a curb drain at road shoulder to divert the rain runoff is recommended. As a long-term measure, the 2 m high gabion wall (25 m long) is recommended to stabilize.

Figure 5h: Cracked Road section in road of RHS (L4)

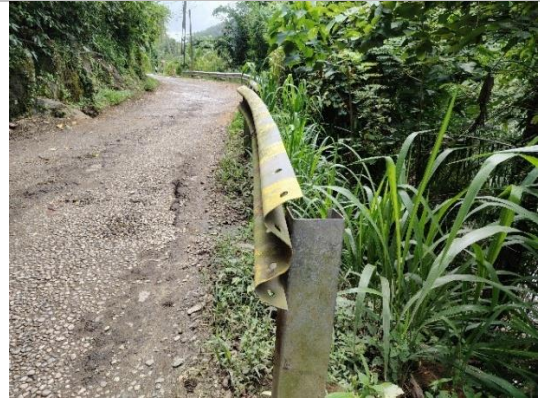
<ul style="list-style-type: none"> Downslope has eroded near to the road shoulder due to uncontrolled surface runoff Small subsidence can be observed at the road edge 	<ul style="list-style-type: none"> As an immediate measure, applying a curb drain (75 mm) at road shoulder to divert the rain runoff is recommended. As a long-term measure, the 3 m high gabion wall (20 m long) is recommended to stabilize.
L7	7 + 150

Figure 5o: Damaged Road section with RDA fence (L6)

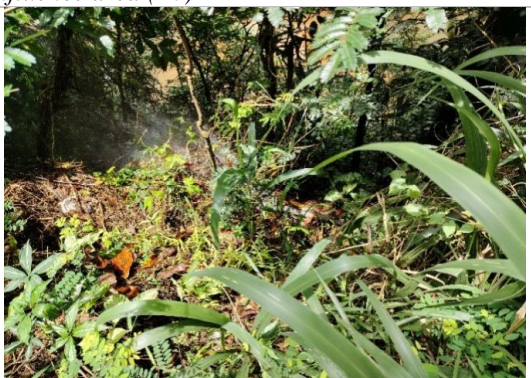
Figure 5s: Broken community water line (L7)

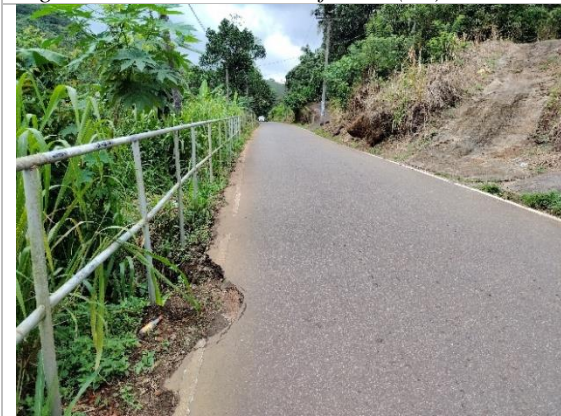
<ul style="list-style-type: none"> Downslope has eroded near to the road shoulder due to uncontrolled surface runoff 	<ul style="list-style-type: none"> As an immediate measure, applying a curb drain at road shoulder to divert the rain runoff is recommended. As a long-term measure, the 1000m X 500mm high RRM wall (200 m long) is recommended to stabilize.
----	--------------------	---	---	--

Figure 5x: Damaged Road section due to water flow (L8)
