REDUCTION OF LANDSLIDE VULNERABILITY BY MITIGATION MEASURES PROJECT

Site Specific Environmental and Social Management Plan

Site No. 190
Cut slop Failure
At Avissawella- Hatton- Nuwara Eliya (A007) Road near Thalduwa
Junction

Kegalle District

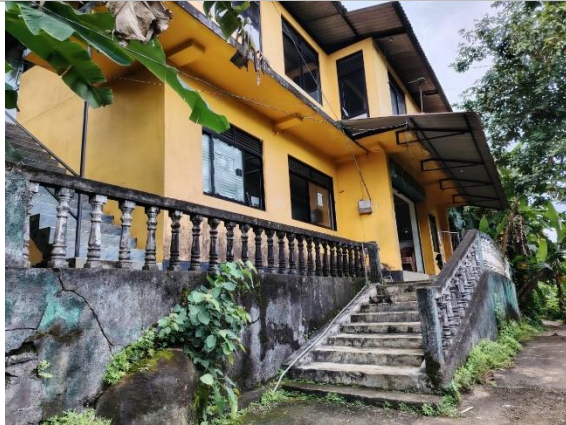
Figure 3a: Thaldywa Bomaluwa Samurdhi Bank (two storied building)

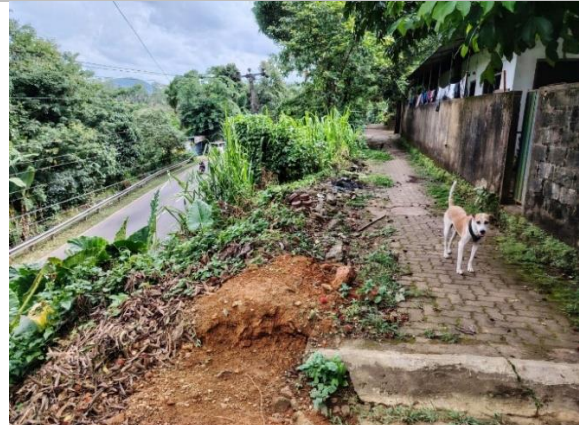
Figure 3b: Downslope near to edge of the sub road with slope failure

Downslope of the mitigation site has eroded near to the road shoulder due to uncontrolled surface runoff and small subsidence can be observed at the road edge. As an immediate measure, applying a curb drain at road shoulder to divert the rain runoff, covered by Tarpaulin sheets to prevent the erosion and as a long-term measure, the 2m high gabion wall (40m long) are recommended to stabilize.

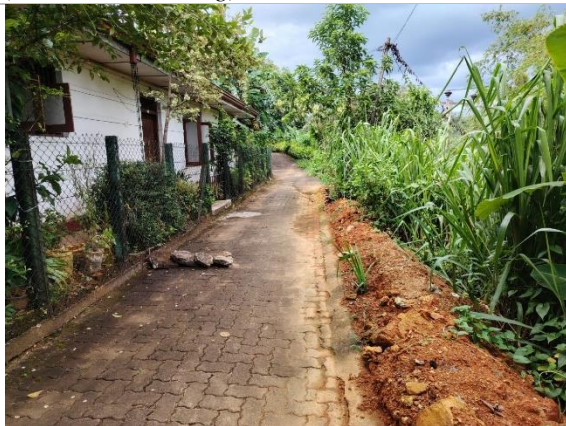
Figure 3c: Sub road parallel to Hatton – Avissawella road (A7), access to Thaldywa Bomaluwa Samurdhi Bank

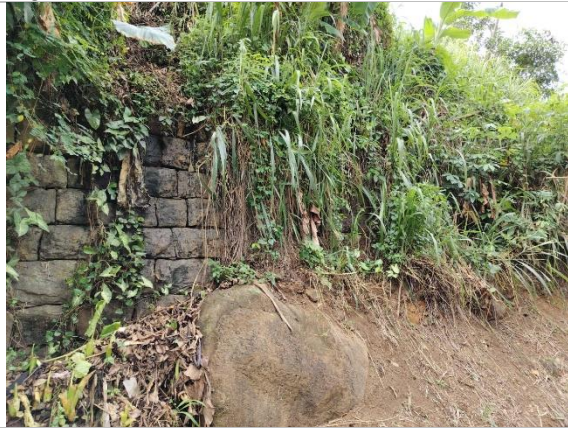
Figure 3g: Damaged retaining wall (Old railway line), deposited rock builders and slope failure front of the Hatton – Avissawella main road (A7)
