REDUCTION OF LANDSLIDE VULNERABILITY BY MITIGATION MEASURES PROJECT

Site Specific Environmental and Social Management Plan

Site No. 43
Sri Gangaramaya Temple – Seetha Eliya
Nuwara Eliya District

October 2022

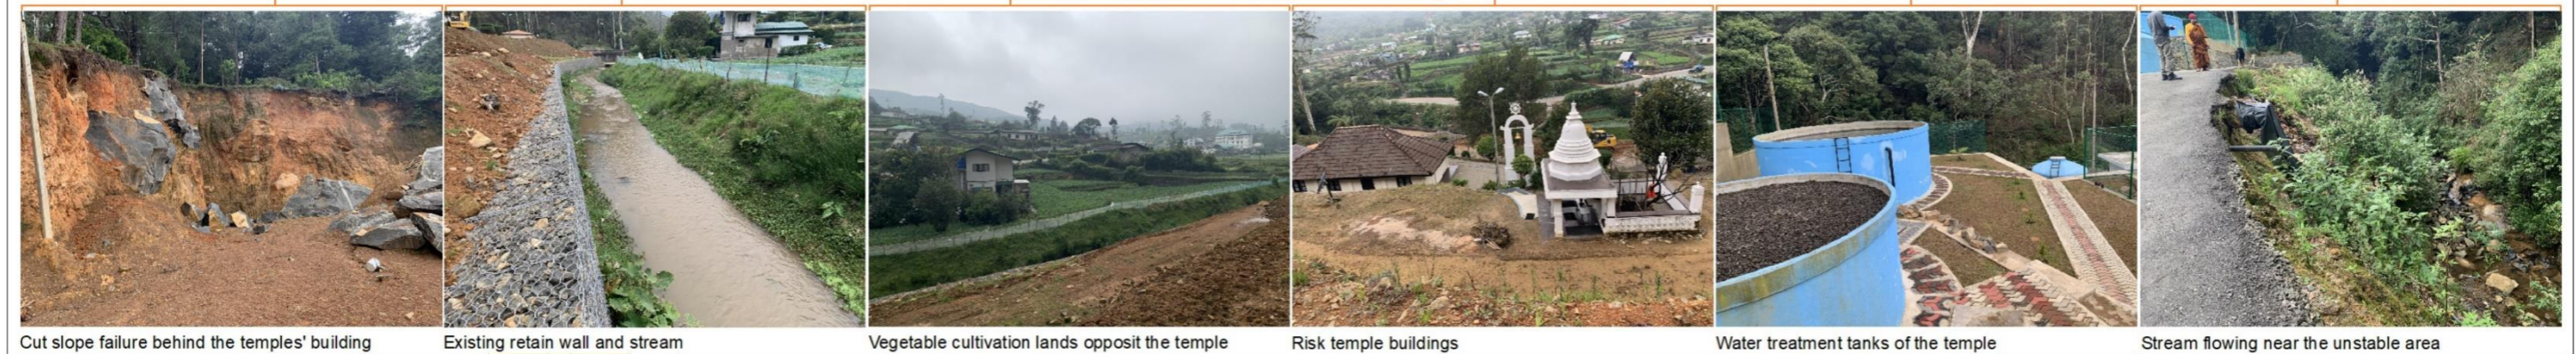
Cut slope failure behind the temples' building

Existing retain wall and stream

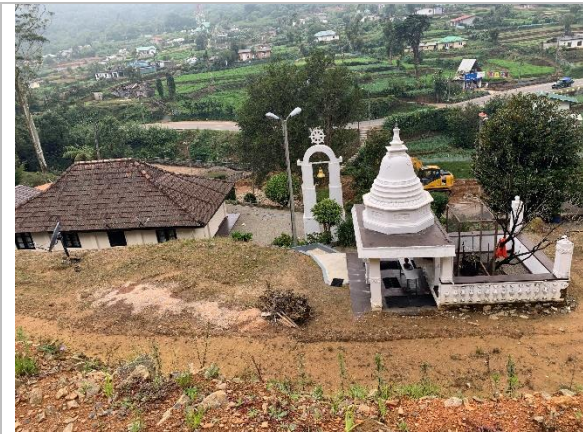
Figure 4a: The Buddhist preaching hall, hermitage, and other buildings of the temple

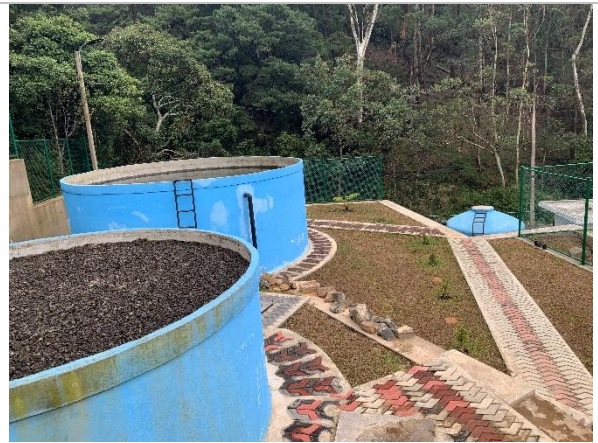
Figure 4b: Water treatment plant and water supply lines

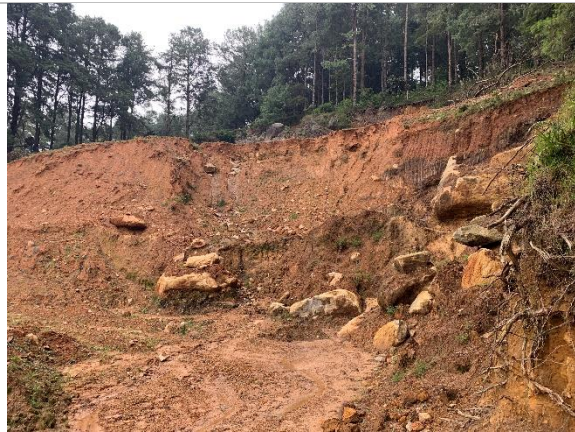
Figure 4c: Proposed area for the Buddhist school and upslope pinus trees

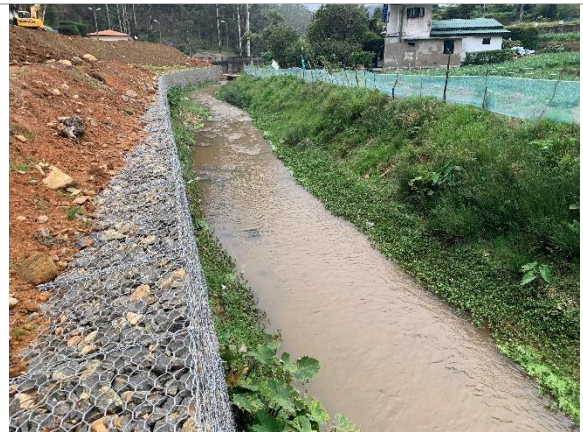
Figure 4h: Stream flowing opposite of the temple (Seetha Eliya Kadura) and existing retaining wall

A gabion wall had been constructed at the stream bank to protect the failed soil mass from erosional impacts and stream bed alterations. As the gabion wall covers only one side of the unstable slope area, the exposed slope has a risk of failure.
