REDUCTION OF LANDSLIDE VULNERABILITY BY MITIGATION MEASURES PROJECT

Site Specific Environmental and Social Management Plan

Site No.70

**Rathnapura Primary and Secondary Tamil School
Rathnapura District**

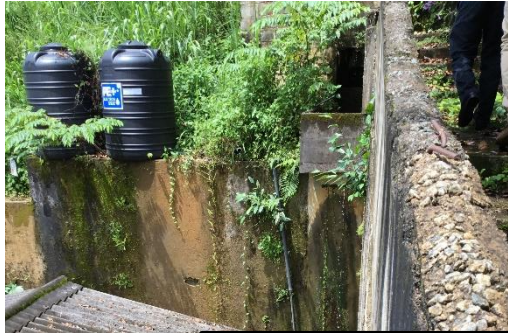
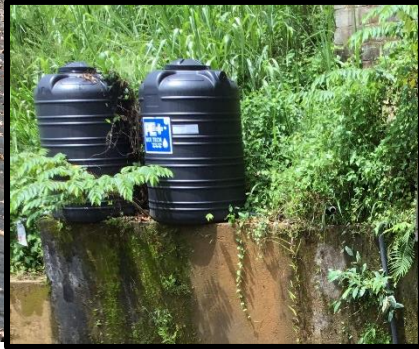
Figure 5a: Water tanks

<p>7.2.4.4 Impacts on service provision (water supply, sewage, electricity)</p> <p>Water tanks on retaining wall and water supply line runs through the mitigation site will be damaged during the construction works and when moving machinery.</p>	Significant
<p>7.2.4.5 Effect due to loss of infrastructure and safety</p> <p>During construction phase, Outer-Circular road; the access road of the school will be obstructed by frequently moving machinery, loaders, trucks etc. as the access road is very narrow. Therefore, most of the heavy machinery, trucks and loaders can obstruct the pedestrian passage and cause traffic during school times. Therefore, effect due to loss of infrastructure and safety is locally significant.</p>	Significant
<p>7.2.4.6 Risks of school children accessing the site during construction</p> <p>During the construction phase site may use excavation machineries, loaders, trucks etc. These machines and heavy vehicles etc. will be used in the school premises where school children and staff are moving. Site may use high voltage power for operation of certain machinery. Construction may use materials such as metal aggregates, steel etc. which can be injurious under improper storage and handling.</p> <p>The school children will be attracted to these machineries, materials and may even enter the site without proper awareness of the site staff. Ignorance of entry of school children and careless operation of machinery can cause fatal injuries and accidents to school children. The risk on school children at site is therefore highly significant.</p>	Highly Significant

<p>xii. Interruption to water tanks and school water supply lines</p> <p>The water lines currently running across failed slope need to be installed properly without being affected during the construction phase. Necessary arrangements should be taken to provide alternative water supply in case of an interruption to water supply. The school management should be consulted during project mobilization to inform the requirement to shift the water lines to a safe location.</p>	Construction	Construction Contractor
<p>xiii. Use of sanitary facilities of contractor’s workforce</p> <p>As per the principal of the Secondary School, the workforce can use sanitary facilities of the school during the construction period.</p>	Construction	Construction Contractor

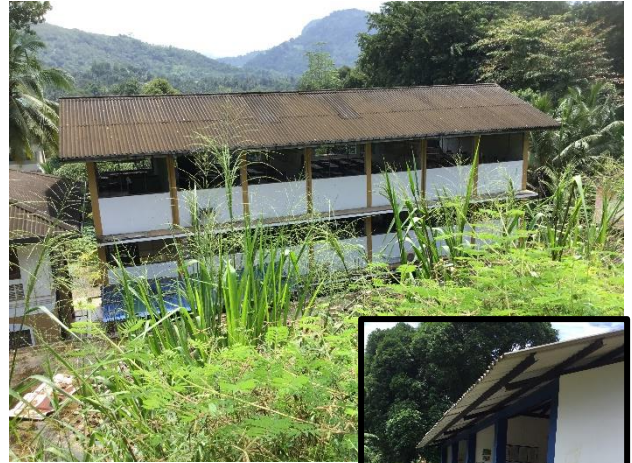
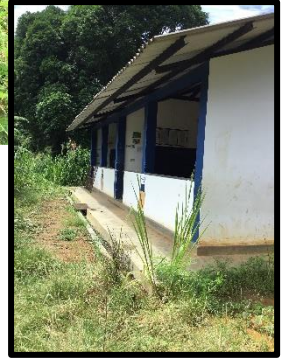
Figure 5b: School Buildings

- The buildings in the school premises currently at risk will be safe, and the unstable areas of the school will be secured from future slope failures.

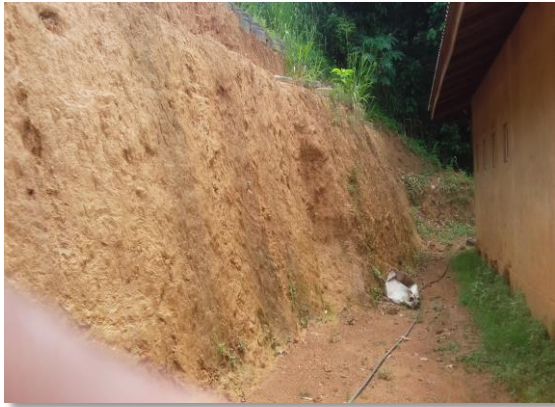
Grade 07 buildings and toilets are located about 15 meters from location 01 on the upper slope. Another cut slope could be observed behind this building about 5-6m height. This is set in 04 steps about 1.2m height. It was observed that ground water was leaking through the base of the cutting surface.

Cut slope in location 01 (behind the grade 07 building)

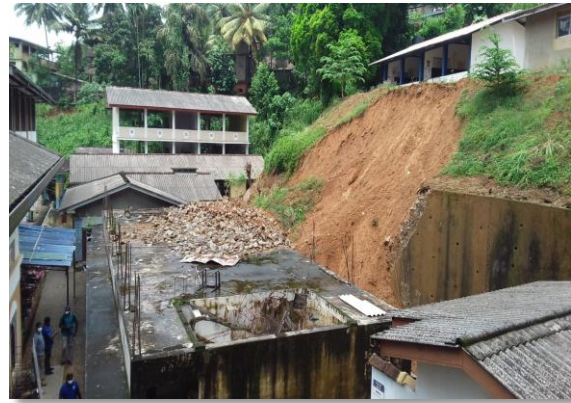
There was a 6m high and 30m long Random Rubble Masonry wall (RRM wall) behind the main hall and it could be observed that part of the wall has collapsed due to heavy rains in this area in May 2021. The under construction building has been totally damaged due to this collapse. The back fill of the RRM wall is unstable about 10 m from the wall and some tension cracks can also be observed.

Slope failure occurred in location 01 (behind the main hall)

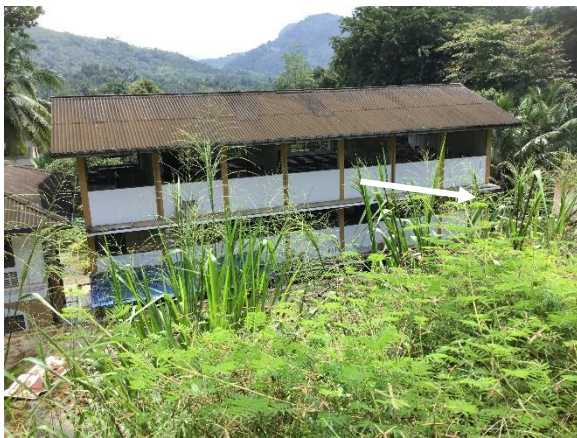
School buildings

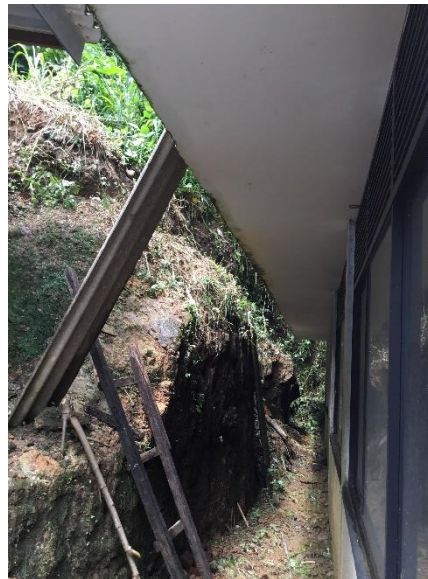
Another unstable slope and rock boulders could be observed behind the primary school buildings as well.

Rock boulders behind the primary school building (Location 03)
