# REDUCTION OF LANDSLIDE VULNERABILITY BY MITIGATION MEASURES PROJECT

## Site Specific Environmental and Social Management Plan

**Site No. 242**

**Unstable and Failed Slopes at Dharmaraja College Premises – Kandy**

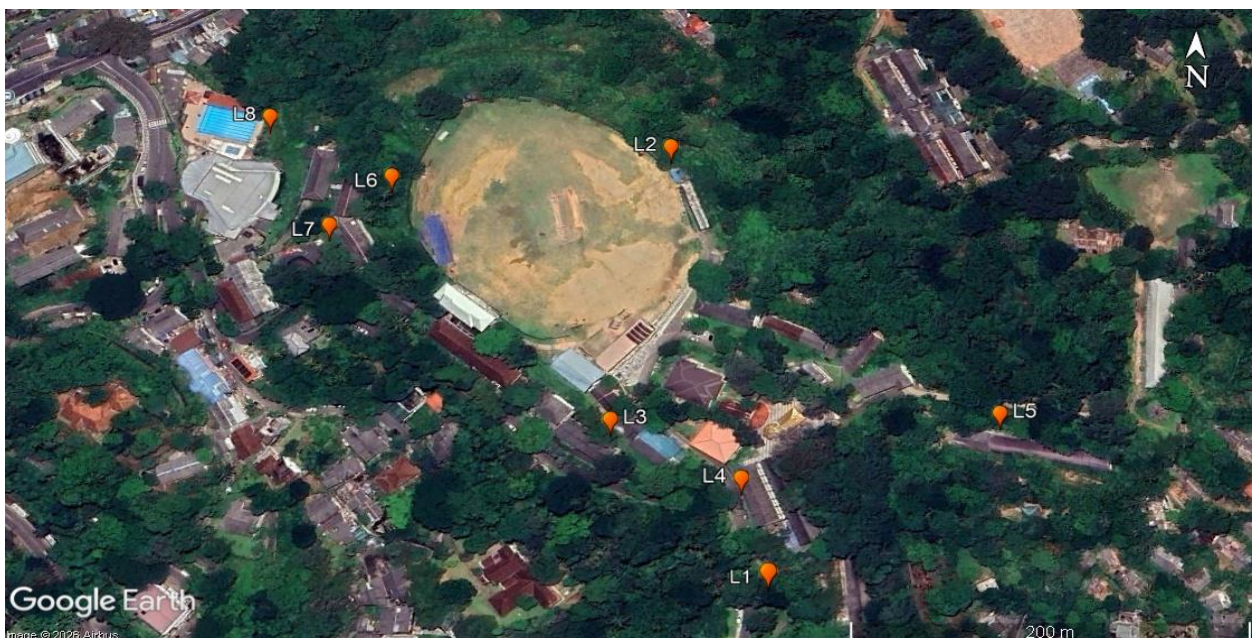
Figure 2: Google image of the proposed landslide mitigation site, the surrounding environmental features and service infrastructure.

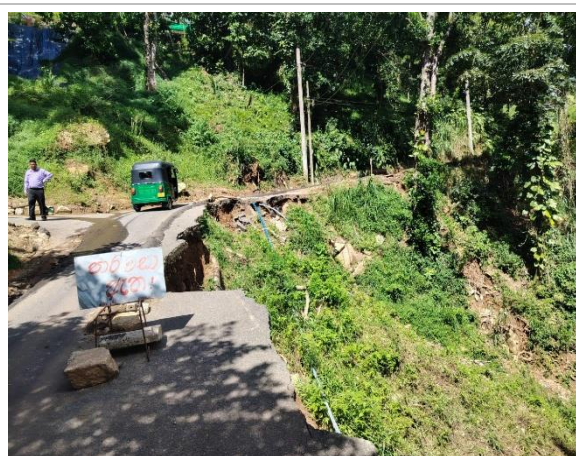
Location 1 consists of failed slopes on both sides of the access road leading to the school. Tensional cracks are visible on the upslope area, indicating ongoing instability. Vegetation cover, including grass and tree species such as Jack and Mango, can be observed on the unstable upslope. Large rock boulders were detached and now rest on the upslope side of the road, while the displaced soil mass has accumulated on the roadway. Water seepage is also observed flowing from the upslope ground through the road surface. In addition, a portion of the road has been damaged due to the downslope movement of the collapsed soil mass. This location remains highly unstable and continues to pose a significant risk. (Approximately this access road have been used 2000 persons including students, teachers, parents, villagers and more than 600 of vehicle fleet daily)

Figure 4a: Location 1; Damaged road and the downslope of the access road

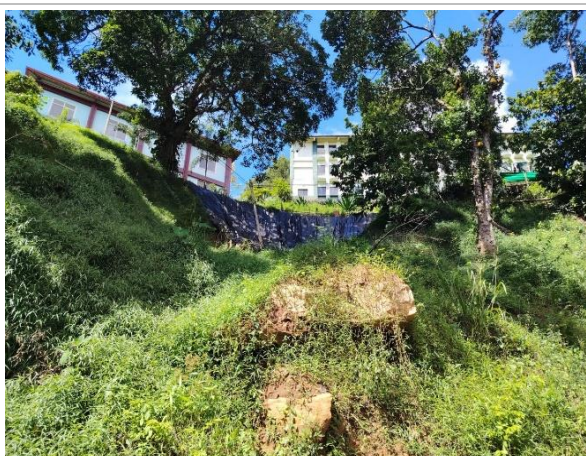
Figure 4b: Location 1; Upslope area of the access road

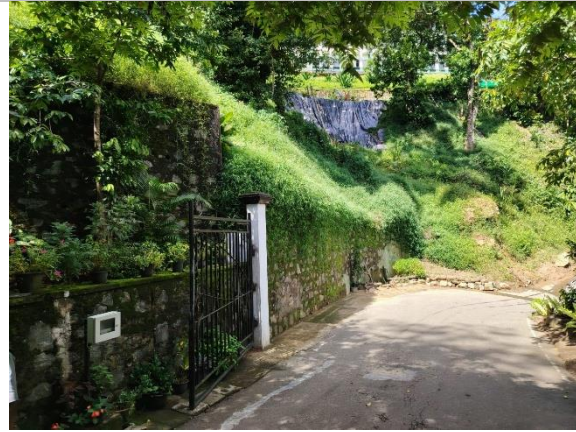
Figure 4c: Location 1; Main entrance to the school

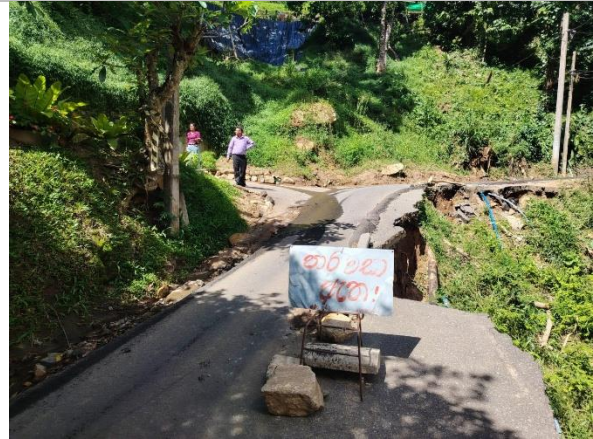
Figure 4d: Location 1; Both up and downslope

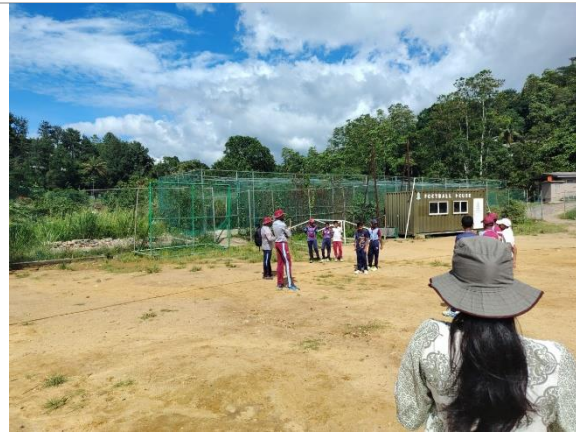
Figure 4e: Location 2 ; Cricket practicing net of the ground

Location 2 is an unstable slope situated behind the cricket practice net house and the school boundary fence. Approximately 60 students (male) and 5 teachers (female 2, male 3) and coaches (male) have been used this affected area. A container box, which was previously used as a football equipment storage facility, is located near the unstable area. At present, both the cricket practice net and the container box football center are not being utilized due to the hazardous condition of the site.

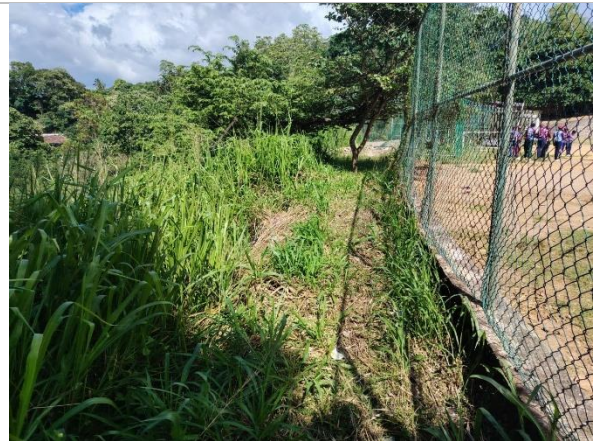
Figure 4f: Location 2; unstable slope behind the cricket practicing net

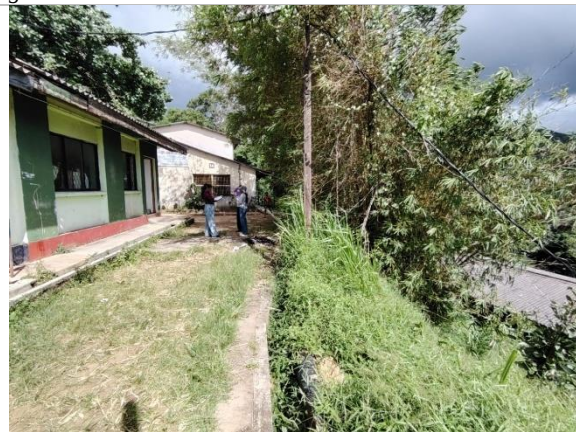
Location 3 is a failed slope located between the staff room, the physical fitness center (gym), and the Commerce Section building. The two-story Commerce Section building accommodates more than 250 students (male) and 2 coaches (male). The school staff room and the physical fitness center are situated on the upslope area, where large ground cracks and cracks on the building walls can be observed, indicating significant instability.

The drainage lines located between these buildings were damaged due to the slope failure. The unstable slope is currently covered with grass, and a bamboo bush is present at the top of the slope. In addition, electricity supply lines are running through the unstable slope area, increasing the potential risk. Due to safety concerns, the physical fitness center (gym) has been abandoned.

Figure 4g: Location 3 ; failed slope located between the staff room, the physical fitness center

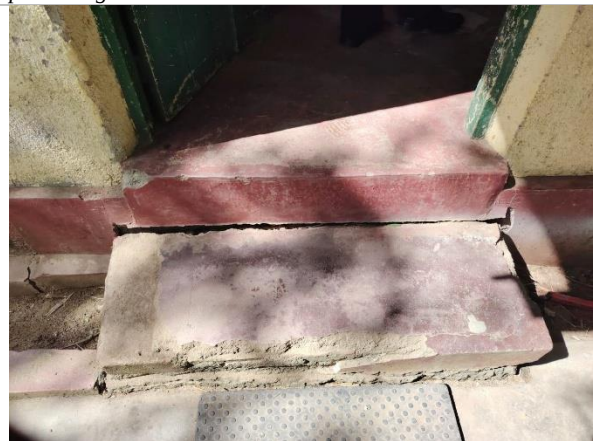
Figure 4h: Location 3 ; Cracks in physical fitness center

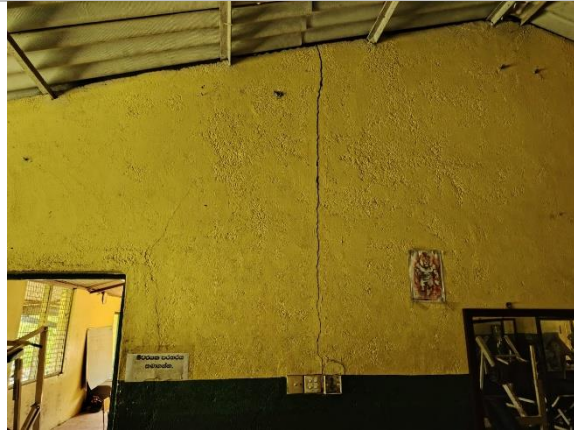
*Figure 4i:Location 3; Cracks in physical fitness center wall*

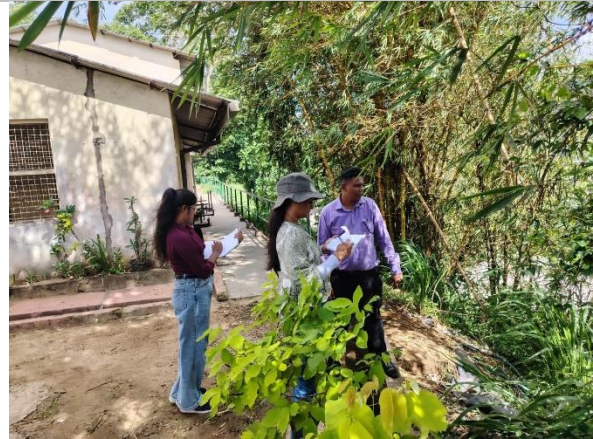
*Figure 4j:Location 3; Bamboo tree near the physical fitness center*

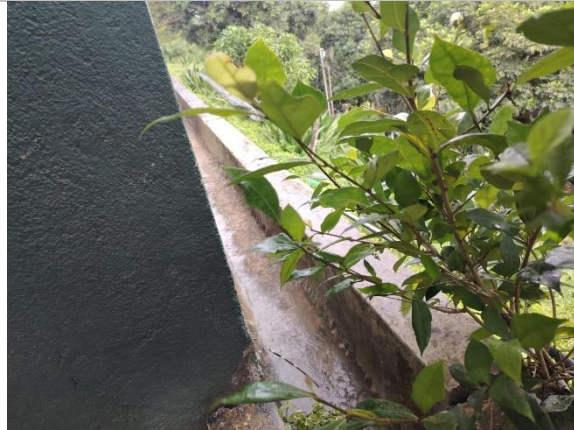
Location 4 is an unstable slope located behind the Grade 8 and 9 classroom building, which is a two-story structure, and the school’s art gallery building. Approximately 670 students (male) study in the Grade 8 and 9 section and nearly 15 teachers (11 female and 4 male) have been provided their service. During rainy periods, students are evacuated from the building due to the potential risk associated with the unstable slope. Ground cracks were observed in the area, and no proper drainage system is present at this location. The school’s art gallery room is also situated within the affected unstable slope area.

*Figure 4k:Location 4; Unstable slope located behind the Grade 8 and 9 classroom building*

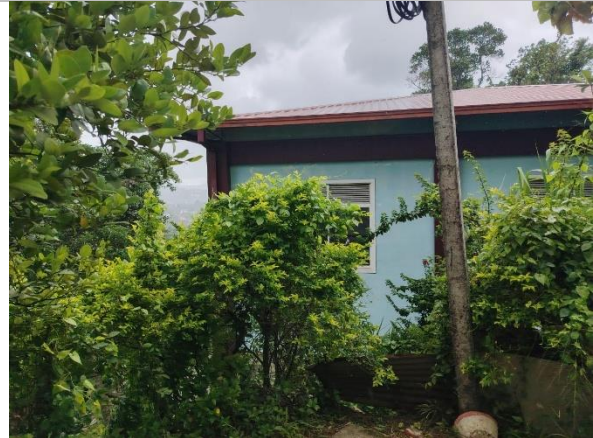
*Figure 4l:Location 4; Grade 8 and 9 classroom building*

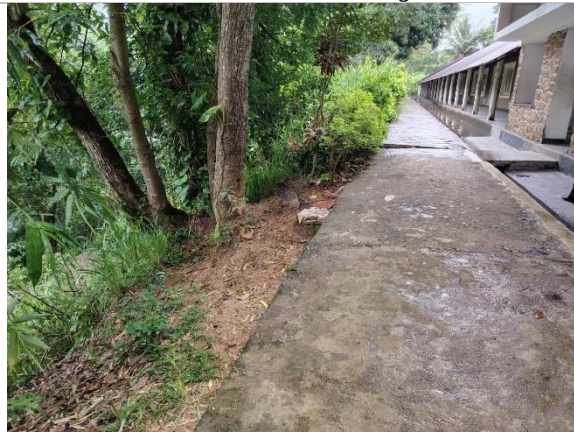
The upslope area is covered with grass and tree species such as Mango and Avocado. Ground cracks were observed in the area, and cracks have also developed on the road leading towards the school hostel located at the downslope area, indicating ongoing ground instability.

*Figure 4m:Location 5; unstable upslope area situated behind the school's aesthetic building*

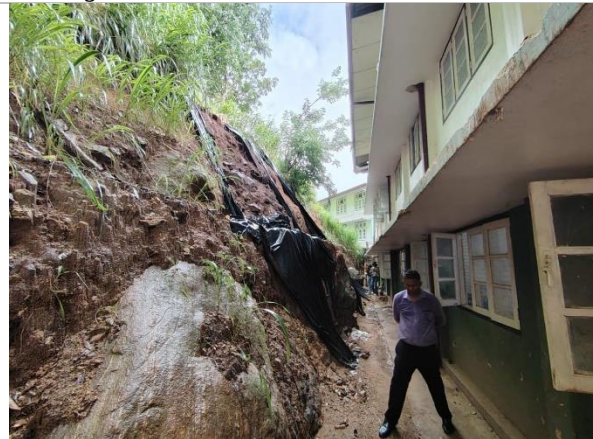
Location 6 is a failed slope located behind the Science Section building. During the Dithwah disaster situation, the failed soil mass entered and accumulated within the classrooms. The building is a three-story structure consisting of classrooms, with nearly 140 students and 7 teachers (5 female and 2 male). No proper drainage system was observed at this location, which may further contribute to slope instability. At present, the failed slope has been covered with a polythene layer as a temporary measure to prevent further water infiltration into the slope.

*Figure 4n:Location 6; failed slope located behind the Science Section building*

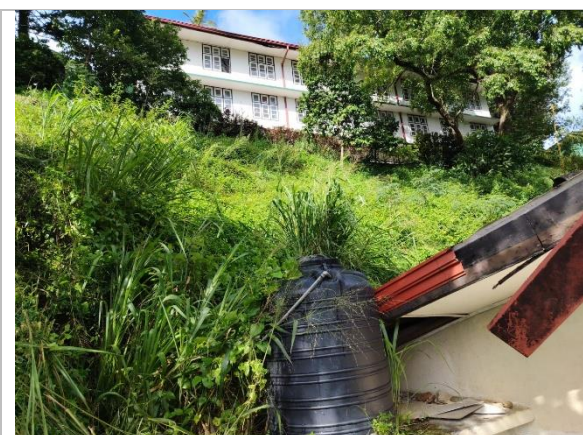
Location 7 is an unstable slope located behind the dental center building. There is a water tank near the building, which is currently not in use. A nurse (female) works at the dental center on a daily basis, while a doctor (male) visits occasionally. The slope area behind the building is at risk of slope failure.

Figure 4p: Location 7; unstable slope located behind the dental center building

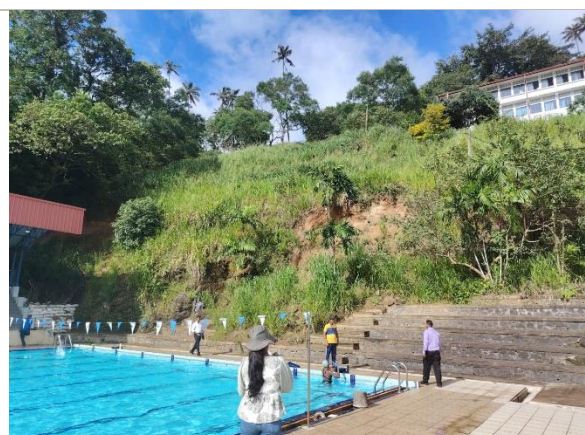
Location 8 is a failed slope located near the swimming pool complex within the school premises. During the disaster incident, the failed soil mass accumulated into the swimming pools. Although the pools have now been cleaned and are currently in use, a significant risk still remains. There are two swimming pools at this location. At present, the failed slope is covered with Mana grass to help stabilize the area. (Approximately 50-60 students including both male and outside female students and 2 or 3 coaches (male) have been used in this area)

Figure 4q: Location 8, Slope behind the swimming pool complex of the school
