# REDUCTION OF LANDSLIDE VULNERABILITY BY MITIGATION MEASURES PROJECT

## Site Specific Environmental and Social Management Plan

**Site No. 244  
Vidyarthi College - Kandy  
Kandy District**

**May 2026**

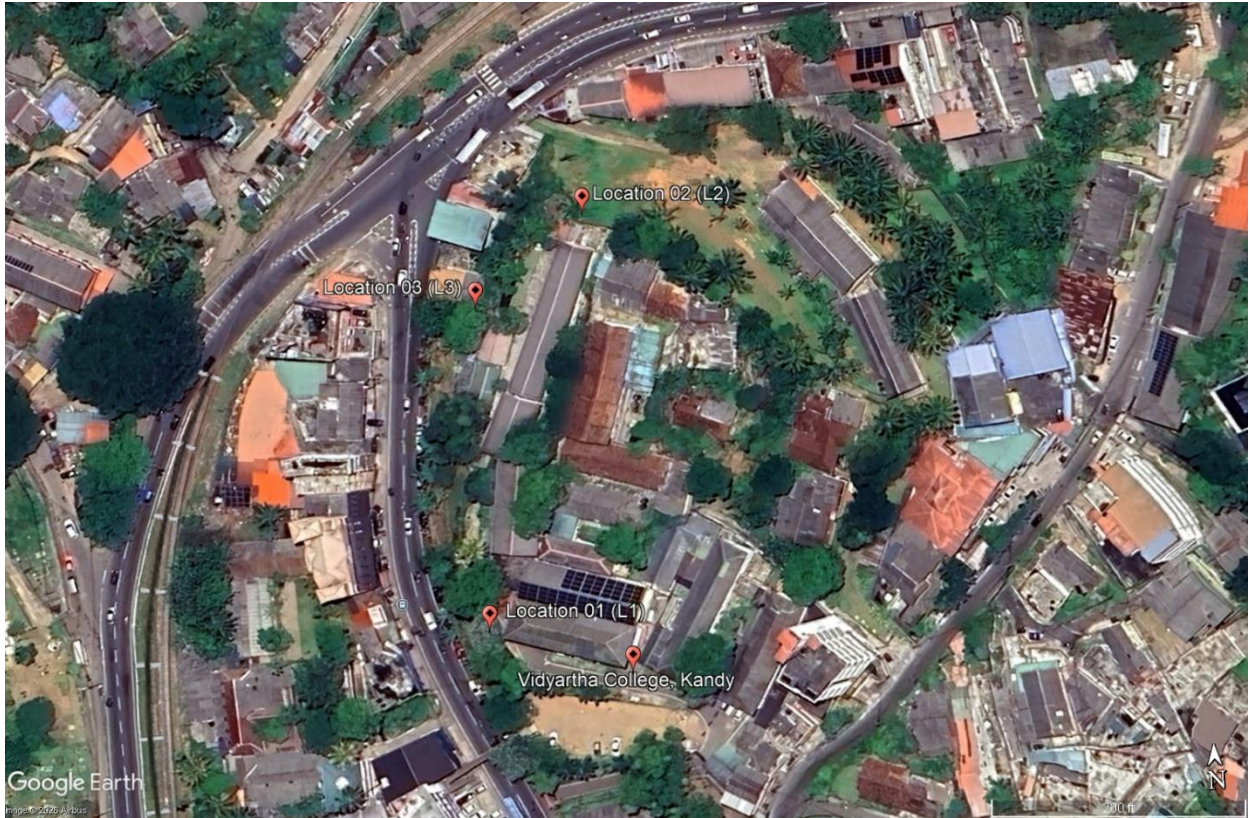
Figure 2: Google image of the proposed landslide mitigation site, the surrounding environmental features, and service infrastructure.

*(Refer to Figure 2; Google image of the proposed landslide mitigation site, the surrounding environmental features and service infrastructure.)*

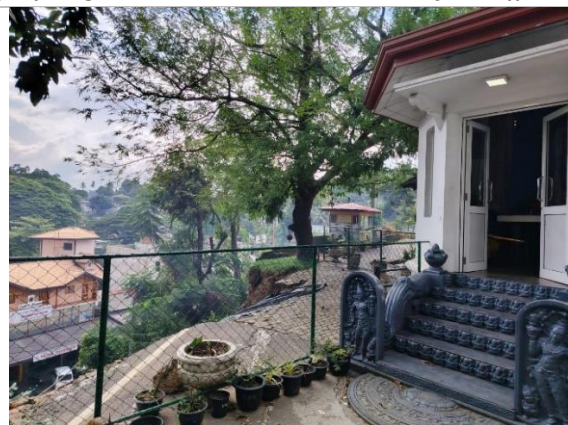
Figure 4a: Mitigation location of Vidyarthi College adjacent to the shrine room (Location 1)  
An Owila tree is observed on the slope area

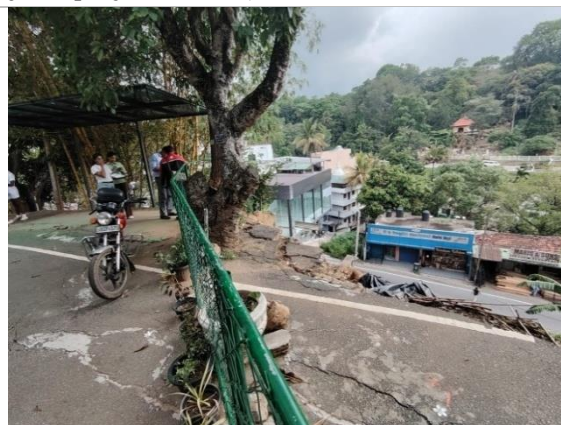
Figure 4b: Fence net made at the Location, Principal's car parking area - Mango tree and Bamboo shrubs are observed (Location 1)

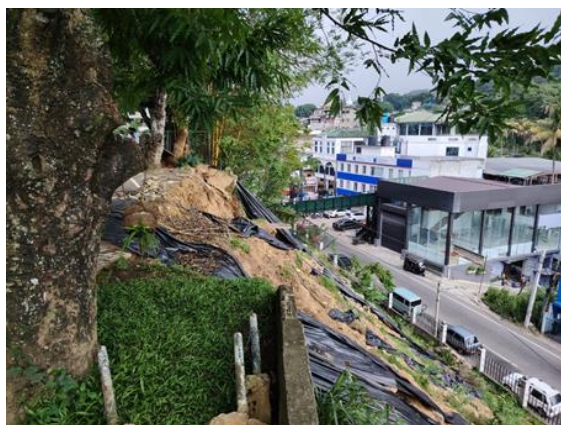
At the first location (L1), no direct structural damage except to the concreted ground and retaining wall. The nearby shrine room and the failure resulted in noticeable displacement of saturated soil masses near the cut slope to the principal's parking area toward the lower boundary section. The movement of soil materials did not cause damage to the school properties. The incident further increased the vulnerability of the front boundary area to future slope failures, particularly due to the presence of steep cut slopes and surcharge loading from large trees such as Owila, Mango, and Avocado located along the slope. In addition, the proximity of the failure zone to the Kandy - Jaffna Road (A9) poses potential long-term risks to nearby transportation infrastructure and pedestrian safety if further slope deterioration occurs.

Figure 4c: Destroyed retaining wall at the edge of the upslope with rock (Location 1)  
Kandy - Jaffna main road (A9) is observed at the downslope

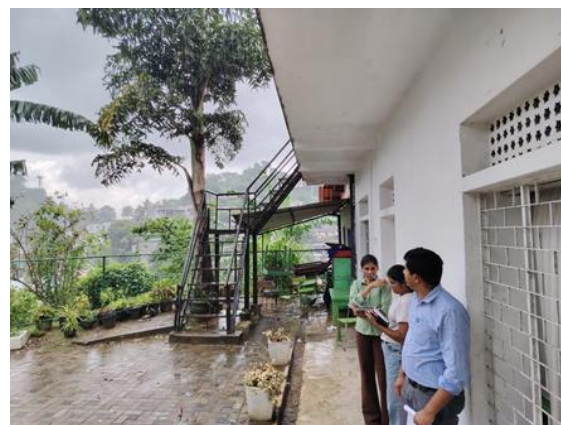
The mitigation location (L2) adjacent to grade 6,7 and 8. This two-storey building is observed cracks at the bottom of walls. The water line for the 6,7 and 8 building is laid nearby the mitigation location 02. Approximately 240 students and 7 teachers (2 male and 5 female) are used this building. The fence net is observed adjacent to the building.

Figure 4d: Affected two-storey building with staircase and fence net (Location 2)

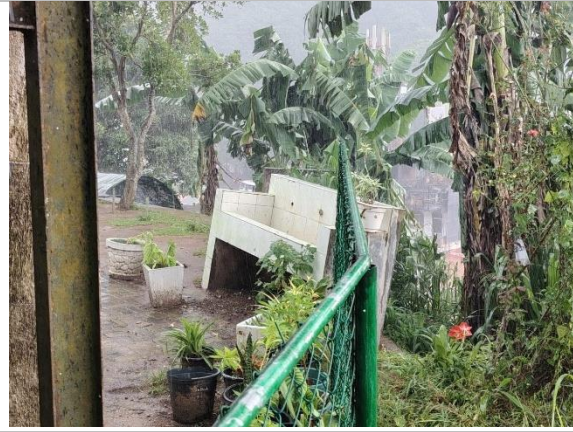
*Figure 4e: Abandoned washing basin, risk slope, and vegetation (Location 2)*

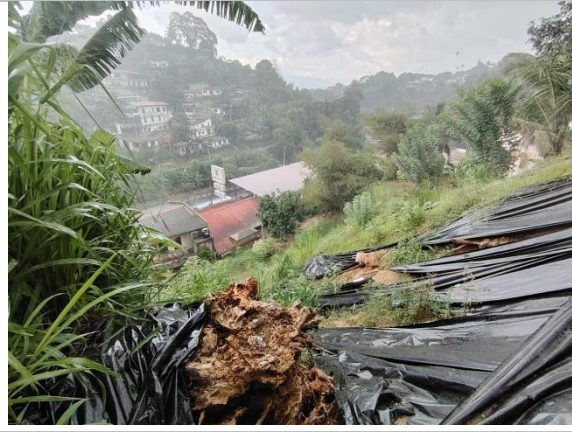
*Figure 4f: Steep slope area covered with Tarpaulin-  
steep slope (Location 2), Grasses and small herbs are  
seen in the slope*

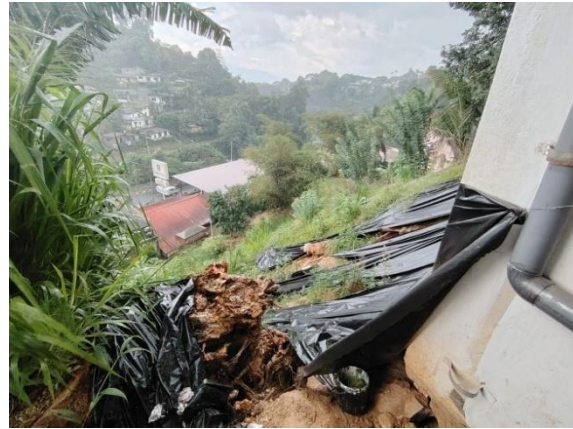
At the second location (L2), soil mass displacement was observed along the steep cut slope adjacent to the two-storey building and the roadside section. Although no major structural damage was identified at this location except the structural displacement of wash basin in front of the building, the slope failure significantly weakened the stability of the surrounding terrain. Surface erosion around the building, localized scouring, and downslope movement of soil materials were evident within the affected section. The unstable slope conditions may increase the susceptibility of the area to future failures during prolonged rainfall events, thereby posing potential threats to nearby school structures, access pathways, and roadside areas.

*Figure 4g: Soil mass failure and soil erosion adjacent  
to the Grade 6, 7, and 8 building (Location 2)*

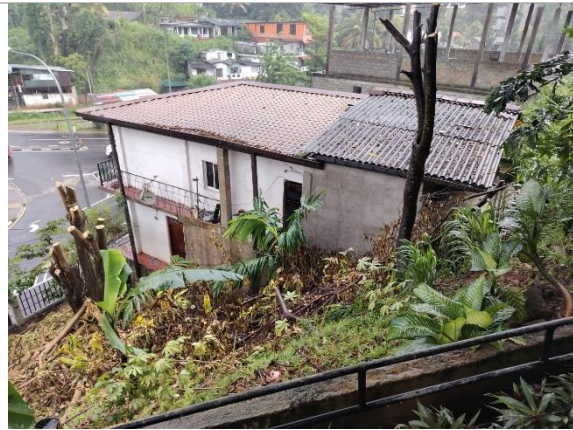
*Figure 4i: Three-storey private building for  
residential and commercial purposes, Surface  
drainage pattern, and vegetation along the  
downslope (Location 3)*

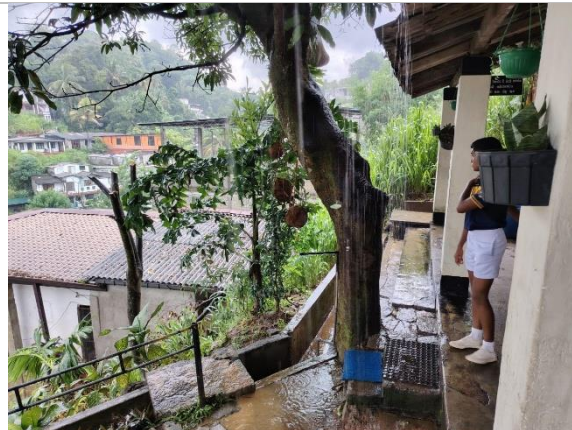
*Figure 4j: Cracked floor of the cadet band building, a  
Mango tree at the edge of the upslope (Location 3)*

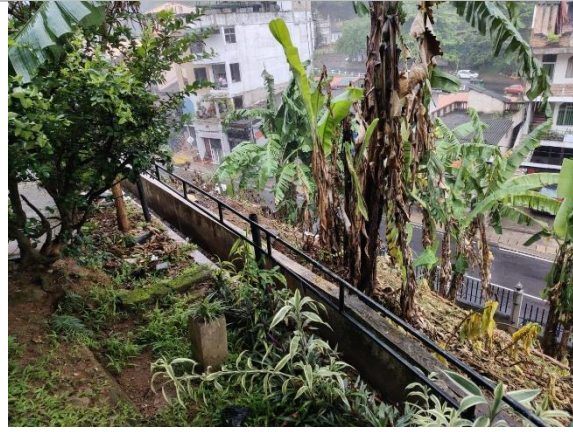
Figure 4k: Slope area with vegetation. The Kandy – Jaffna main road (A9) is seen at the downslope (Location 3)

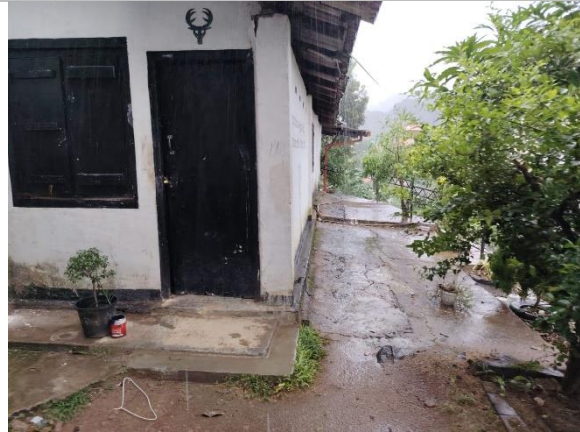
Figure 4l: Single-storey canteen building beside the cadet band building with cracked walls (Location 3)

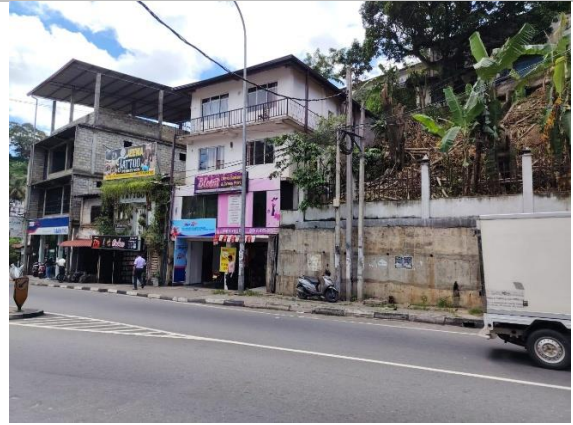
Figure 4m: Three-storey private building adjacent to mitigation Location 03, retaining wall and the Kandy - Jaffna main road (A9)

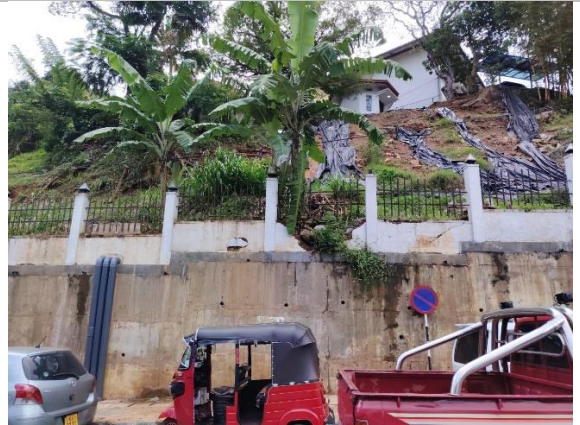
Figure 4n: Steep slope of Location 03 with vegetation and school boundary
