# REDUCTION OF LANDSLIDE VULNERABILITY BY MITIGATION MEASURES PROJECT

## Site Specific Environmental and Social Management Plan

**Site No. 246**

**Sri Swarnajothi National College - Kiribathkumbura  
Kandy District**

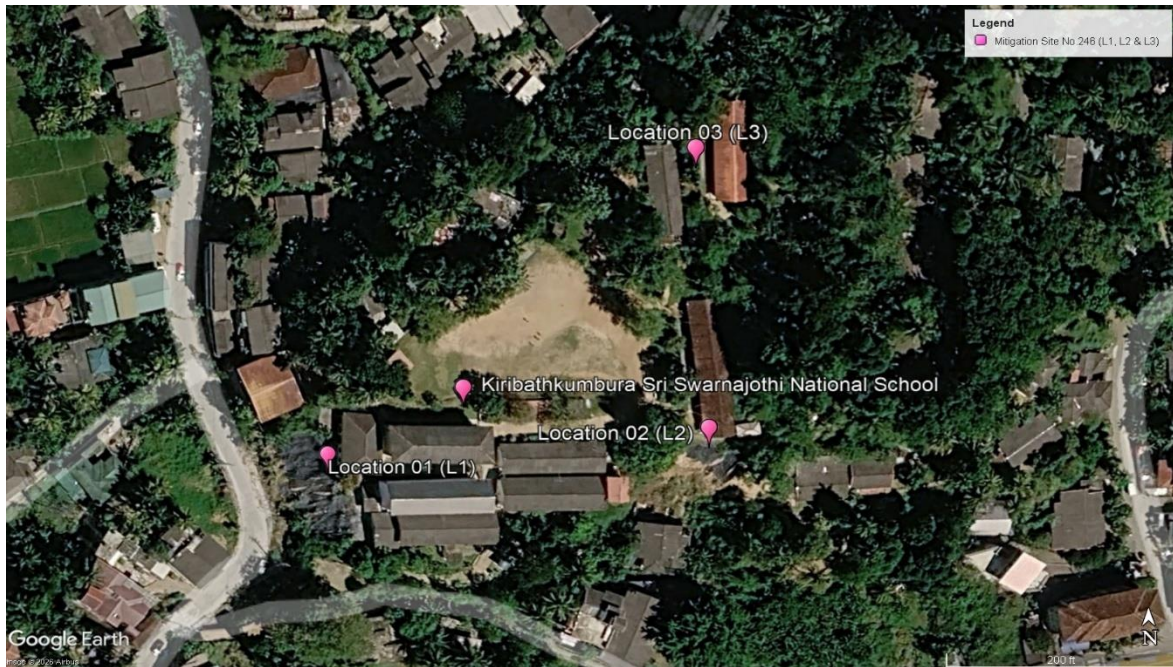
Figure 2: Google image of the proposed landslide mitigation site, the surrounding environmental features, and service infrastructure.

The proposed mitigation sites are located within Sri Swarnajothi National School in Kiribathkumbura. The total extent of the school premises is approximately four (4) acres and 28 perches. The general topography of the area is characterized by moderately steep and undulating terrain with sloping ground conditions. The school premises are situated adjacent to the Wathurakumbura–Kiribathkumbura Road, which is maintained by the Provincial Road Development Authority (PRDA), and are located approximately 300 m from the Kandy–Colombo Main Road. The site is bounded by the Wathurakumbura–Kiribathkumbura Road to the west, while the southern and eastern boundaries are surrounded by commercial buildings and residential houses. A small stream flows along the south-eastern boundary of the school premises. The land is owned by the Department of Education.

*(Refer to Fig. 2 for the Google image showing the proposed landslide mitigation sites, surrounding features, and existing service infrastructure.)*

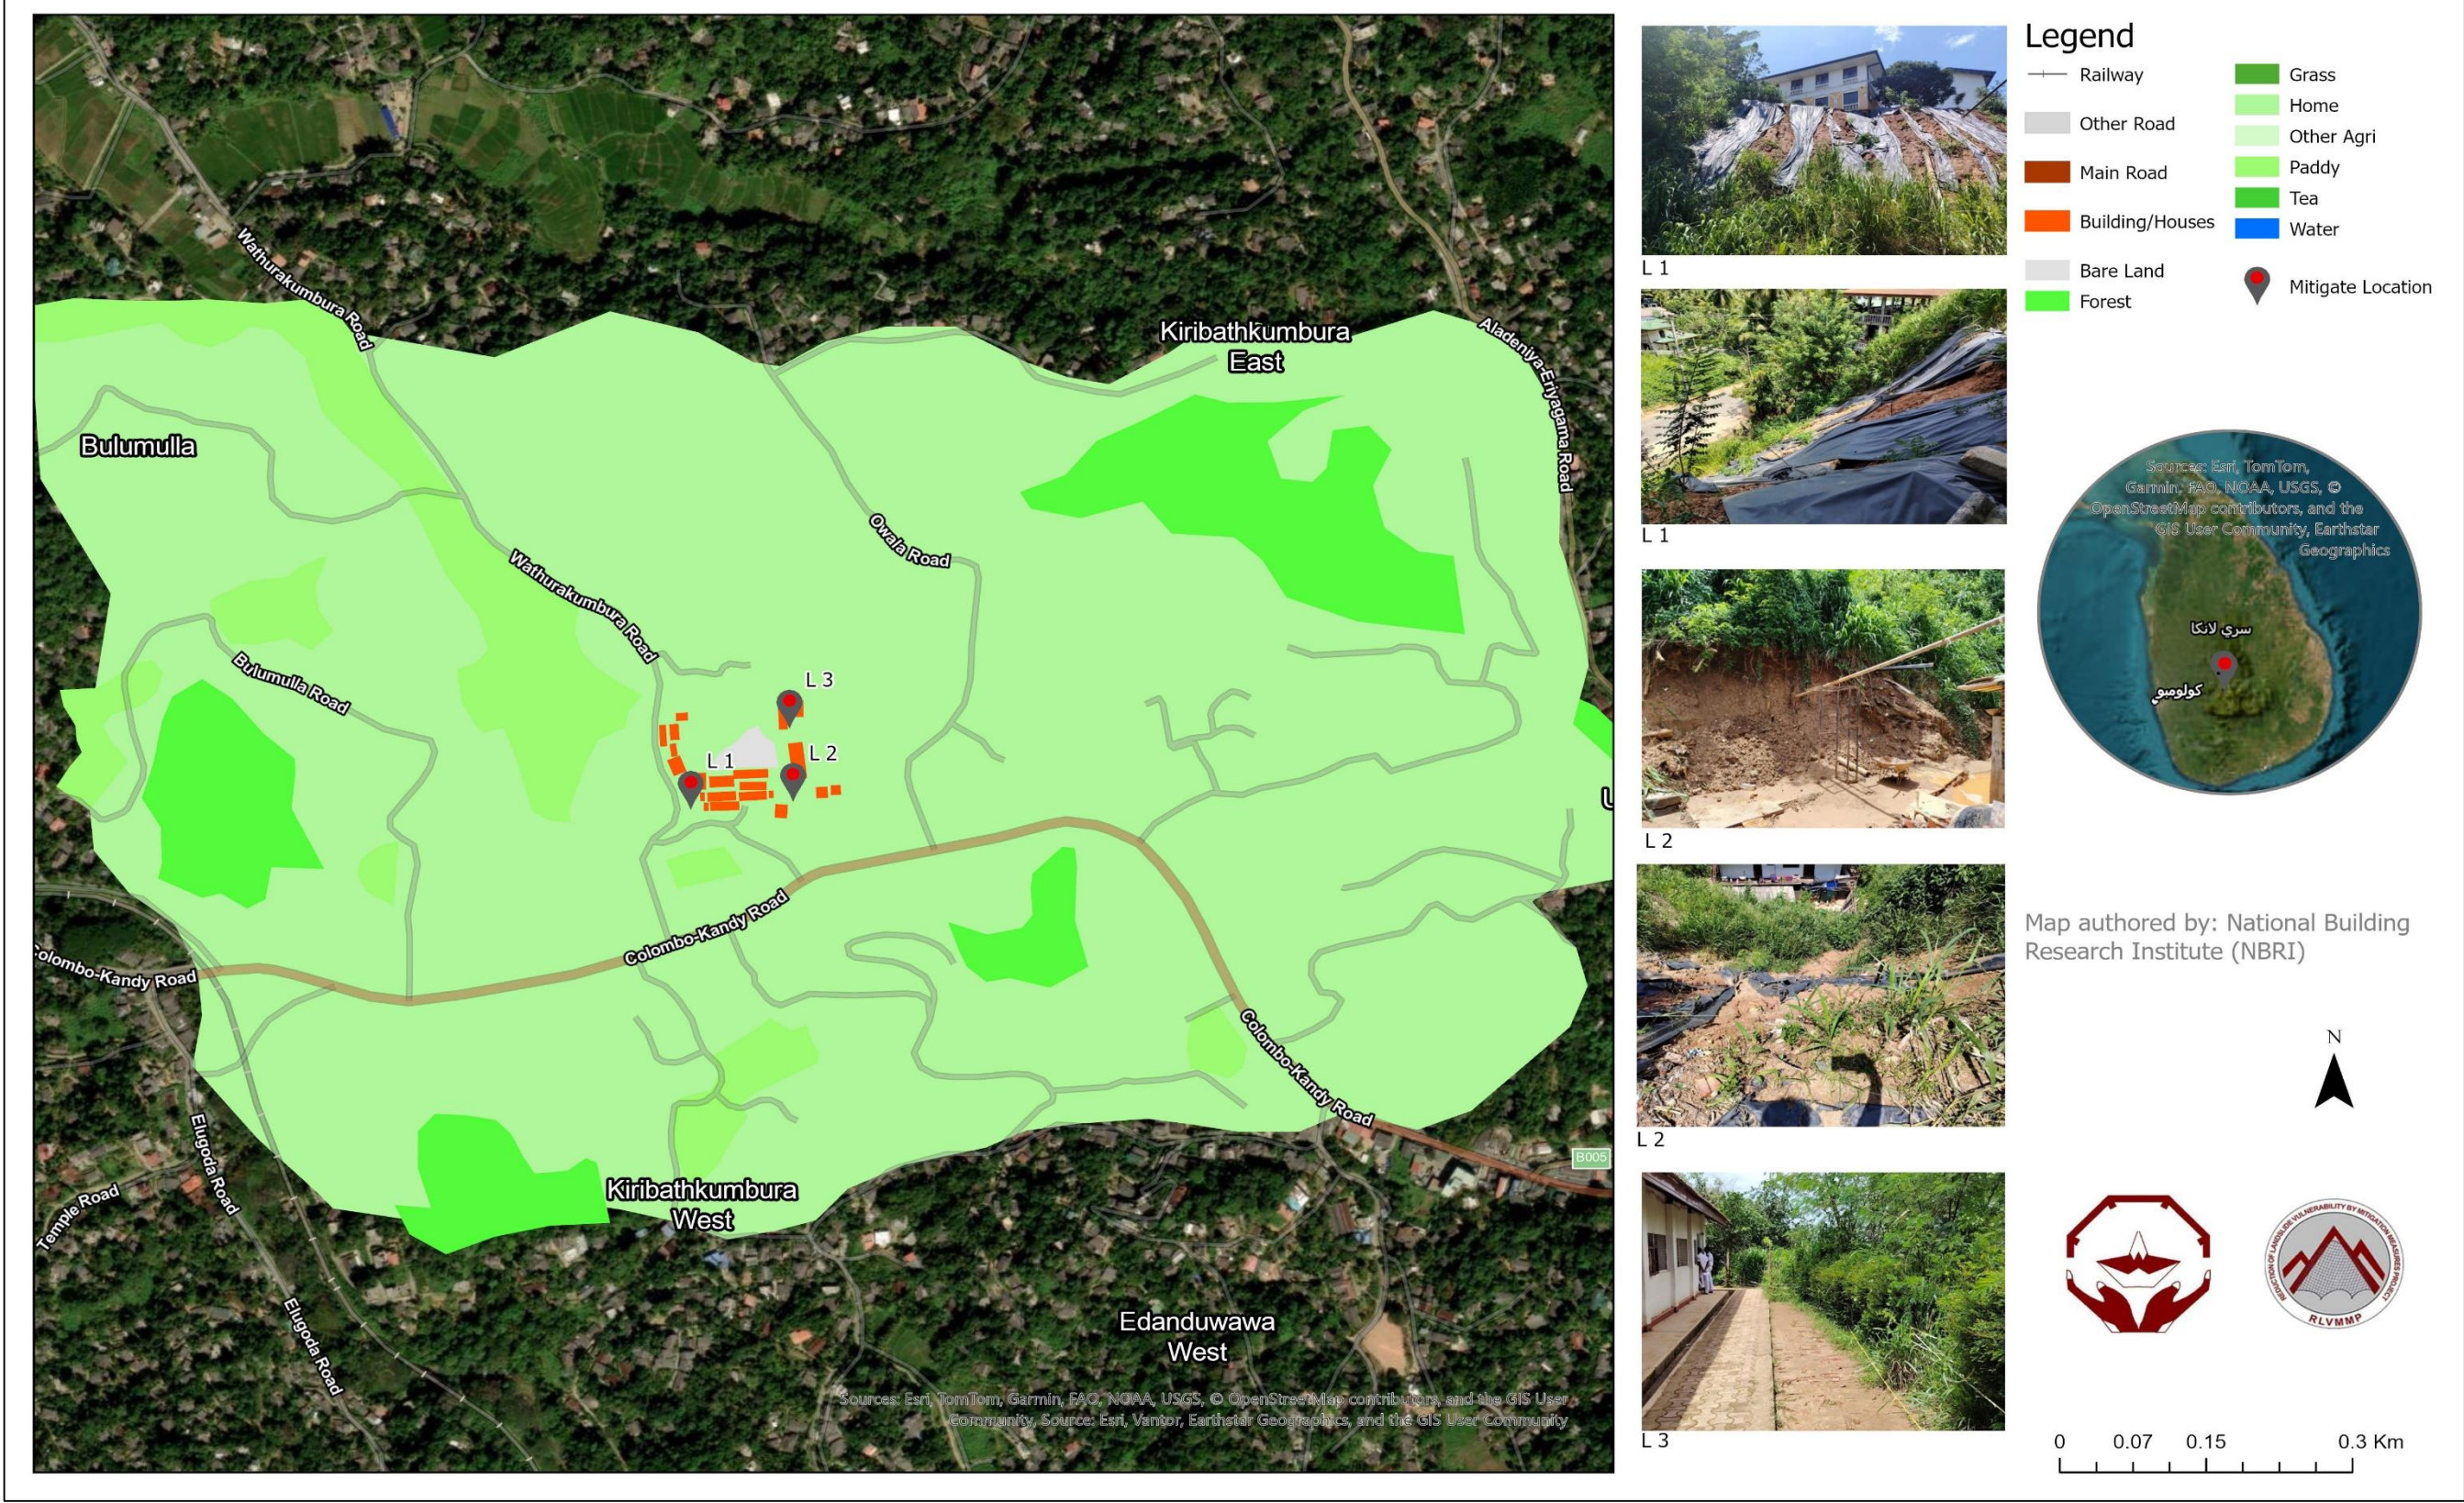
Figure 3: Google image, land use, risk elements and the photographs of special features of the location

The three areas of the slope failures and potential cut slope failures are located in Sri Swarnajothi National College premises. L1 slope is located behind to the Mahindodaya laboratory and in between front boundary of Kiribathkumbura – Wathurakumbura road. L2 is adjacent to the Martin Wickramasinghe Hall. There is private land at the toe of the slope, where a residential house is located very close to the slope boundary. L3 is located nearby the Mahagamasekara Hall and at the toe of the slope, the Ediriweera Sarathchandra Building is situated.

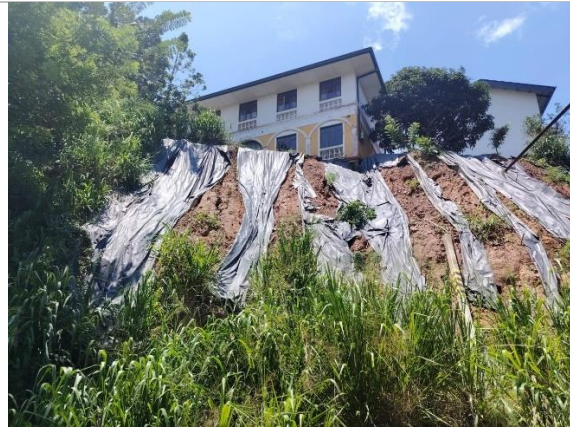
*Figure 4a: Steep slope adjacent to Mahindodaya laboratory of the Sri Swarnajothi National School – Kiribathkumbura (Front boundary of the school, Location 01 (L1))*

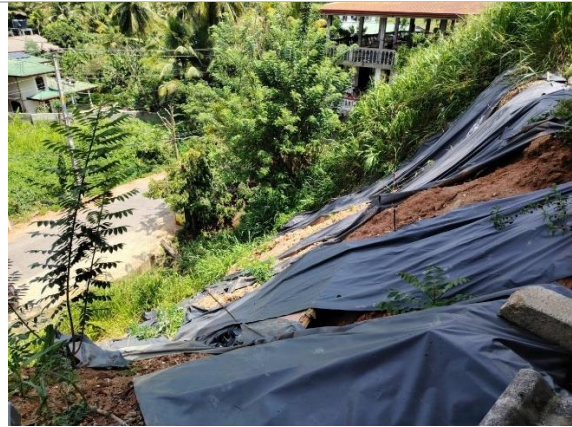
Cyclone “Ditwah,” which occurred in November 2025, caused significant impacts across the country, particularly in the Central and Uva Provinces, affecting social life, the environment, and infrastructure facilities. Many school premises located in hilly areas were severely affected by landslides and slope failures. Sri Swarnajothi National School, located in Kiribathkumbura, was also impacted by this disaster. At Location L1, which is the slope area located between the Kiribathkumbura–Wathurakumbura Road and the two-storey Mahindodaya Laboratory building, severe slope instability and soil mass movement were observed. As a result of the unsafe condition of the building and the surrounding slope area, the computer laboratories and students were relocated to another building situated in front of the Mahindodaya Laboratory. This building was previously used as the school auditorium. Consequently, the school currently does not have a dedicated auditorium facility and has to use a nearby temple to conduct meetings and other school functions. In addition, visible structural cracks have developed in the Mahindodaya Laboratory building, and the building has now been abandoned due to safety concerns.

*Figure 4b: Tarpaulin covered failure steep slope in between Mahindodaya laboratory and Kiribathkumbura–Wathurakumbura road (Location 01 (L1))*

- Stabilize the existing cut slope by installing long soil nails with a reinforced concrete grid beam
- Provide adequate toe support by constructing a 2.0 m high retaining wall along the toe of the slope, after removing all loose debris and failed material
- Construct an “L”-shaped surface drain along the crest of the slope to intercept and collect surface runoff, and safely discharge it into the existing cascade drainage system within the premises

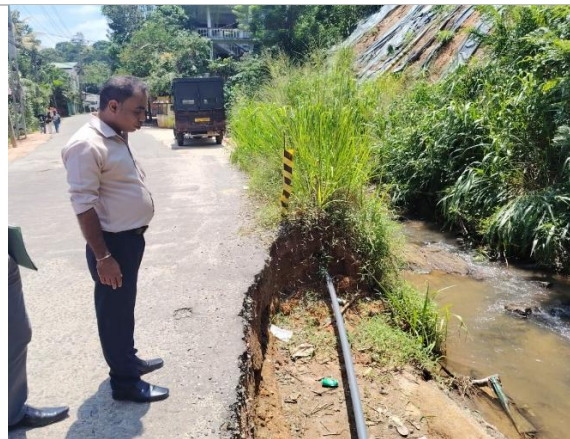
The mitigation location is situated along the front boundary of the school premises, adjacent to the Mahindodaya Laboratory Building and the Kiribathkumbura–Wathurakumbura Road. Water stream flowing along the mitigation location. A three-storey private building and the school staff washroom are also located in close proximity to the identified slope failure area. The drainage system serving the Mahindodaya Laboratory Building discharges towards the mitigation area, which may contribute to increased water infiltration and slope instability during periods of heavy rainfall. The Mahindodaya Laboratory Building accommodates several educational facilities, including the E-Nenasala Centre, Language Laboratory, Computer Laboratory, and Advanced Level (A/L) section. Approximately 30 students utilize the A/L section of the building. Due to the potential risk associated with the unstable slope, the Mahindodaya Building has been temporarily evacuated as a precautionary measure to ensure the safety of students and staff. Approximately 180 students (100 female, 80 male) and 5 teachers (4 female, 1 male) have used this area.

*Figure 4c: Water stream flow along Kiribathkumbura – Wathurakumbura road near to the mitigation location 01 (L1)*

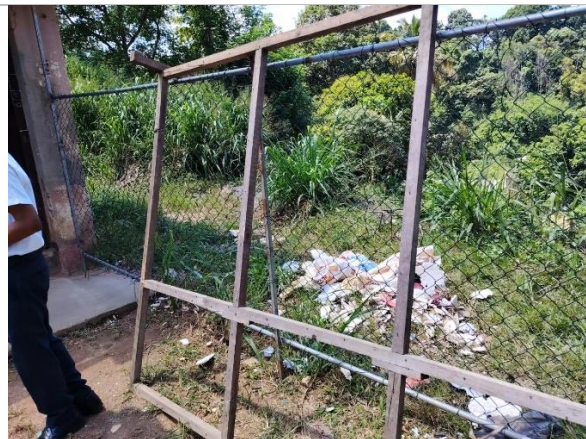
*Figure 4d: Fence net near by the edge of the slope at the location 02 (L2)*

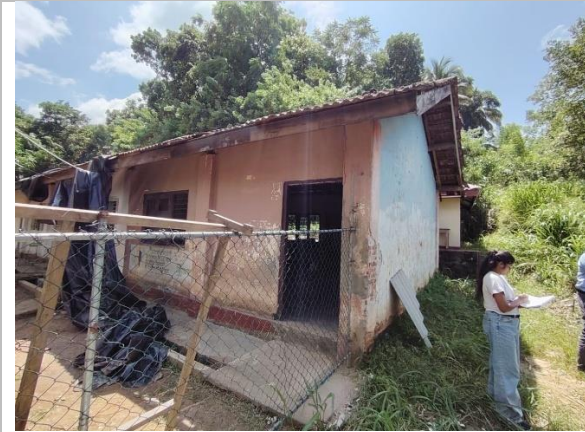
The second mitigation location is situated adjacent to the Martin Wickramasinghe Building, a single-storey school facility located at the edge of the unstable slope. The building accommodates four Grade 7 classrooms with a total student population of approximately 162 (female- 91, male 71) and 6 teachers (female 4, male 2). Although the building is located within the potential risk zone of the slope failure, classes continue to be conducted due to the lack of suitable alternative classroom facilities within the school premises.

Figure 4e: Martin Wickramasinghe (single storey) building adjacent to location 02 (L2)

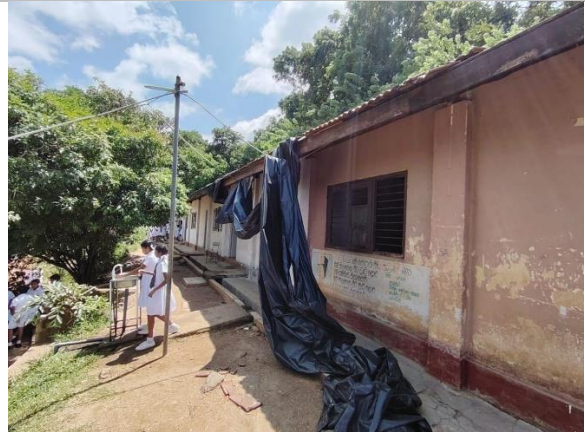
Figure 4f: Wash basin and water line nearby the location 02 (L2)

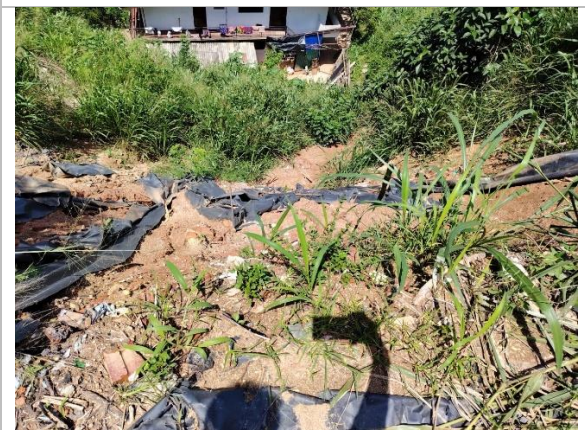
Location L2, which is the slope area adjacent to the Martin Wickramasinghe Hall and the residence of Mr. Gunarathne Wickramasinghe, slope failure incidents have created a significant risk to both the school community and the nearby residences. The building located near this unstable slope area is currently used for Grade 7 classes. However, the school does not have sufficient alternative space to relocate the students, as the available facilities are already fully occupied. In addition, children of this age group do not fully understand the potential danger associated with slope instability and are often seen playing around the affected slope area, increasing the risk to their safety.

At the toe of the slope, the residence belonging to Mr. Gunarathne Wickramasinghe was also severely affected by the landslide. A large volume of soil mass had moved into the property during the failure event, causing considerable difficulties for the occupants. Although a portion of the deposited soil has now been removed, the landslide damaged the boundary wall of the property. Due to the continuing risk of further slope movement, the residents have removed all equipment and belongings located at the rear side of the house adjacent to the slope area. The affected residents and the school administration have requested an immediate remedial solution to stabilize the slope and ensure the safety of the students, staff, and nearby residents.

Two residential houses are located downslope and in close proximity to the failed slope area. One of these houses is situated directly at the toe of the steep failed slope and is therefore particularly vulnerable to potential slope movements and falling debris. In addition, a washroom facility located adjacent to the unstable slope has been abandoned and is no longer in use due to safety concerns associated with the slope instability.

Figure 4g: Steep failed downslope at location 02 with covered by Tarpaulin and nearby house at the toe area of the slope

- A Resting type retaining wall is recommended at the toe of the slope to provide lateral support and strengthen the slope
- Proper surface drainage arrangements shall be introduced to control uncontrolled runoff and minimize water infiltration into the slope. This includes;
  - i. Cut off drain shall be constructed along the top of the retaining wall
  - ii. The unpaved portion between the building and the slope crest should be covered with a properly graded concrete pavement. This will prevent direct surface water infiltration into the slope
  - iii. The pavement should be constructed with adequate slope toward the surface drain to ensure efficient water discharge

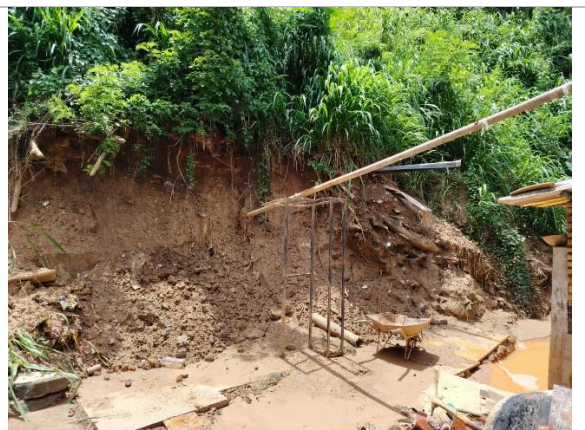
Figure 4h: At the failed bottom of the steep slope location 02 (L2)

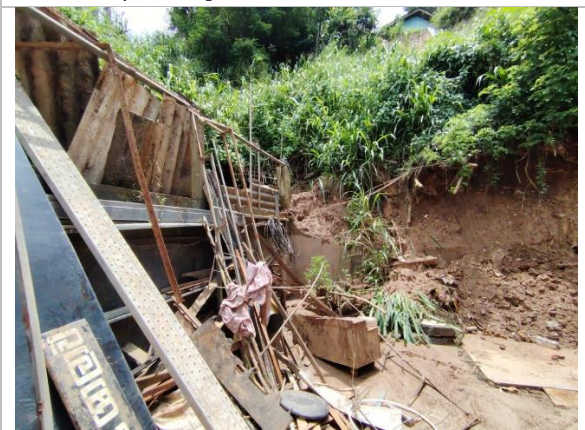
Figure 4i: Destructed retaining wall and property of the resident adjacent house at location 02 (L2)

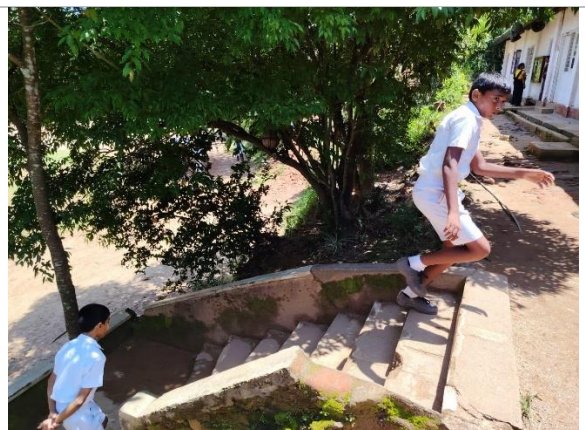
Figure 4j: Staircase nearby the location 02 which provide access to the Martin Wickramasinghe building (L2)

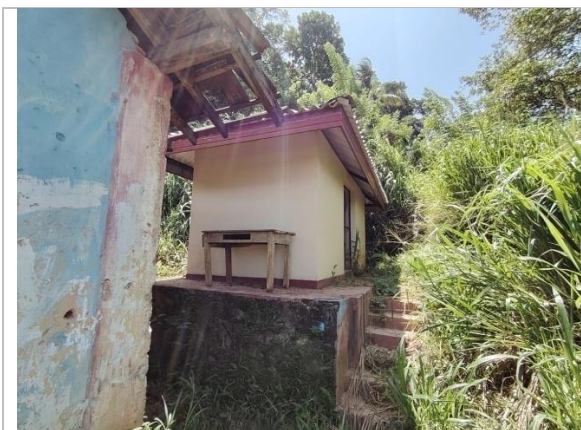
Figure 4k: Abandoned washroom nearby the location 02 (L2)

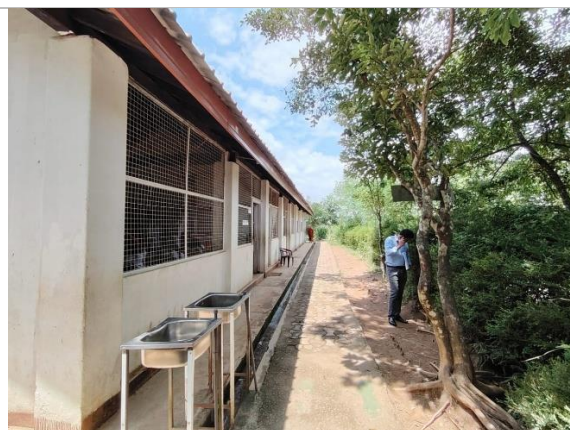
At Location L3, which is the slope area located behind the Ediriweera Sarachchandra Hall and Mahagamasekara Hall, slope instability conditions and soil mass movement pose a considerable risk to the school buildings and students. Similar to the other affected locations, the school management does not have sufficient space to relocate the students to safer buildings in the event of a major slope failure or emergency situation. Due to the limited availability of classroom and building facilities within the school premises, managing student safety during hazardous conditions has become a major concern. Therefore, immediate attention and suitable mitigation measures are required to reduce the risk associated with the unstable slope area.

The third mitigation location is situated on the failed slope between the Ediriweera Sarathchandra Hall and the Mahagama Sekara Hall, both of which are single-storey school buildings. Grade 8 classes are conducted in the Ediriweera Sarathchandra Hall, while Grade 6 classes are conducted in the Mahagama Sekara Hall. Each building accommodates four classrooms, serving a considerable number of students on a daily basis. Approximately 80 students (42 female, 38 male) and 3 teachers (all female) have used this area.

Figure 4l: Downslope in front of the Ediriweera Sarathchandra building (single storey) at location 03 (L3)

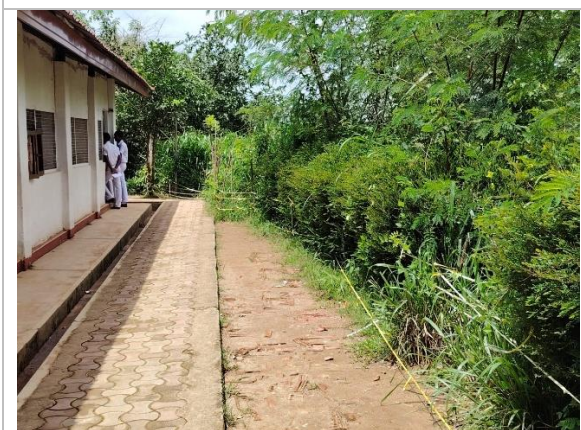
A temporary protective fence and vegetation cover are present along the slope section in front of the Ediriweera Sarathchandra Hall. However, these measures provide only limited protection against further slope deterioration and are not considered adequate for long-term slope stabilization. Given the close proximity of the educational facilities to the unstable slope, appropriate mitigation measures are required to ensure the safety of students, staff, and school infrastructure.

Figure 4m: Temporary fence with covered with vegetation at location 03 (L3)
