# REDUCTION OF LANDSLIDE VULNERABILITY BY MITIGATION MEASURES PROJECT

## Site Specific Environmental and Social Management Plan

**Site No. 247**

**Wariyapola Sri Sumangala / Sylvester's College - Kandy  
Kandy District**

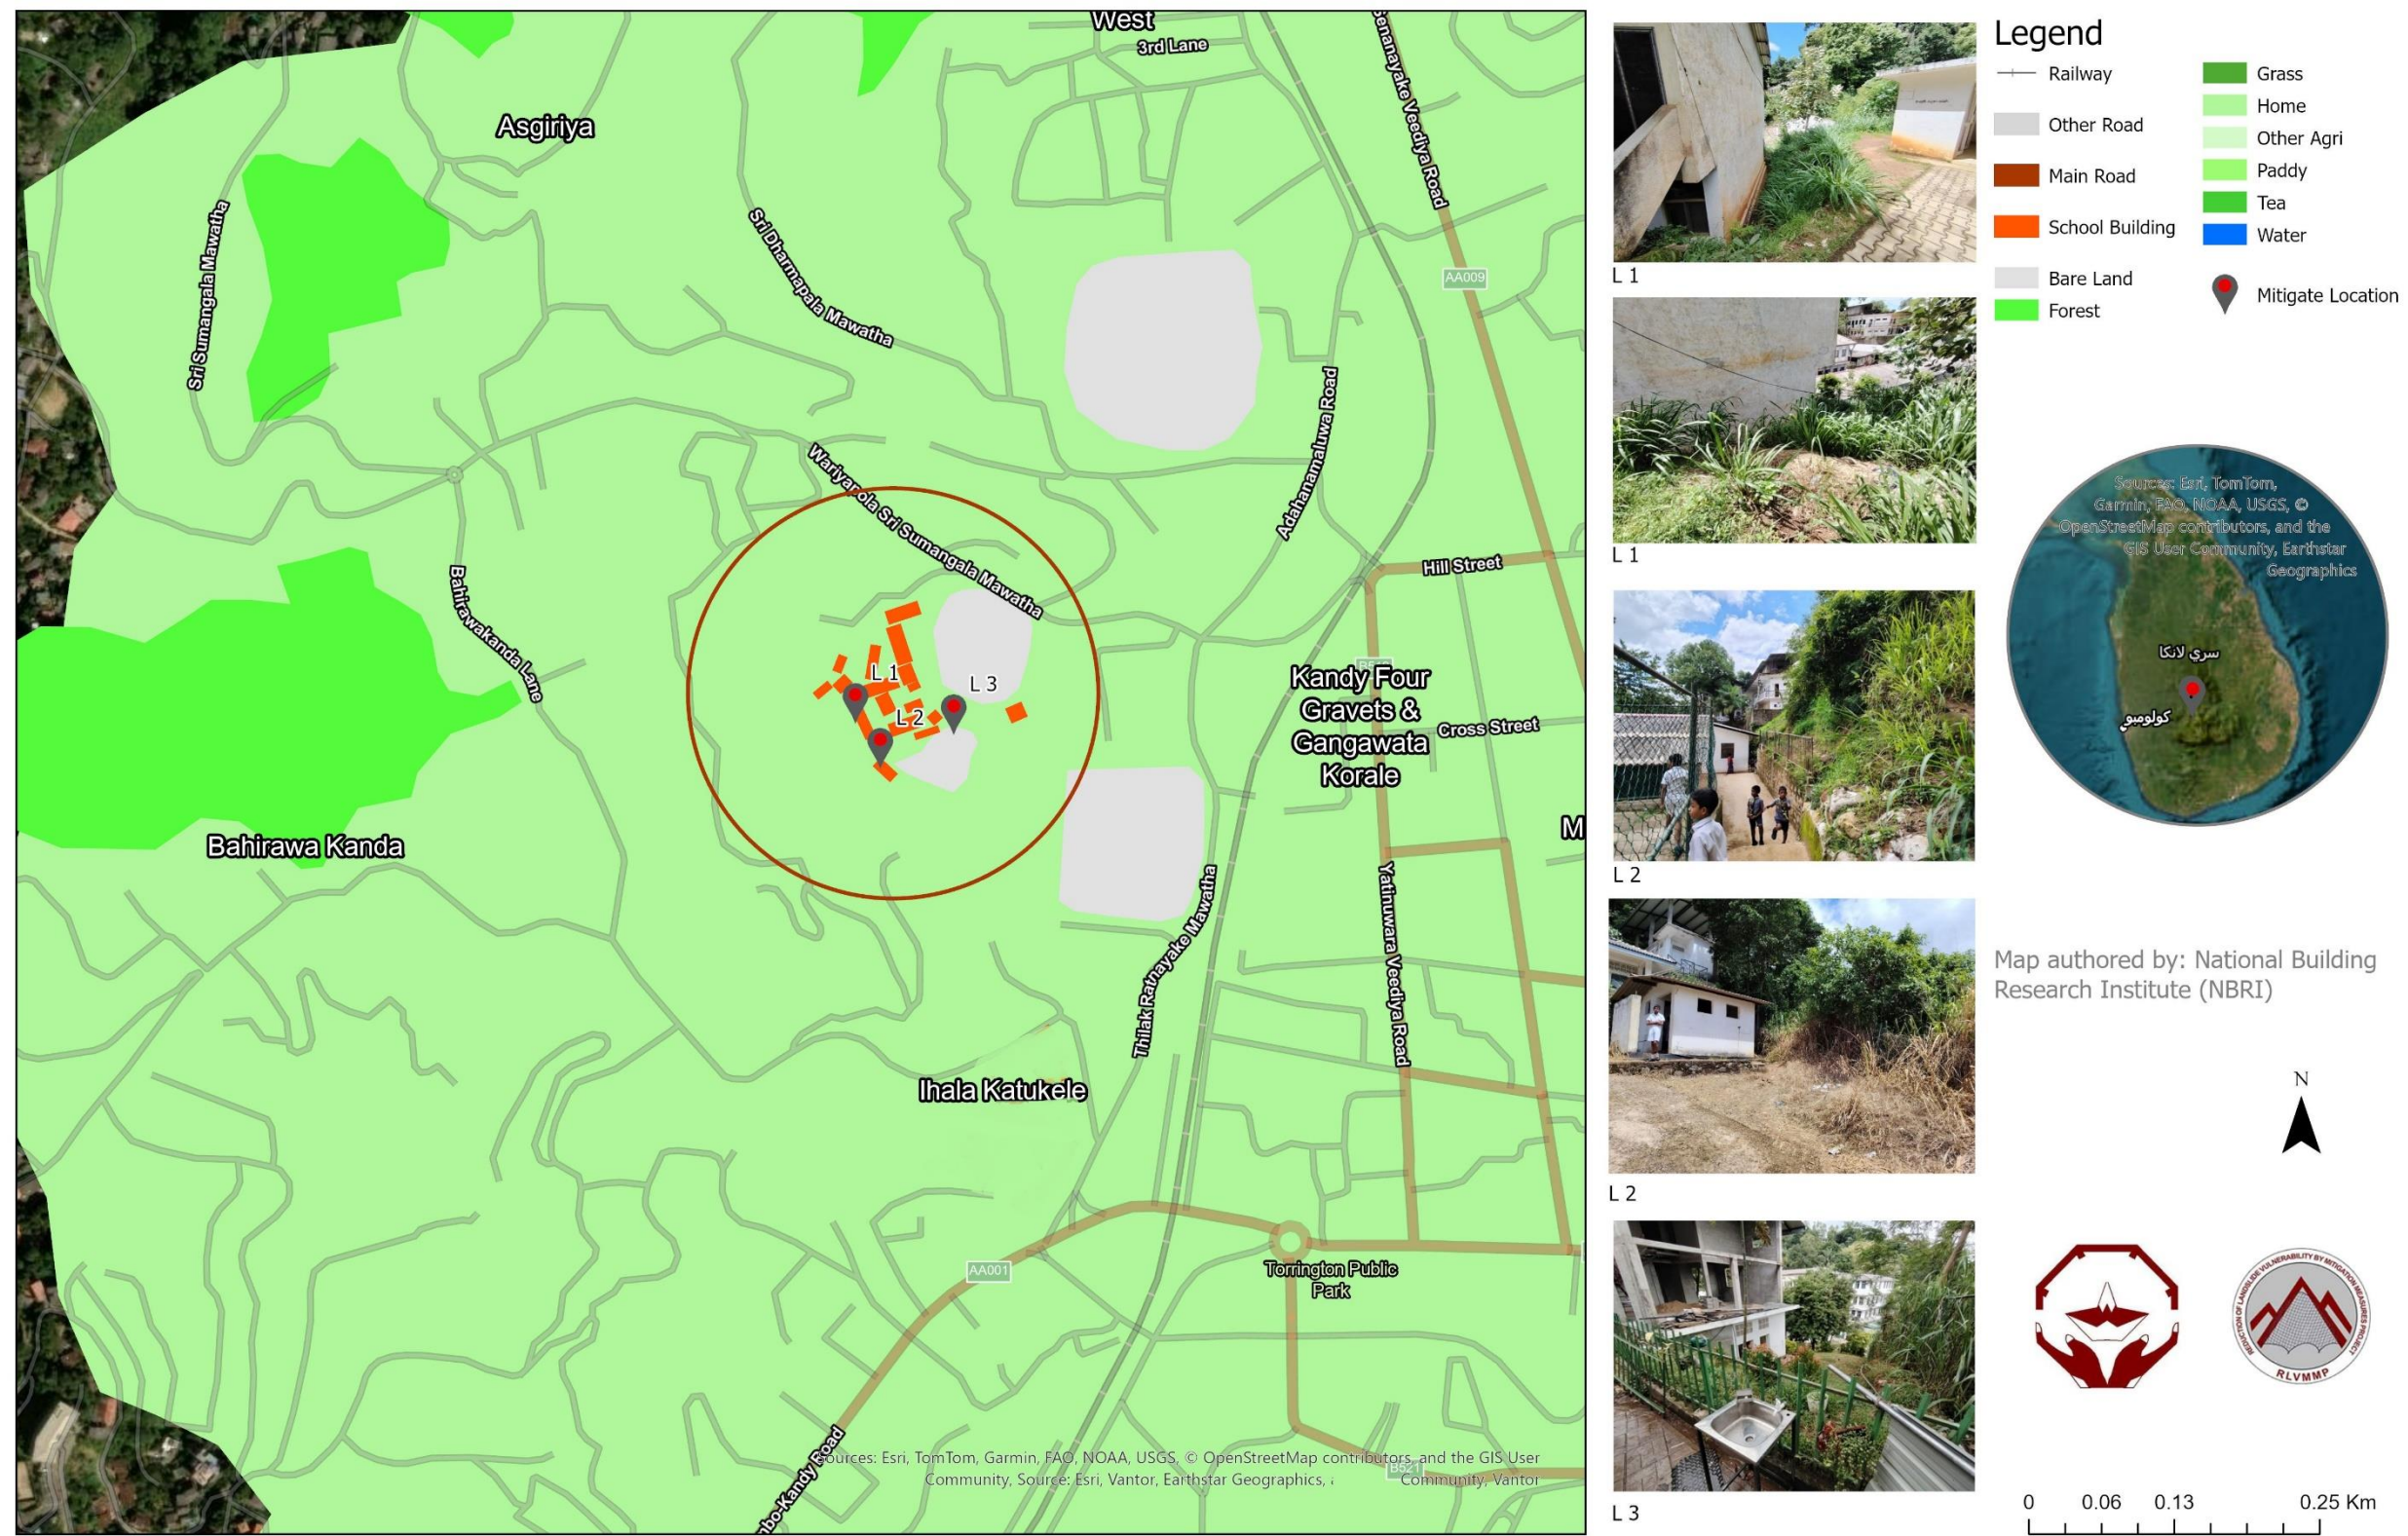
Figure 3: Google image, cross sections, land use, risk elements and the photographs of special features of the location

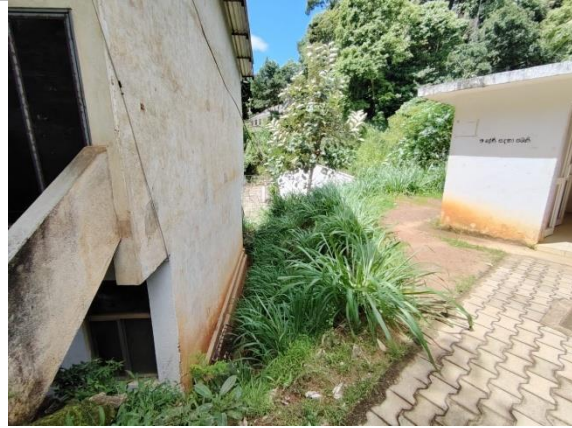
The first location (L1) was observed behind Grade 9 (three storey building). This location is situated at the lower section of a steep cut slope where the washroom area occupies the upper elevation. There is an approximately 4 m high slope with an inclination of about 70° located adjacent to the Grade 9 classrooms.

Although no failure has occurred to date, the slope appears to be in a potentially unstable condition, with a risk of failure that could damage the nearby building.

Figure 4a: Mitigation location of Wariyapola Sri Sumangala College, behind Grade 9 building (Location 1)

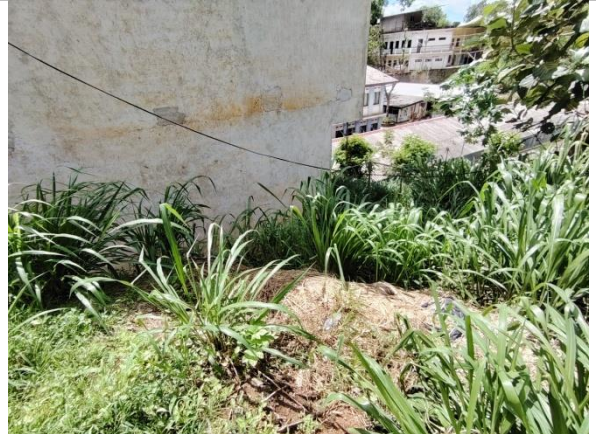
Figure 4b: Approximately 4m high slope with 70° inclination and Electricity line along the slope section (Location 1)

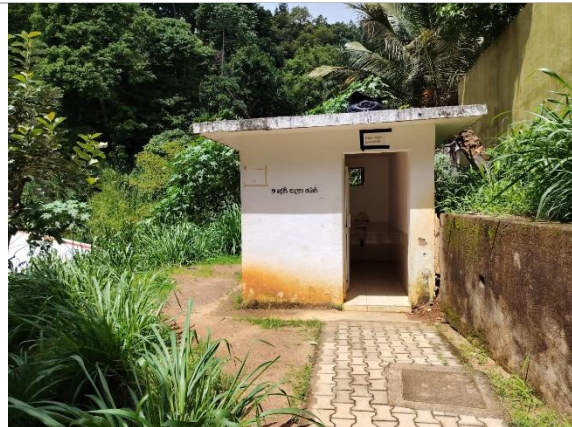
Figure 4c: Washroom and retaining wall nearby the mitigation location (Location 1)

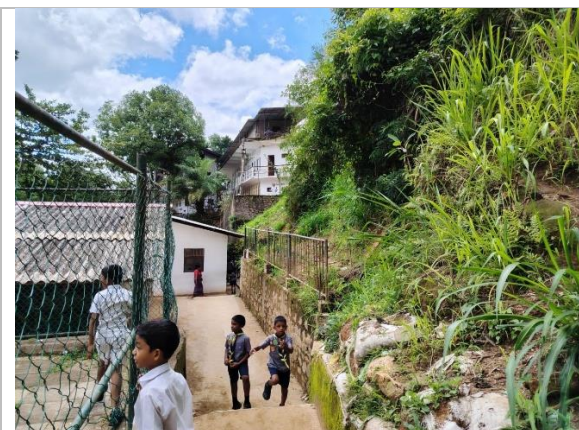
Library (two storey) building and fence net was situated at the upper slope of the second mitigation location (L2). Retaining wall was cracked and soil erosion is noticeable in the slope. Play area, grade 1 and 2 building are located at the bottom of slope. The observed slope failure at this location is classified as a shallow landslide. This area is occupying for 320 students and 8 teachers (5 female, 3 male).

*Figure 4e: The toe of the upslope area with retaining wall, vegetation and soil erosion adjacent to the play area (Location 2)*

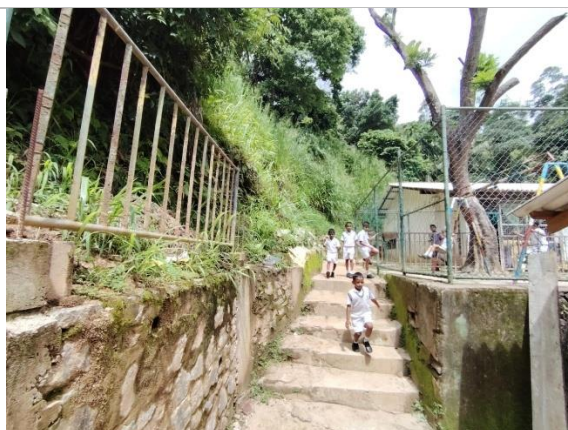
*Figure 4f: Fence, retaining wall and stair case adjacent play area and Grade 1 (Location 2)*

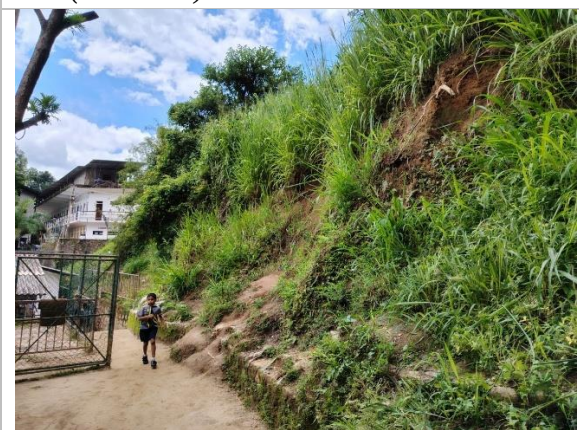
At the second location (L2), soil mass displacement was observed along the steep cut slope adjacent to the two-storey library buildings. The slope failure significantly weakened the stability of the surrounding terrain. Surface erosion around the building, localized scouring, and downslope movement of soil materials were evident within the affected section. The unstable slope conditions may increase the susceptibility of the area to future failures during prolonged rainfall events, thereby posing potential threats to nearby school grade 2, grade 1, play area, and library building.

*Figure 4g: Soil mass failure and soil erosion adjacent to mitigation location (Location 2)*

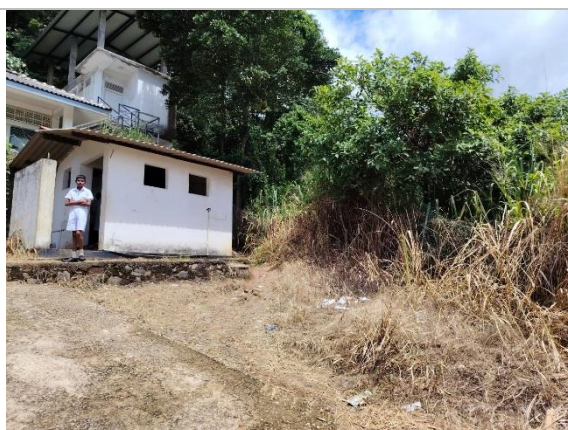
*Figure 4h: Library building, Washroom, and vegetation border with fence at the edge of the upslope (Location 2)*

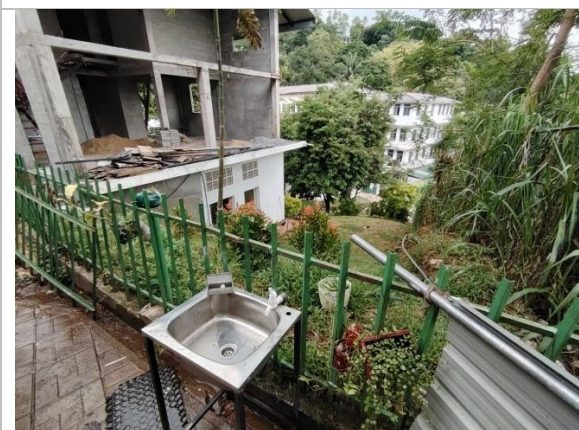
*Figure 4i: Fence and water line adjacent to the boundary of Sumangala College and Sylvester's College. Three storey building (Under construction) is nearby the mitigation location and the school boundary (Location 3)*

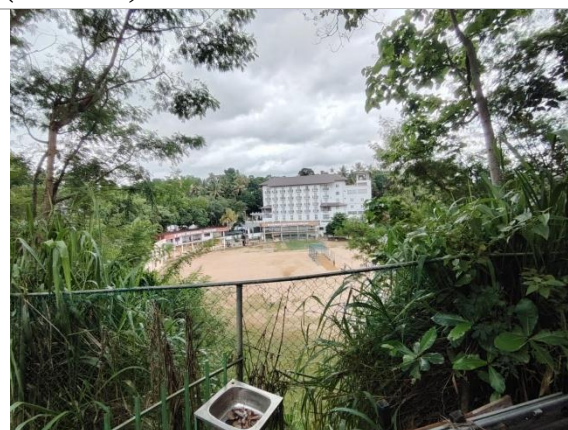
*Figure 4j: Water line, and fence net with vegetation which is adjacent to mitigation location, Playground of Sylvester's College is adjacent to toe area of downslope (Location 3)*

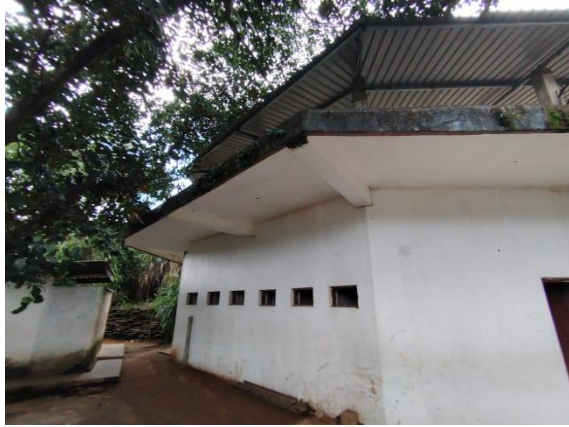
Figure 4k: Pavilion and Music room of two storey building adjacent to the playground, and washroom near by the mitigation area (Location 3)

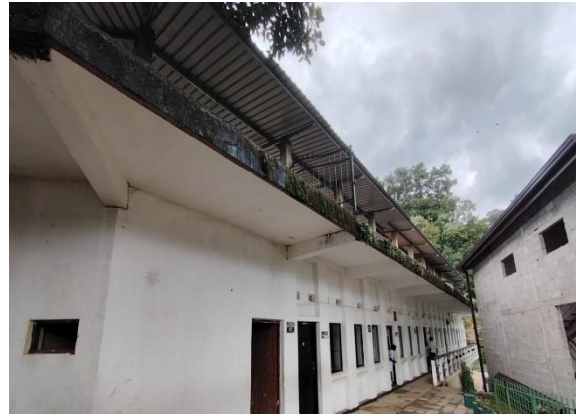
Figure 4l: Two storey building and the newly constructed building adjacent to the mitigation area (Location 3)
