## REDUCTION OF LANDSLIDE VULNERABILITY BY MITIGATION MEASURES PROJECT

Site Specific Environmental and Social Management Plan

## Site No. 50 Udapola estate, Paladeniya (Virugammanaya) Kegalle District

May 2021

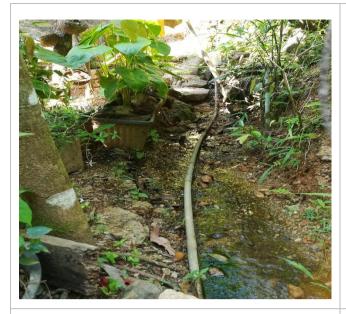
Figure 4: Elements and services those may be affected by the project actions

Figure 04 (a) – Water runs through a house due to non-availability of drainage system.

Figure 04 (b) – Vegetation surrounding the slope

Figure 04 (c) – Houses expose to unstable slope.
