REDUCTION OF LANDSLIDE VULNERABILITY BY MITIGATION MEASURES PROJECT

Site Specific Environmental and Social Management Plan

Site No. 160

**Failed Slope between culvert no. 18/3 and 18/5 of Galagedara -
Rambukkana (B122) Road**

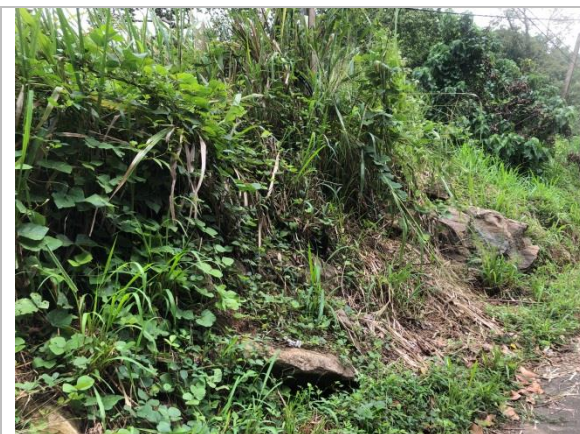
Figure 4a: Downslope area with debris deposit

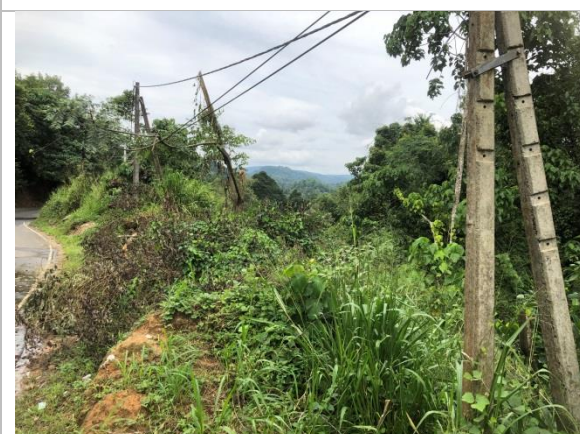
Figure 4c: Risk high tension electricity lines

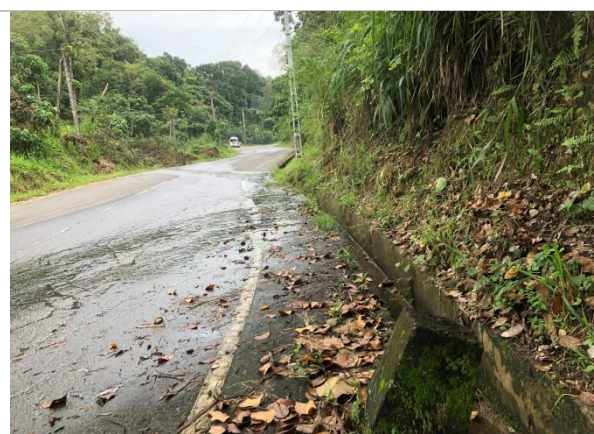
Figure 4d: Damaged road section

With the failed soil mass in 2019, rocks/debris had extended towards the road obstructing completely its passage for commuters and vehicle transportation for a day. It had blocked the access to Rambukkana and Hatharaliyadda area. The slope failure had damaged the road; cracks formed and electricity supply lines of the Ceylon Electricity Board. No any casualties or physical damages to the houses were reported.

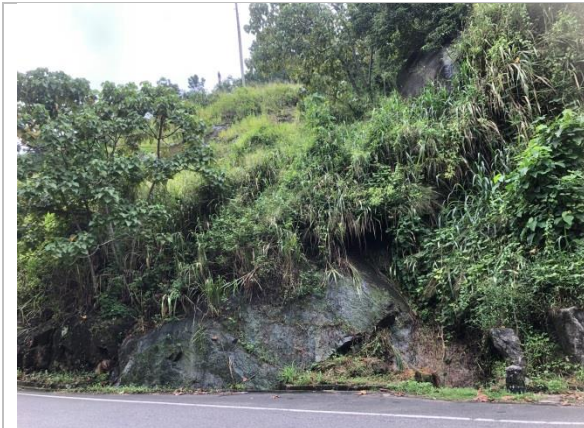
Figure 4e: Unstable rock boulders at the upslope

To prevent further collapse of unstable rock segments from the exposed bedrock, it is recommended to the rope hooking in the necessary sections. The area to be covered by this mitigation is around 300m².

7.2.2.4 Explosive hazards and hazardous materials Since the affected area has large rock boulders, explosives may be used if the rock blasting is envisaged. If the rock blasting is envisaged, it may pose risk due to unsafe use. If these operations are to be done on affected slopes the risk of improper use of explosive and accidents from rock fragments are significant. The impact is considered as highly significant because there are large rock boulders can be seen at the upslope.	Highly Significant
