REDUCTION OF LANDSLIDE VULNERABILITY BY MITIGATION MEASURES PROJECT

Site Specific Environmental and Social Management Plan

Site No. 164

**Slope Failure in between culvert No. 153/3 and 153/4 of Peradeniya -
Badulla - Chenkaladi Hwy (A5)**

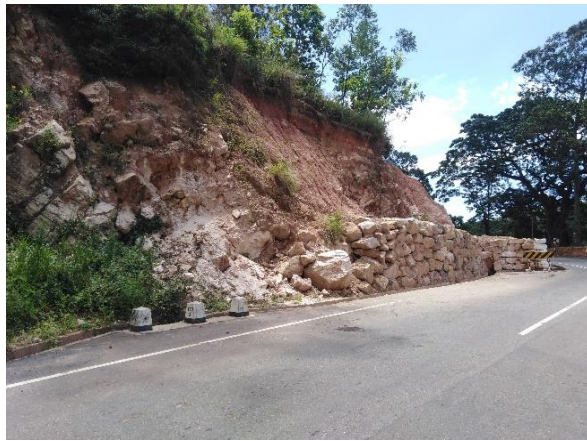
Figure 5a: Slope failure

The upslope land of the estate was damaged due to the slope failure. The failed debris (soil and rocks) mass had extended only up to the road. At present, a large block of moved soil mass is resting over the upslope road reservation area. The rubble wall which was temporary built by RDA to protection of the road and uses from further fallen rocks and soil debris. There was no damage recorded for people or vehicles.

This slope failure will be activated again with the upcoming rains and the road will be blocked with the falling rock and soil mass. During rainy season it poses a high risk on the commuters and vehicle transportation on the road due to potential risk of the slope failure. The unstable slope section in the tea plantation imposes a high risk on the workers of the tea estate.

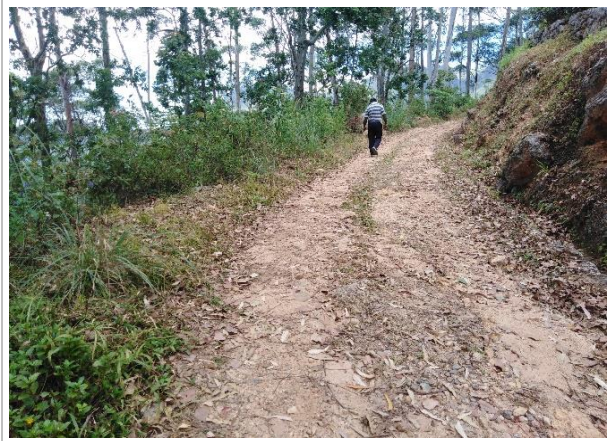
Figure 5b: Upslope road towards the estate

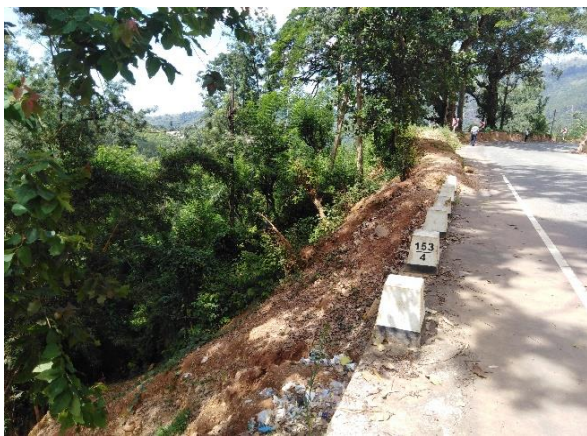
Figure 5c: Downslope area

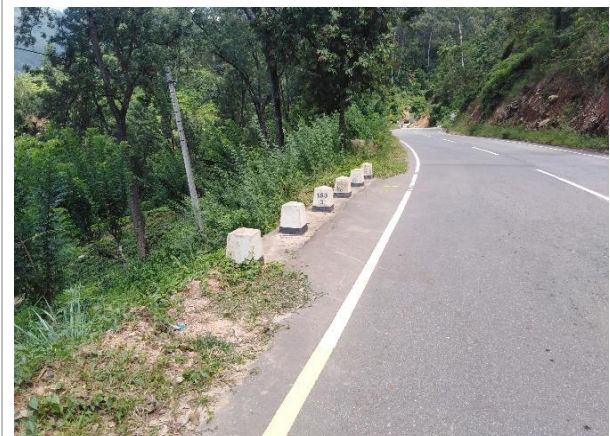
Figure 5d: Tea plantation and the road

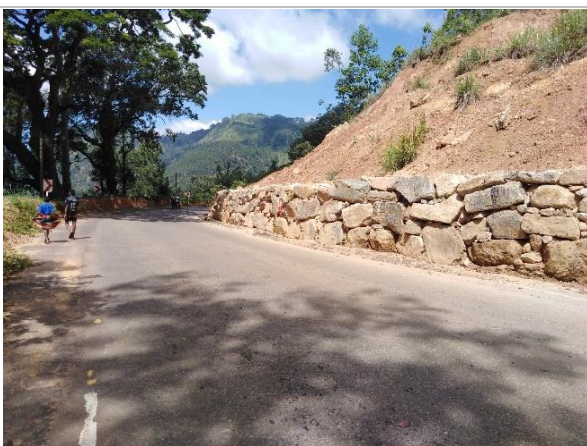
Figure 5e: Temporary built retaining wall

According to the request of the Lunugala Divisional Secretary, a preliminary field study was conducted by the Scientists of the National Building Research Organisation. Accordingly, considering the risk situation and the emergency situation at the place, recommendations for emergency response were issued. The rubble wall which was temporary built by RDA to protection of the road and uses from further fallen rocks and soil debris

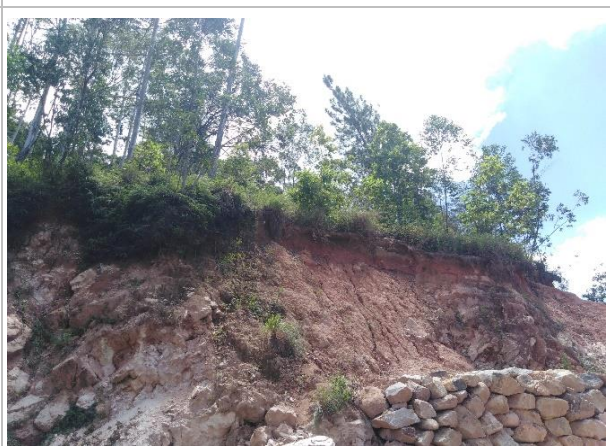
Figure 5f: Upslope vegetation
