REDUCTION OF LANDSLIDE VULNERABILITY BY MITIGATION MEASURES PROJECT

Site Specific Environmental and Social Management Plan

Site No. 165

**Failed Slope close to culvert No.166/14 of Peradeniya - Badulla -
Chenkaladi Hwy (A5)**

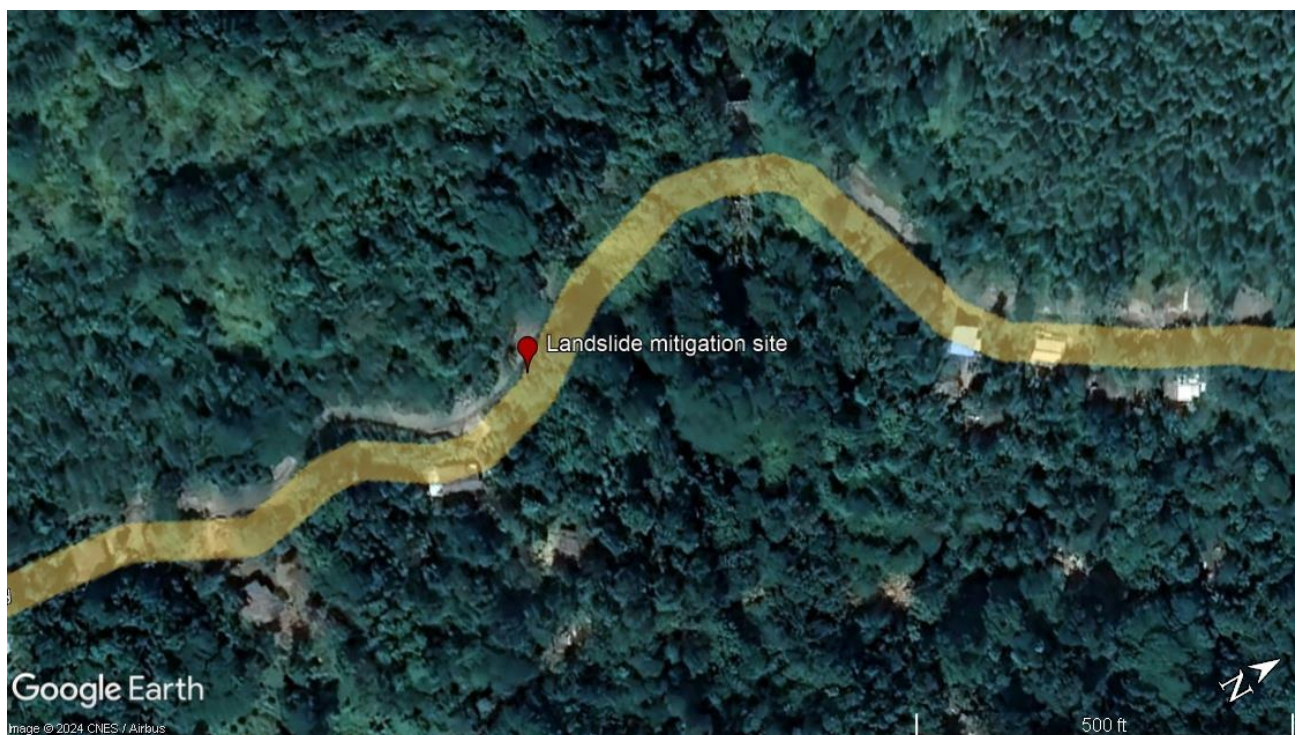
The proposed mitigation site is located close to culvert No.166/14 along Badulla to Bibila Road (LHS and RHS). The failed slope section is located in a sloppy terrain of Adawatta Estate where the natural slope has been cut for the road construction. The slope failure has emerged on the left-hand side in the upslope of the road including the road section and the reservation area. The elevation of the area is nearly 759 m. The extent of site proposed to be mitigated is about 4375 m². The land ownership of the upslope land is Adawatta Estate and the road reservation is owned by Road Development Authority. A natural stream called “Geradiya Ella is flowing at the downslope area.

Figure 2: Google image of the proposed landslide mitigation site, the surrounding environmental features and service infrastructure.

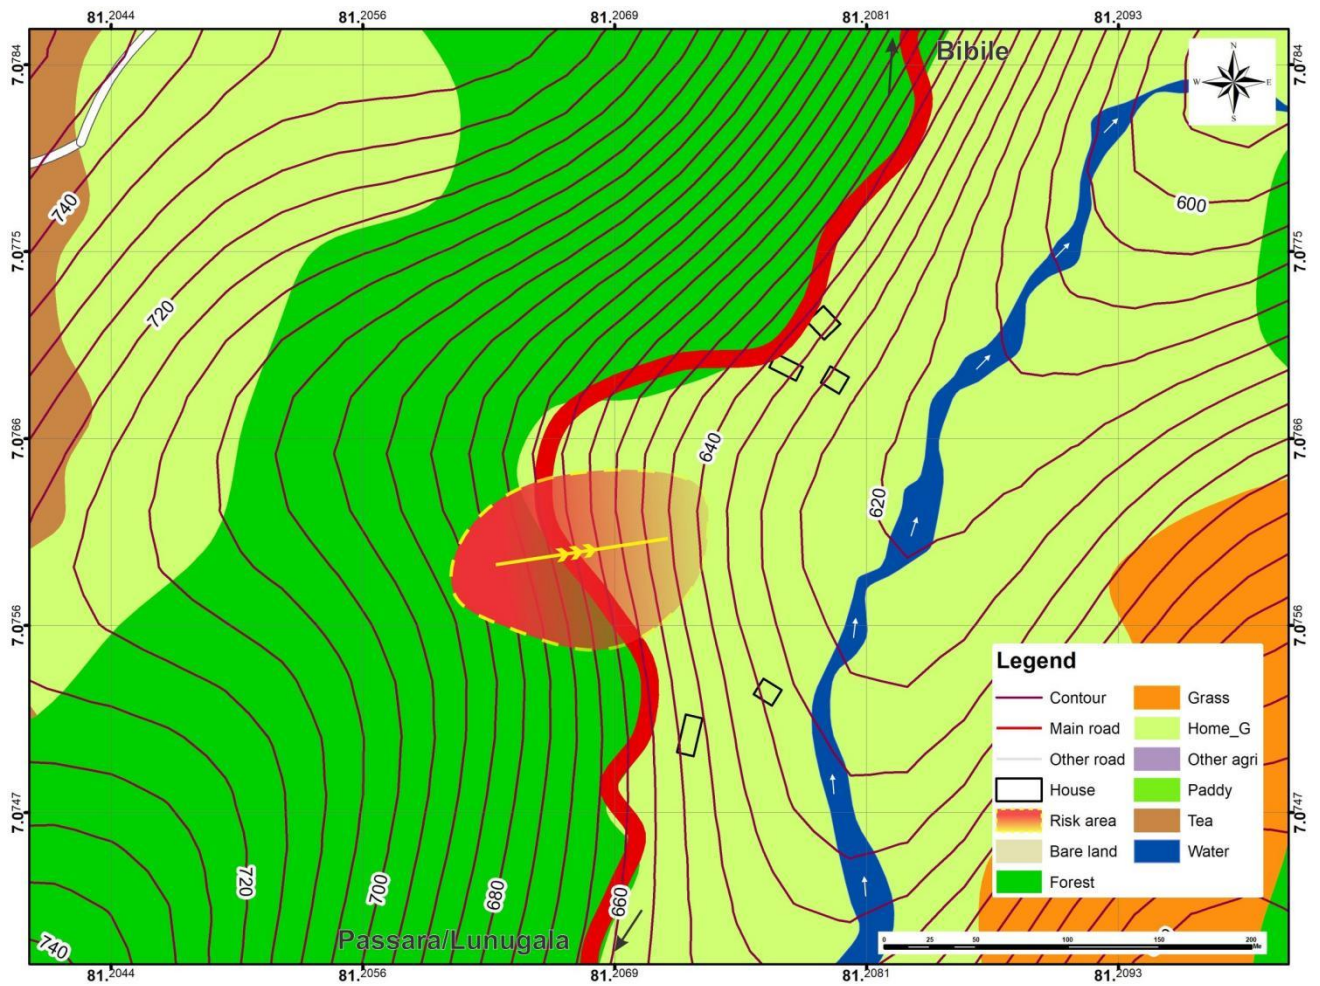
Figure 3: Google image, cross sections, land use and risk elements of the location

The area of the slope failure is located in an area where the slope had been cut to provide space to build the road; Badulla to Bibila (A5) close to culvert No.166/14. The vegetation in the already disturbed area due to the landslide is an abandoned tea and rubber plantations owned by the Adawatta Estate. More than 30m height two trees called “Dun tree” can be identified in the disturb upslope and its create a high risk to road. There are impinging loose weathered rocks and fractured pieces of rocks are seen at the upslope area. The downslope area consists of grasses and small shrubs and no cultivation. Fractured rocks and loose soils are also seen. There are no occupied houses directly upslope and downslope of the failed slope. A stream “Geradiya Ella” flows at the downslope area and Regulasi” bridge lies across the stream near this unstable slope area. A small tea boutique is located at the end of the upslope road shoulder area. This road is the only access road to Lunugala from Badulla area which provides the facilities and services to the public.

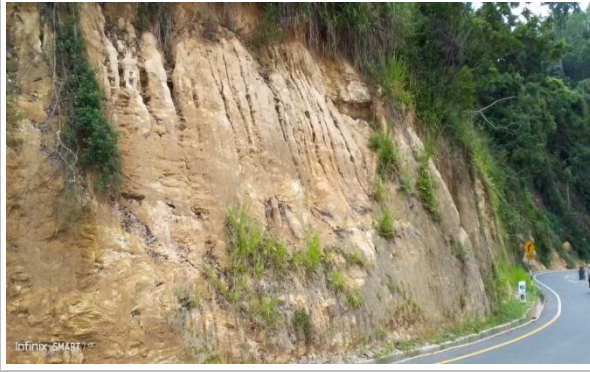
Figure 4a: Upslope area

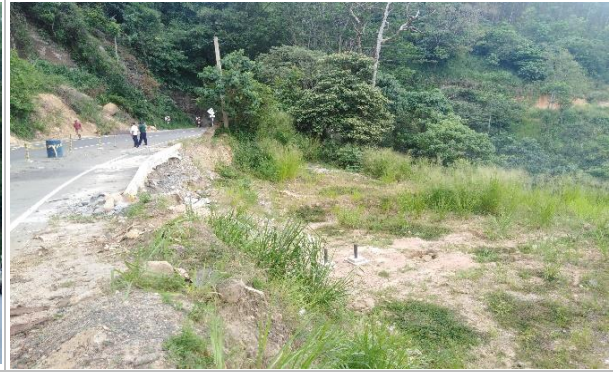
Figure 4b: Downslope area

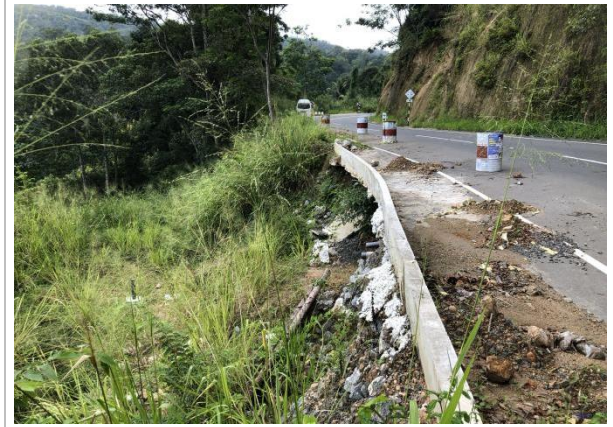
Figure 4d: Damaged road section

The failed soil mass accumulated on the road section and disturbed the access to Passara to Bibila area and vehicle transportation. No casualties, injuries, or damages to vehicles, however, the road shoulder (RHS/ LHS) was damaged due to the incident.

There are no remedial measures already undertaken to reduce the potential risk. The damaged road has been repaired temporarily and the damaged road section was closed using the barricade by RDA
